**SOUTH DAKOTA STATE HISTORIC PRESERVATION OFFICE
HISTORIC SITES SURVEY STRUCTURE FORM**

CURRENT FUNCTION: <u>Storage</u>	FOUNDATION: <u>Poured concrete</u>
CURRENT SUBFUNCTION: <u>Storage</u>	ROOF MATERIAL: <u>Cedar shingles</u>
HISTORIC FUNCTION: <u>Livestock barn</u>	ROOF SHAPE: <u>Gable roof</u>
HISTORIC SUBFUNCTION: <u>Hay and grain storage</u>	STRUCTURAL SYSTEM: <u>Balloon framing</u>
	STYLE: <u>Gable roof barn</u>
OCCUPIED: <u>Yes</u>	TYPE: <u>Livestock barn</u> <u>2x4 & 2x6 studs, 1x8</u> <u># 106 drop siding,</u> <u>1/2"x6" cedar lap</u> <u>siding and steel</u> <u>roofing</u>
ACCESSIBLE: <u>Yes with permission</u>	WALLS: _____
STORIES: <u>2</u>	SIGNIFICANT PERSON: <u>Wm. Slattery</u>
*DATE OF CONSTRUCTION: <u>1910 to 1920</u>	CULTURAL AFFILIATION: <u>?</u>

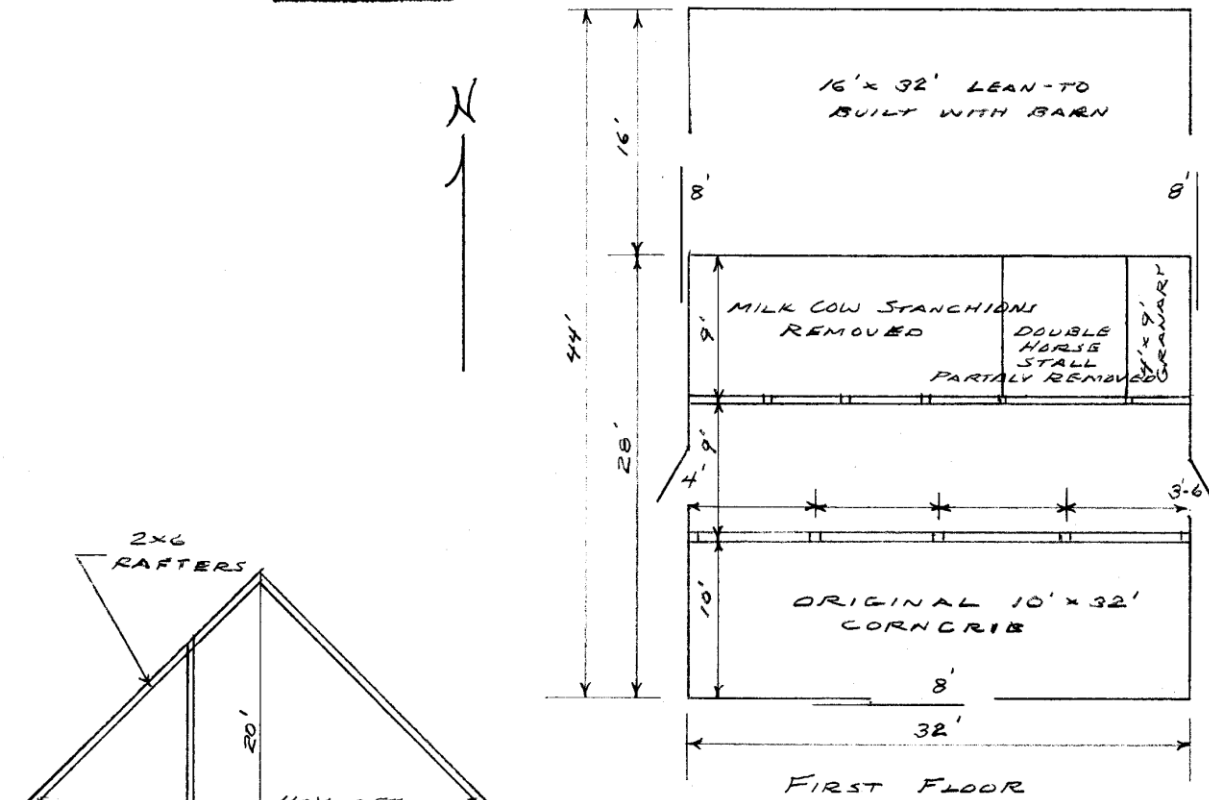
SKETCH MAP

- 2x4 STUDS
- 2x6 STUDS ADDED
- 1x6 CRIBBING BOARDS AND
- 1x8 #106
- DROP SIDING
- POURED CONCRETE FOUNDATION
- 2x4 STUDS
- 1x8 #106
- DROP SIDING
- 2x4 STUDS
- 1x8 SHIPLAP

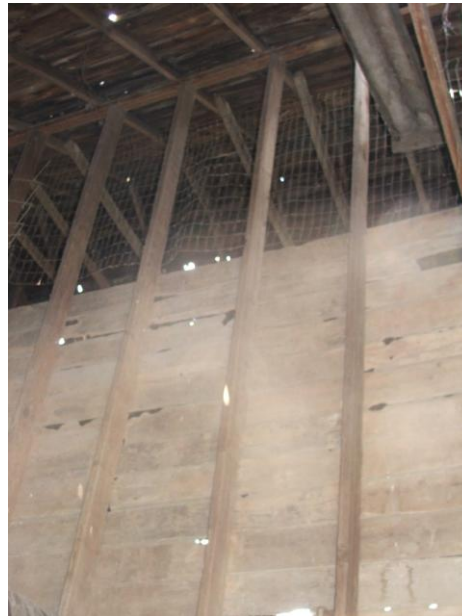
ROLL NUMBER: 5
PHOTO NUMBER: 5

First floor, looking North into corncrib, 2x6 stud wall, 1x8 #106 drop siding and wire at the top to keep corn out of the hayloft.

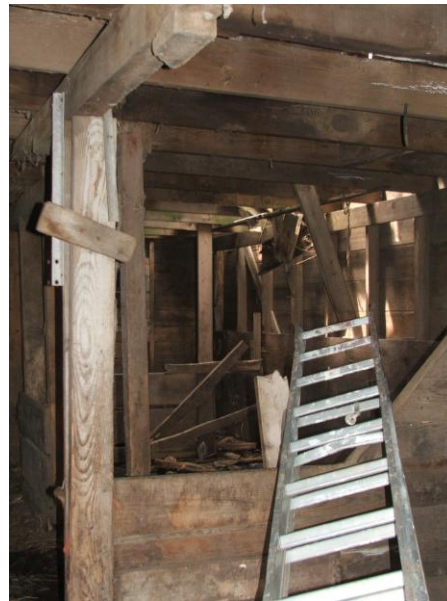
ROLL NUMBER: _____
PHOTO NUMBER: 6

INTERIOR NOTES: Two rows of 4x6 and (2) 2x6 posts, and 4x6 beams support the 2x8 joists for the 18' x 32' hayloft. 4' x 12' granary are still in the NE corner. A double horse stall was on the North wall and the owner stated that the rest of the north wall was where milk cow stanchions were.

First floor, looking NW, remains of double horse stall and where milk cow stanchions were.

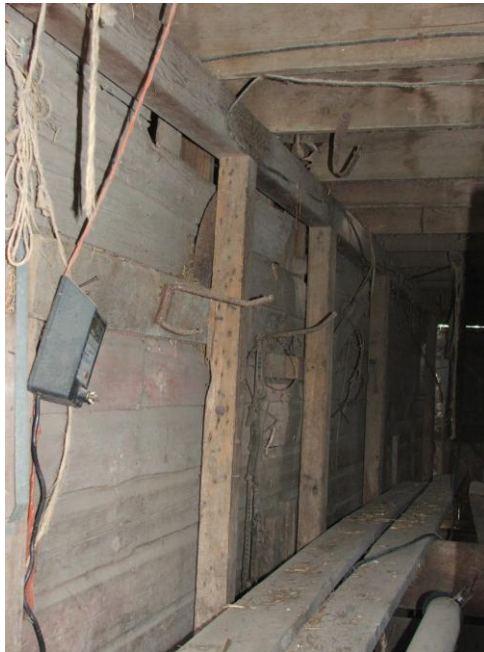
ROLL NUMBER: _____
PHOTO NUMBER: 7

CAMERA DIRECTION: First floor, looking SW,
4x6 posts and 4x6 beam
supporting South end of
2x8 joists for hayloft.

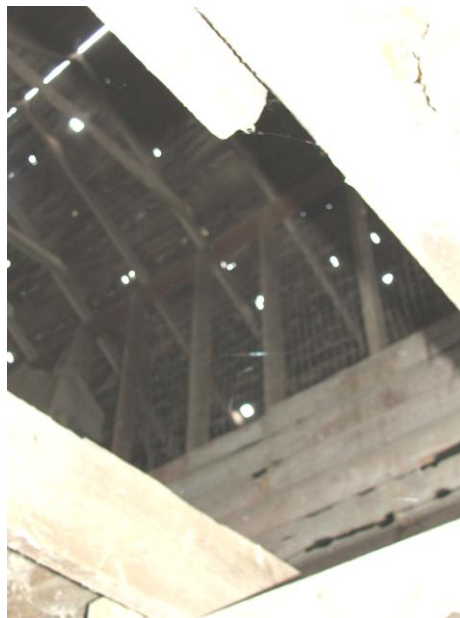
ROLL NUMBER: _____
PHOTO NUMBER: 8

CAMERA DIRECTION: Hayloft, looking SE,
North wall of corncrib
and bracing on rafters 4'
O. C.

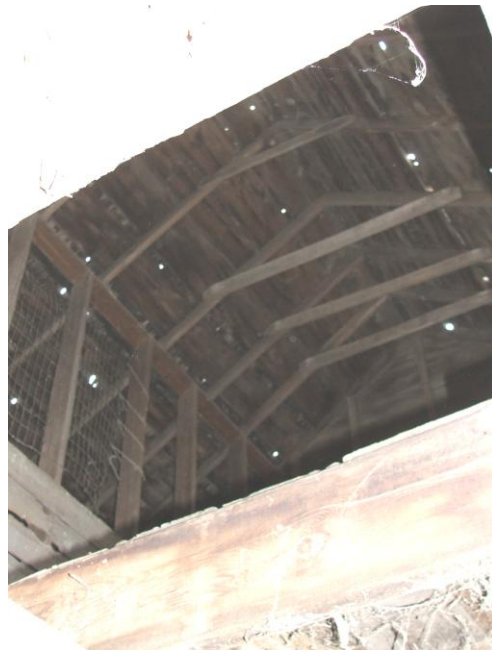
ROLL NUMBER: _____
PHOTO NUMBER: 9

**Hayloft, looking SW,
North wall of corn crib
and rafter bracing 2' O.
C.**

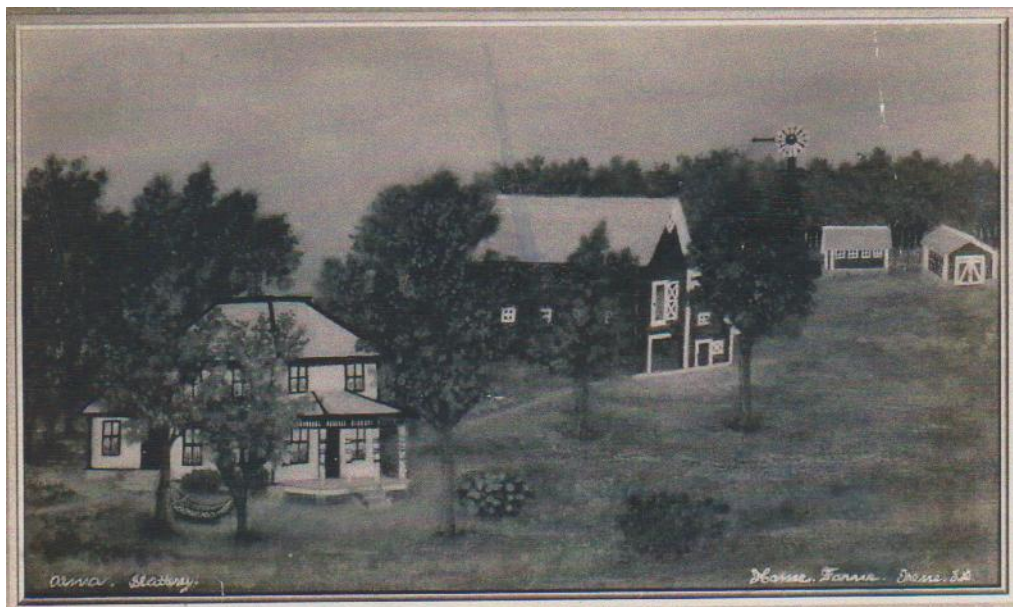
ROLL NUMBER: _____
PHOTO NUMBER: 10

**Photo of a painting from
the very early 1900's.**
