#### SITE INFORMATION

May 24, 2012 \*SURVEY DATE: Correction Nov. 7, 2013 \*SURVEYOR: Jim Stone

\*ADDRESS: 30222 458<sup>th</sup> Ave.

STRUCTURE DETAILS				
SHPO ID:		_		
*PROPERTY NAME:				
OTHER NAME:				
<b>CURRENT FUNCTION:</b>	Vacant	FOUNDATI	ION:	Poured concrete
CURRENT SUBFUNCTION:	Storage	ROOF MATER	IAL:	Steel
HISTORIC FUNCTION:	Livestock barn	ROOF SHA	APE:	Gambrel
HISTORIC SUBFUNCTION:	Hay and grain storage	STRUCTURAL SYST	EM:	Balloon framing
		STY	YLE:	Gambrel roof barn
OCCUPIED:	Yes	TY	YPE:	Livestock barn
ACCESSIBLE:	Yes with permission	WAI	LLS:	2x6 and 2x8, sheathing & ½"x6" cedar lap siding
STORIES:	2	SIGNIFICANT PERSON:	N	/illiam W. Schmidt
*DATE OF CONSTRUCTION:	1915 to 1925 CU	ILTURAL AFFILIATION:		?

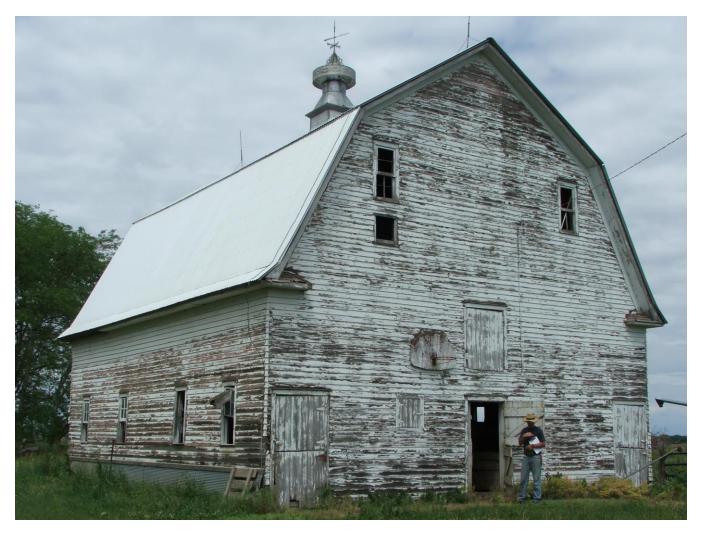
DATE OF PHOTO:
 May 24, 2012
 PHOTO NUMBER:
 2

CAMERA DIRECTION:
 Looking NE, SW corner

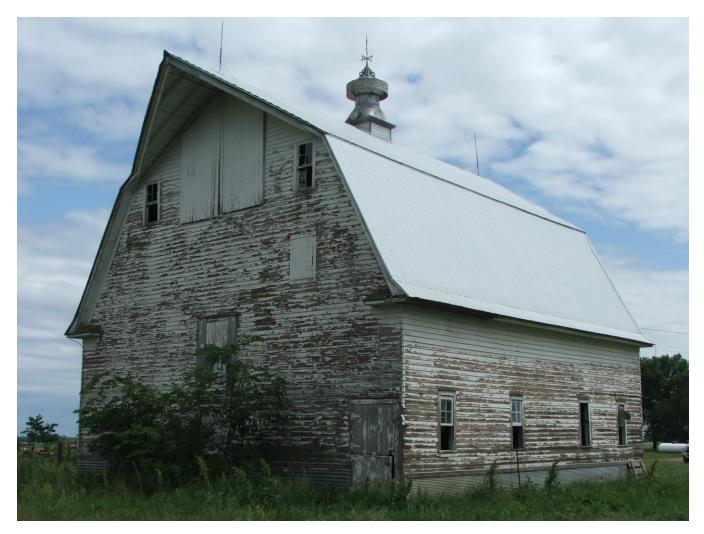
DATE OF PHOTO:
 May 24, 2012
 PHOTO NUMBER:
 3

CAMERA DIRECTION:
 Looking SE, NW corner

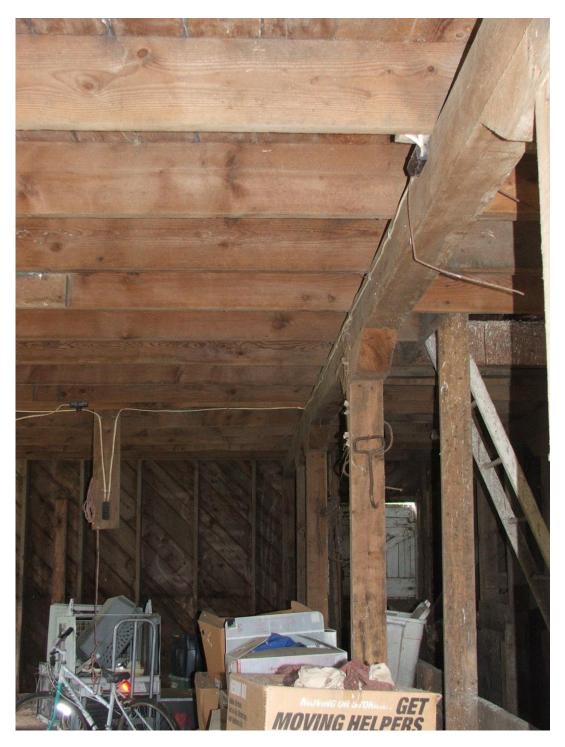
5 First floor, looking North, 6x6 posts & 6x8 beam

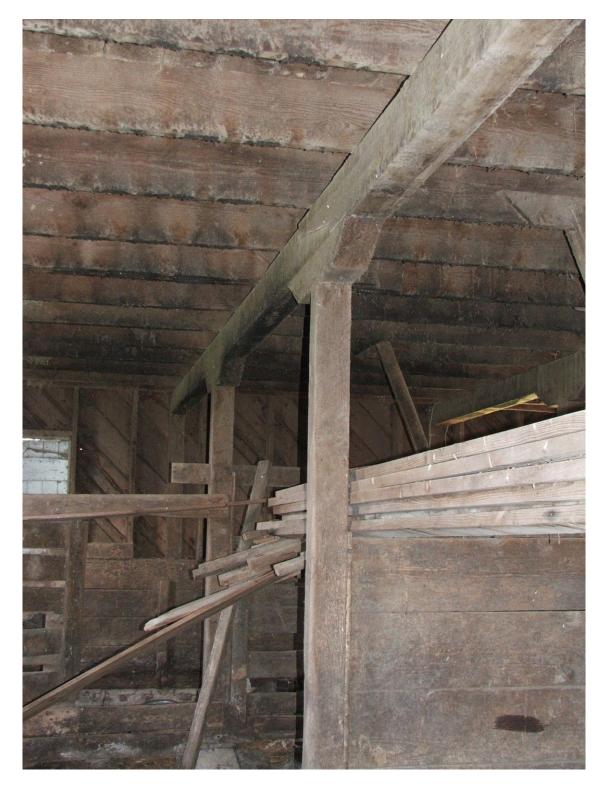
ROLL NUMBER:	
PHOTO NUMBER:	6
	First floor, looking
	South, 6x6 posts & 6x8
CAMERA DIRECTION:	beam

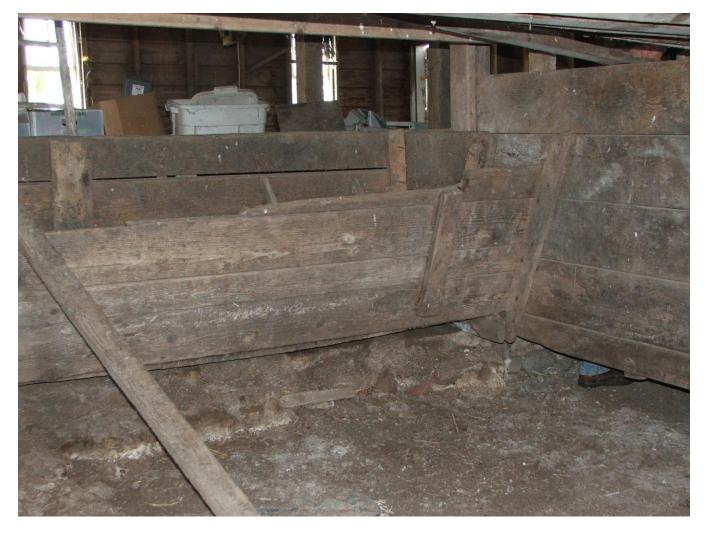
ROLL NUMBER:	
PHOTO NUMBER:	7
CAMERA DIRECTION:	First floor, looking West into original horse stall

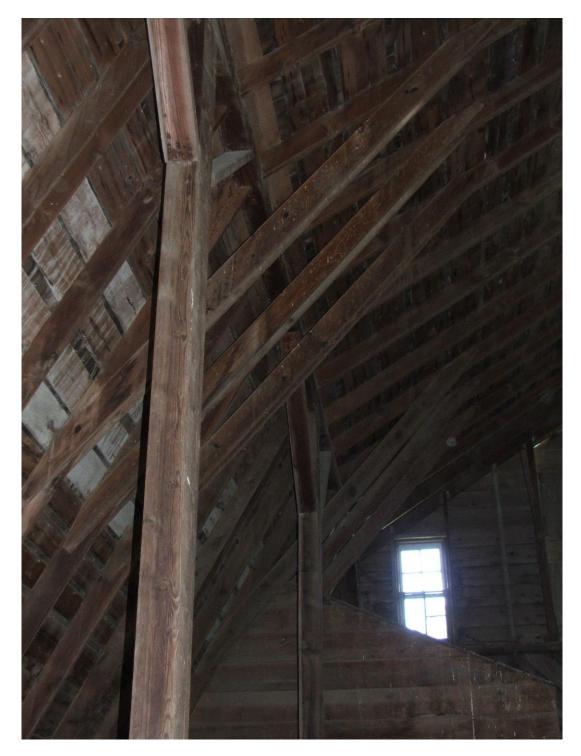
DATE OF PHOTO:
 May 24, 2012
 PHOTO NUMBER:
 8

Hayloft, looking North,<br/>6x6 post, 6x6 rafter &<br/>rafter bracing
 6x6 rafter &<br/>rafter bracing

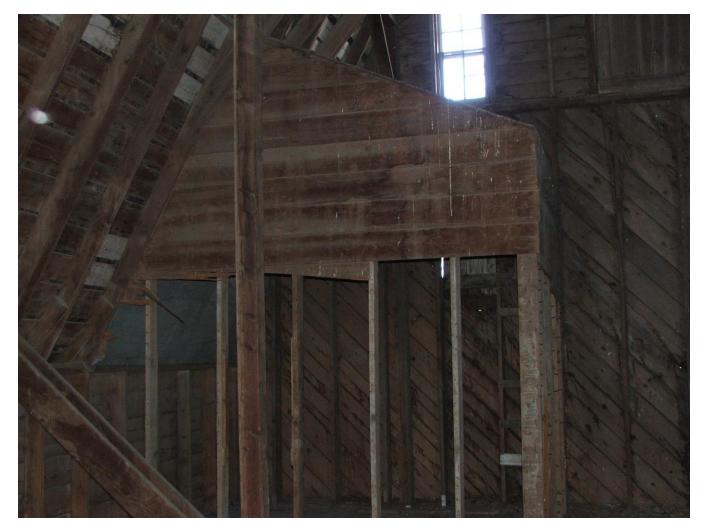
9 Hayloft, granary in NW corner, with roof over granary

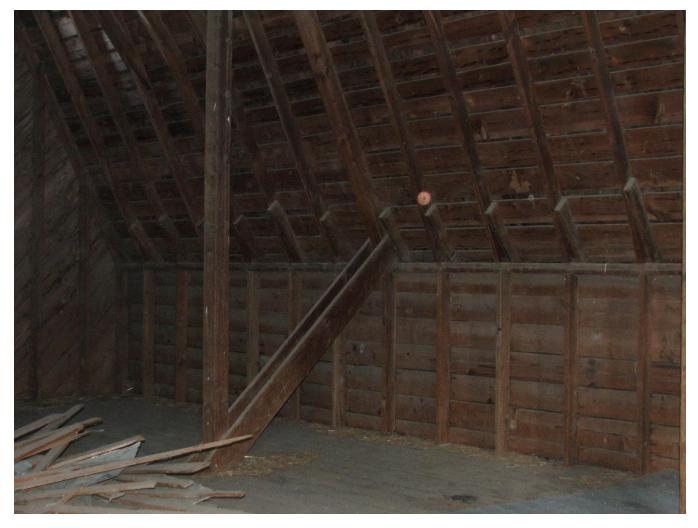
**ROLL NUMBER:** PHOTO NUMBER: 10 Hayloft, looking NE, two 2x10's bracing from 6x6 rafter to bottom of 6x6
