**SOUTH DAKOTA STATE HISTORIC PRESERVATION OFFICE
HISTORIC SITES SURVEY STRUCTURE FORM**

*SURVEY DATE: May 11, 2013 *ADDRESS: 29896 463rd Ave.
*SURVEYOR: Jim Stone *COUNTY: Clay
*CITY: Centerville

OCCUPIED: Yes STYLE: Western feeder barn
 TYPE: Livestock barn
2x4& 2x6studs, 1x6 drop siding, 1/2"x6" cedar lap siding and covered partially with steel
 ACCESSIBLE: Yes with permission WALLS: _____

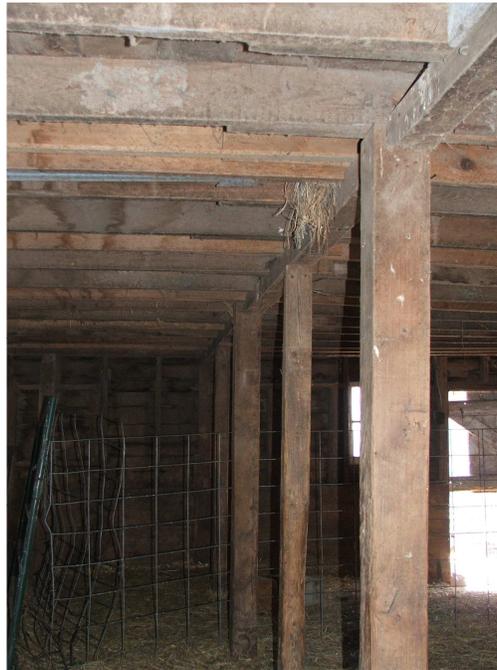
ROLL NUMBER: 5
PHOTO NUMBER: 5

INTERIOR NOTES: Three rows of 4x6 posts support 4x6 beams, which support 2x6 floor joists.

CAMERA DIRECTION: First floor, looking NW ,
4x6 posts and 4x6 beam,
2x6 floor joists

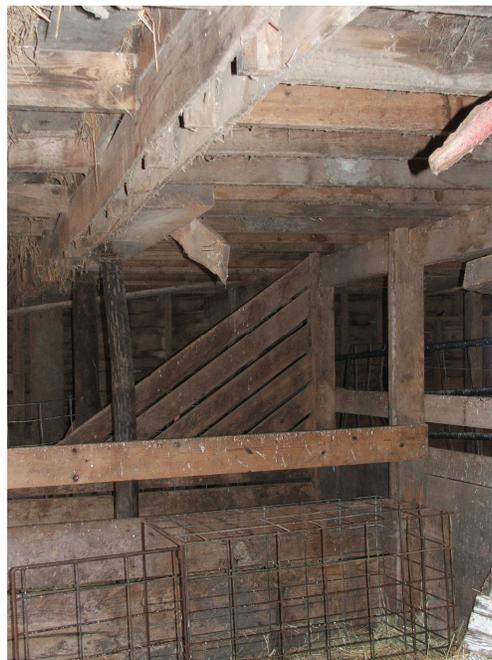
ROLL NUMBER: 6
PHOTO NUMBER: 6

ALTERED/MOVED NOTES: Roof has steel roofing and walls have been covered with some steel roofing over the 1/2 x 6 cedar lap siding over 1x6 drop siding. Interior 2x4 wall was removed and supported by 4x6 posts and 4x6 beam 2' south, lean-to removed from the west side.

CAMERA DIRECTION: First floor, looking NW,
2x4 wall cutout, post and
beam installed 2' south

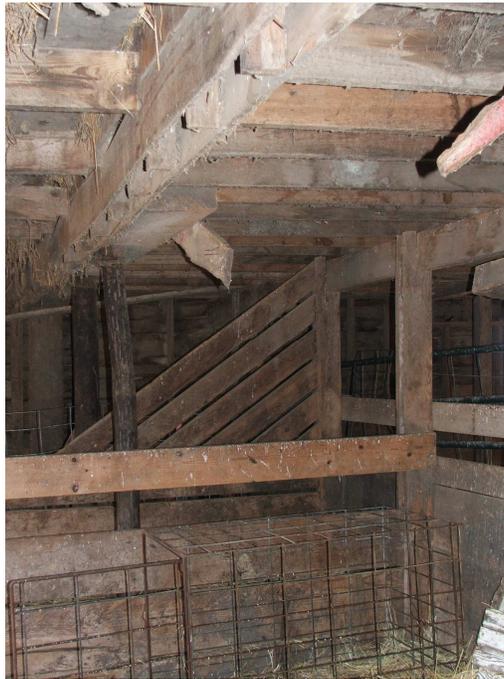
ROLL NUMBER: 7
PHOTO NUMBER: 7

**Looking NW, stair railing
& looking down stairs
from second floor**

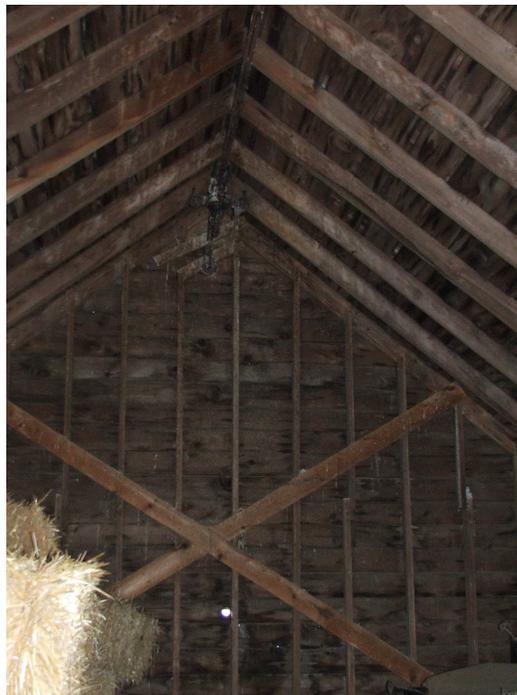
ROLL NUMBER: 8
PHOTO NUMBER: 8

**Hayloft, looking west,
west gable end**

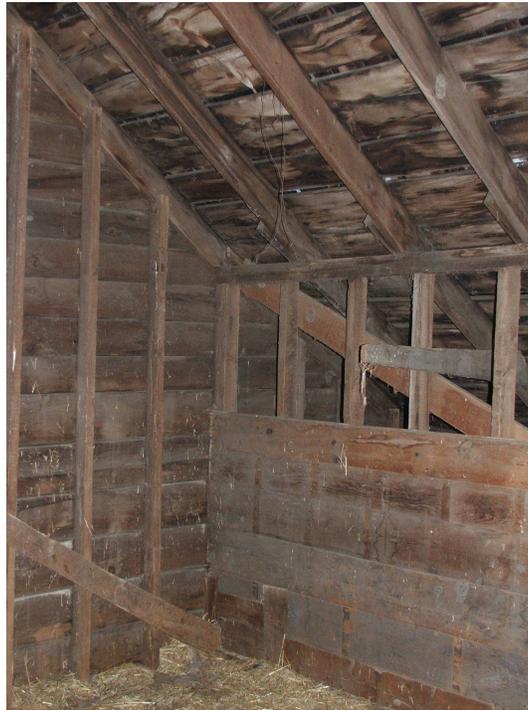
ROLL NUMBER: 9
PHOTO NUMBER: 9
CAMERA DIRECTION: Hayloft, looking SE, 7'
wall in hayloft, 2x4 studs,
2x6 rafters
