SOUTH DAKOTA STATE HISTORIC PRESERVATION OFFICE
HISTORIC SITES SURVEY STRUCTURE FORM

*ADDRESS: 30624 464th Ave.
*COUNTY: Clay
*CITY: Centerville

HISTORIC FUNCTION: Horse barn

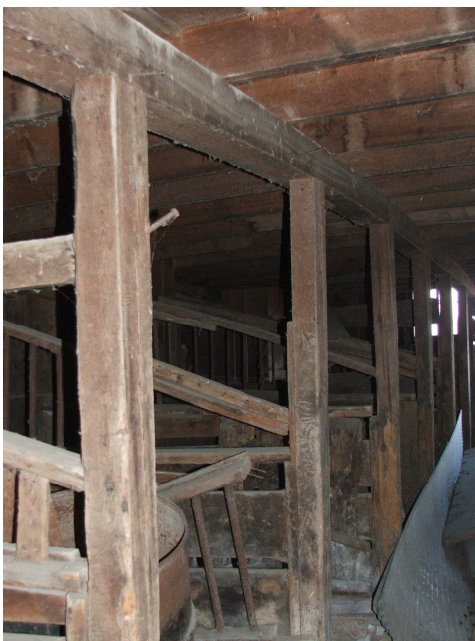
ROLL NUMBER: _____
PHOTO NUMBER: 5

CAMERA DIRECTION: First floor, looking North,
single horse stalls on
West side.

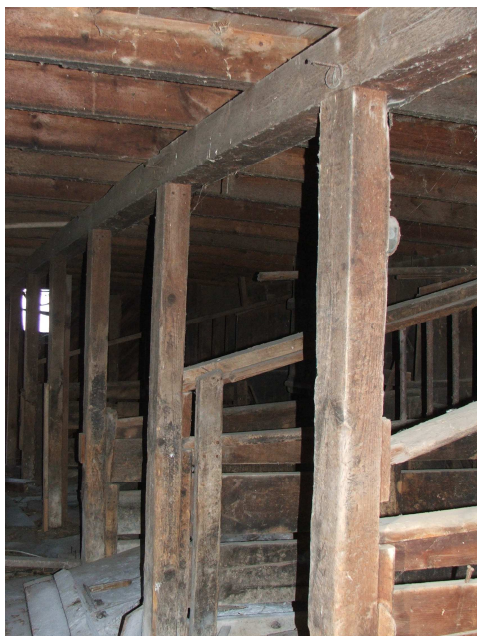
ROLL NUMBER: _____
PHOTO NUMBER: 6

CAMERA DIRECTION: First floor, Looking
North, single horse stalls
on the East side.

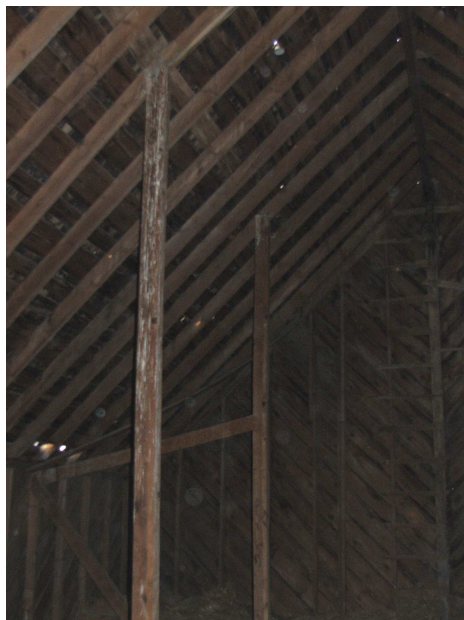
ROLL NUMBER: _____
PHOTO NUMBER: 7

CAMERA DIRECTION: Hayloft, looking North,
4x6 posts 10' O. C. note
lack of beam to support
rafters

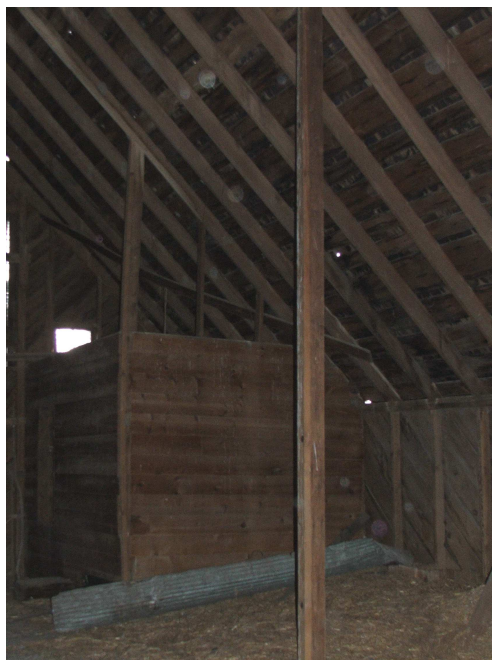
ROLL NUMBER: _____
PHOTO NUMBER: 8

CAMERA DIRECTION: Hayloft, looking SW,
granary in SW corner
