#### **SITE INFORMATION**

#### STRUCTURE DETAILS

SHPO ID:		<u>-</u>							
*PROPERTY NAME:									
OTHER NAME:									
CURRENT FUNCTION:	Storage	FOUNDATION:	Poured concrete foundation						
CURRENT SUBFUNCTION:	Storage	ROOF MATERIAL:	Corri galv. steel roofing over cedar shingles						
HISTORIC FUNCTION:	Dairy barn	ROOF SHAPE:							
HISTORIC SUBFUNCTION:		STRUCTURAL SYSTEM:							
morewice sobi enerion.	Tray and grain storage	-	Gable roof barn						
OCCUPIED:	Yes	TYPE:	-						
ACCESSIBLE:	Yes with permission	WALLS:	vertical siding and corri. galv. steel						
STORIES:	2	SIGNIFICANT PERSON: An	aton Henrikson						
*DATE OF CONSTRUCTION:		LTURAL AFFILIATION:	?						
ALTERED/MOVED NOTES: Original site. Milk cow stanchions have been removed. Roof and walls									
are covered with 26" wide galvanized corrugated steel roofing. Interior has been remodeled into horse									
barn. Two double horse stalls have been added and two pens added on West side.

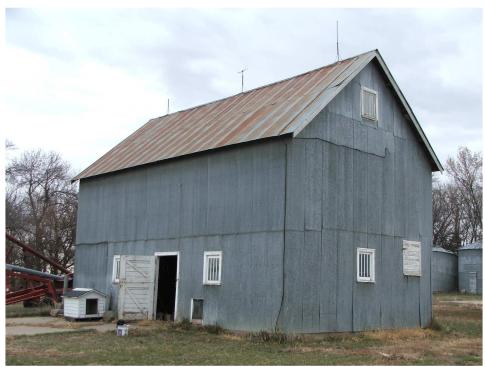
DATE OF PHOTO: October 30, 2012 PHOTO NUMBER: 1

CAMERA DIRECTION: Looking NE, SW corner

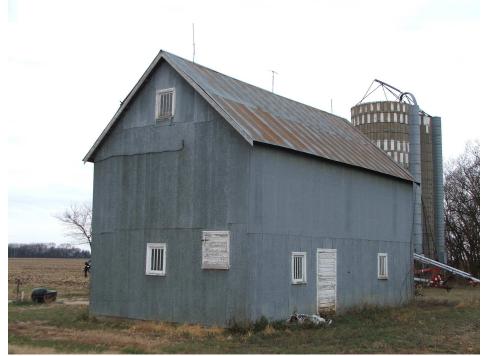
PHOTOGRAPHER: Jim Stone ROLL NUMBER:
DATE OF PHOTO: October 30, 2012 PHOTO NUMBER: 2
CAMERA DIRECTION: Looking NW, SE corner

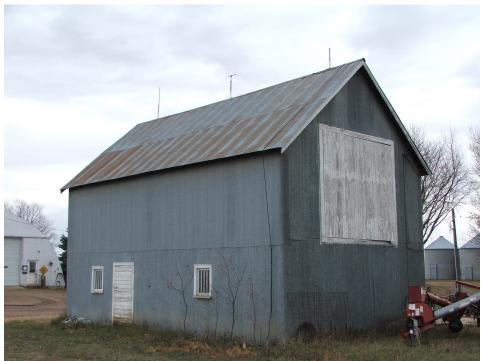
PHOTOGRAPHER: Jim Stone ROLL NUMBER: DATE OF PHOTO: October 30, 2012 PHOTO NUMBER: 3
CAMERA DIRECTION: Looking SW, NE corner

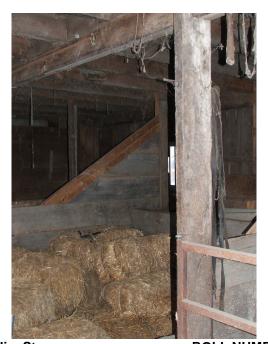
CAMERA DIRECTION: granary in NE corner

First floor, looking NE,

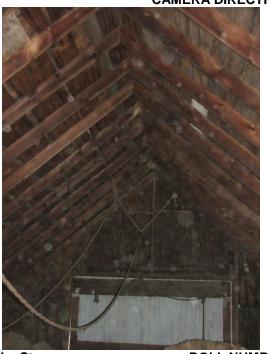
Hayloft, looking West, 2x6 bracing from top of

CAMERA DIRECTION: wall down to floor.
