**SOUTH DAKOTA STATE HISTORIC PRESERVATION OFFICE
HISTORIC SITES SURVEY STRUCTURE FORM**

*SURVEY DATE: April 3, 2013 *ADDRESS: 29747 467th Ave.
*SURVEYOR: Jim Stone *COUNTY: Clay
*CITY: Beresford

CURRENT FUNCTION: Calving barn

HISTORIC FUNCTION: Livestock barn

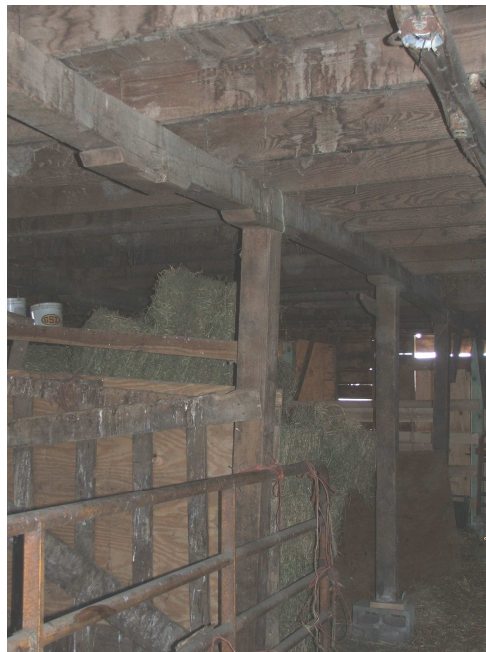
ALTERED/MOVED NOTES: Moved from NE 1/4 of Section 17, Glenwood twp., about 3 miles.
Any evidence of horse stalls and milk cow stanchions has been removed. Owner says that the horse stalls were on the North wall. Posts in barn have rotted off and are being replaced with 6x6 treated posts.

ROLL NUMBER: _____
PHOTO NUMBER: 4
CAMERA DIRECTION: First floor, looking SW,
6x6 treated posts and
6x6 beam

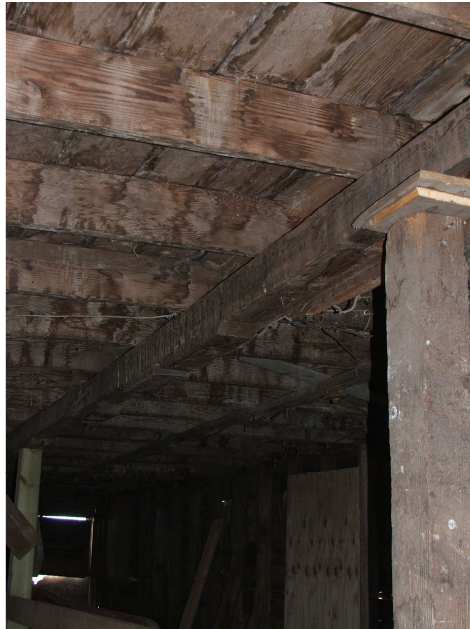
CAMERA DIRECTION: First floor, looking NW,
6x6 posts, 6x6 beam
and 2x8 floor joists.

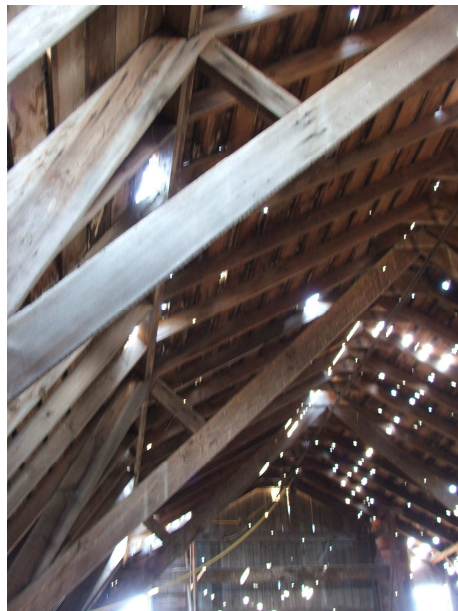
CAMERA DIRECTION: Hayloft, looking East,
2x10 bracing from peak
down to top of wall, 12'
O. C., Shawver truss
system

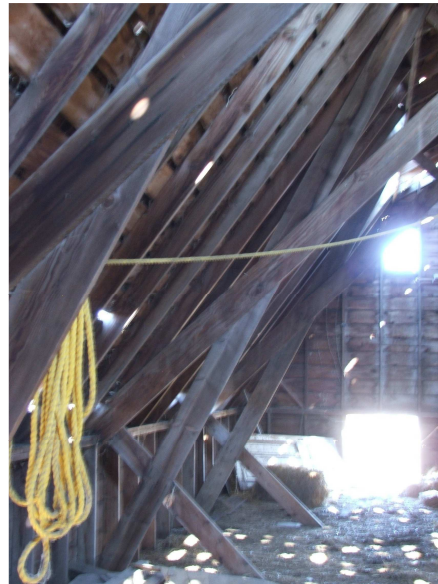
**Hayloft, looking East,
2x10 from hip down to
the floor, 2x10 from peak
down to the top of wall
on hayloft, this is a
Shawver truss system,
also a 2x10 from the top
of wall down to floor
joists, all 12' O. C.**

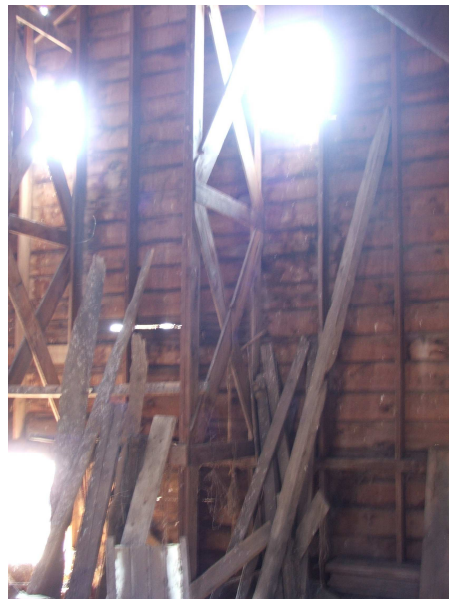
**Hayloft, looking SW,
vertical truss to re-
enforce Gable end wall**

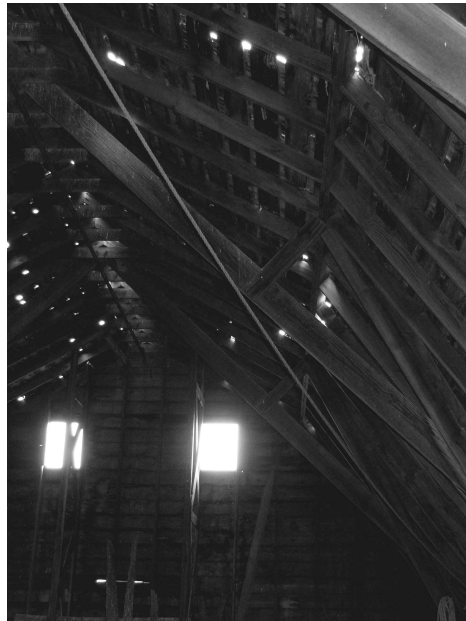
**Hayloft, looking West,
upper part of Shawver
truss, 2x10 from peak
down to top of wall 12'
O.C.**

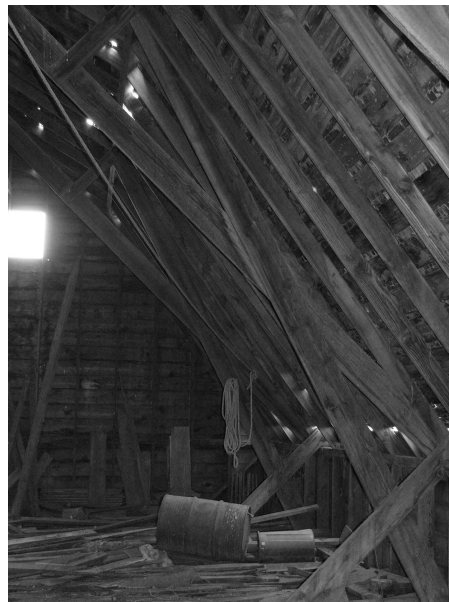
**Hayloft, looking West,
lower part of Shawver
truss. 2x10 from hip to
floor and 2x10 from peak
down to top of wall, 12'
O. C.**

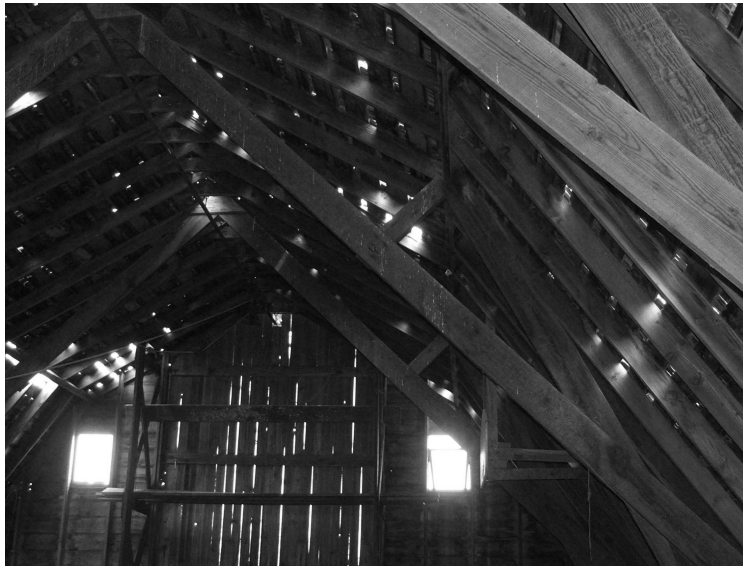
**Hayloft, looking East,
upper part of Shawver
truss, 2x10 from the
peak down to top of wall
and 2x20 from hip down
to floor, 12' O. C.**

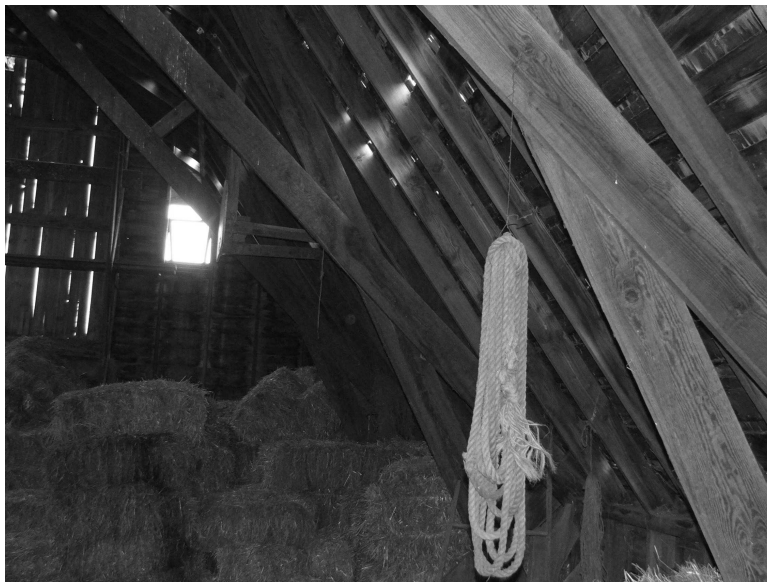
**Hayloft, looking East,
lower part of Shawver
truss, 2x10 from peak
down to top of wall
and 2x10 from hip down to
the floor, 12' O. C.**
