**SOUTH DAKOTA STATE HISTORIC PRESERVATION OFFICE
HISTORIC SITES SURVEY STRUCTURE FORM**

*SURVEY DATE: November 27, 2012 *ADDRESS: 46470 303rd Street
*SURVEYOR: Jim Stone *COUNTY: Clay
*CITY: Centerville

CURRENT FUNCTION: <u>Calving and cattle</u>	FOUNDATION: <u>Poured concrete foundation</u>
CURRENT SUBFUNCTION: <u>Storage</u>	ROOF MATERIAL: <u>Asphalt shingles over cedar shingles</u>
HISTORIC FUNCTION: <u>Livestock barn</u>	ROOF SHAPE: <u>Gable</u>
HISTORIC SUBFUNCTION: <u>Hay storage</u>	STRUCTURAL SYSTEM: <u>Balloon framing</u>
OCCUPIED: <u>Yes</u>	STYLE: <u>Gable roof barn</u>
ACCESSIBLE: <u>Yes with permission</u>	TYPE: <u>Livestock barn</u>
	WALLS: <u>2x4 studs with 1x6 #106 drop siding</u>
STORIES: <u>2</u>	SIGNIFICANT PERSON: <u>Andrew Norin</u>
*DATE OF CONSTRUCTION: <u>About 1900</u>	CULTURAL AFFILIATION: <u>?</u>

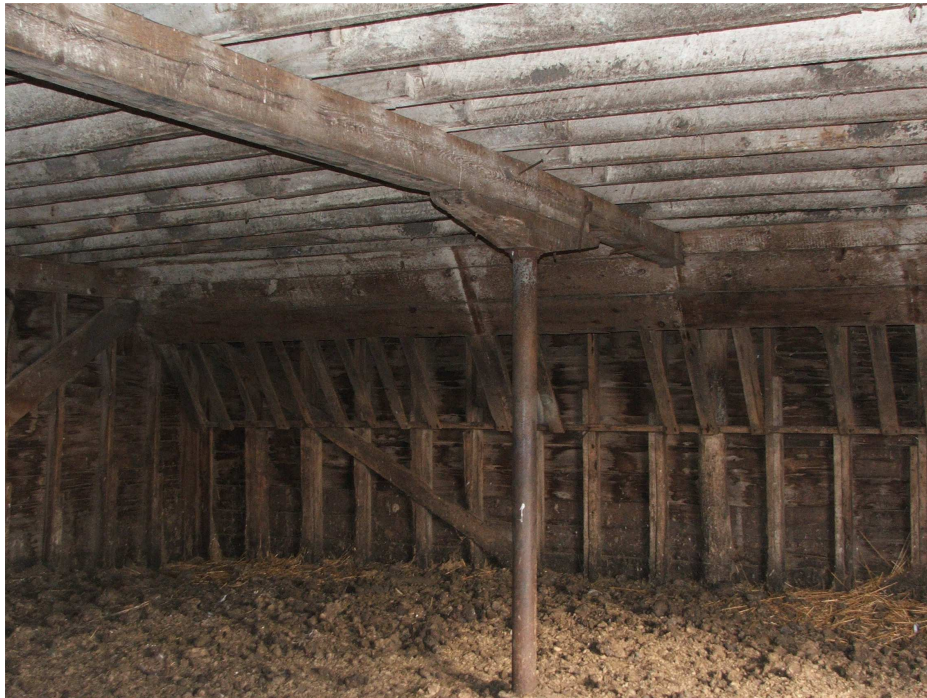
ALTERED/MOVED NOTES: Original site. Any evidence of milk cow stanchions or horse stalls has been removed. Roof has been shingled with asphalt shingles. Has been converted into a barn for cattle. Has hay feed racks on the East and West walls to feed cattle in bad weather. There are trap doors in hay-loft floor to lift up to fill hay feed racks below and then close to retain heat.

ROLL NUMBER: _____
PHOTO NUMBER: 5
CAMERA DIRECTION: First floor, looking East,
Feed rack on East wall

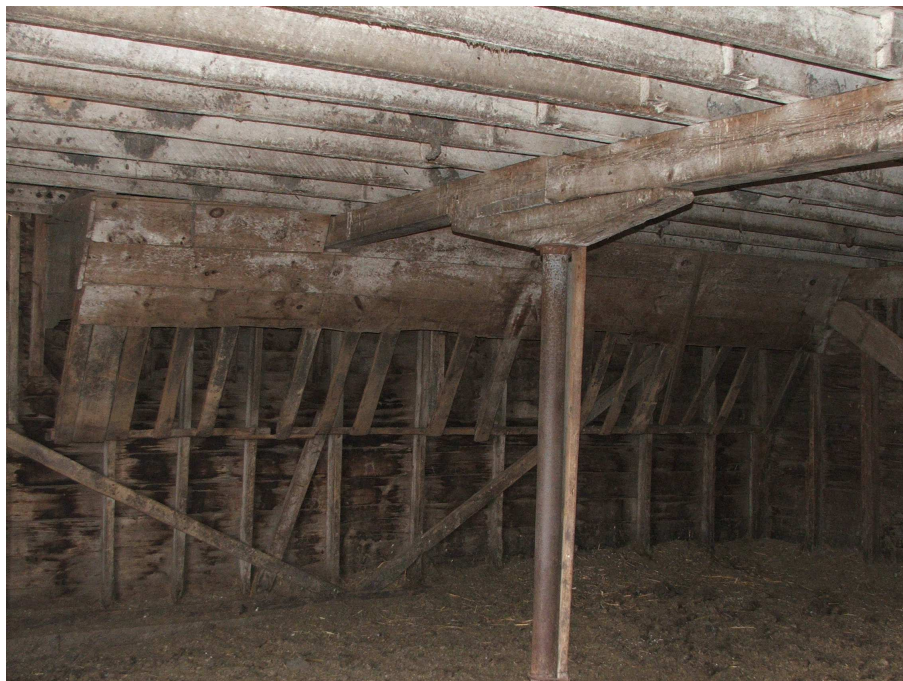
ROLL NUMBER: _____
PHOTO NUMBER: 6
CAMERA DIRECTION: First floor, looking West,
feed rack on West wall.

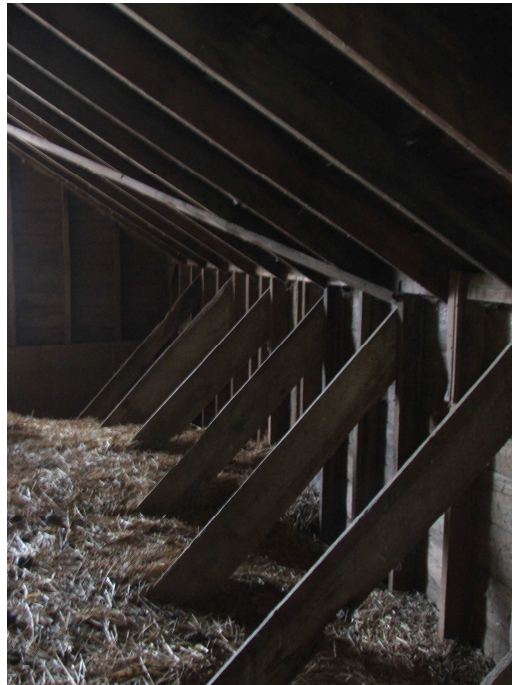
ROLL NUMBER: _____
PHOTO NUMBER: 7

OTHER NOTES: 2x4 stud walls with 1x6 #106 drop siding. Rafters are 2x6's. 1x8 bracing from top of wall in hayloft down to floor joists, 4' O.C. Has two galvanized metal ventilators on ridge of roof. Windows are 8"x10" four light over 8"x10" four light in the East gable end. The balance of windows are 8"x10" four light.

CAMERA DIRECTION: Hayloft, looking East,
2x6 rafters and 1x8
bracing 4' O.C.

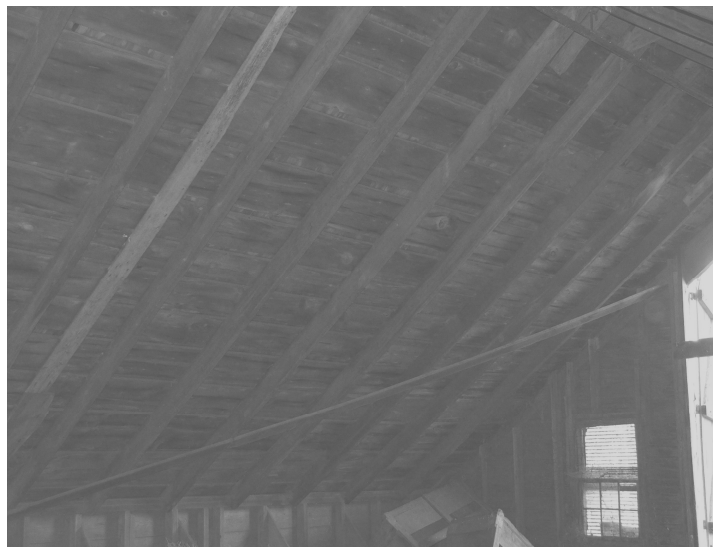
ROLL NUMBER: _____
PHOTO NUMBER: 8

CAMERA DIRECTION: Hayloft, looking NE,
rafters and diagonal
bracing on bottom of
rafters .
