SITE INFORMATION

STRUCTURE DETAILS

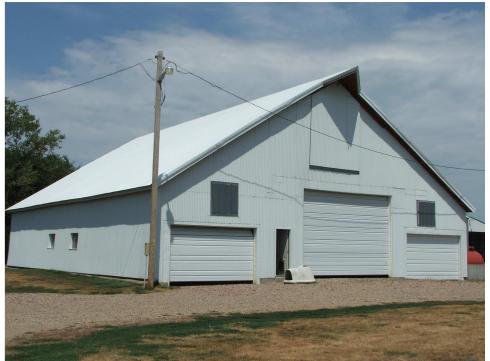
DATE OF PHOTO: July 23, 2012 PHOTO NUMBER: 1

CAMERA DIRECTION: Looking NE, SW corner

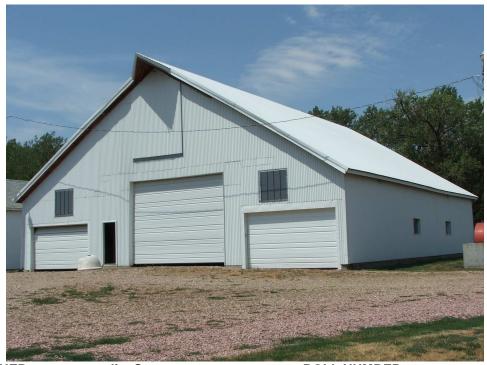
PHOTOGRAPHER: Jim Stone ROLL NUMBER:
DATE OF PHOTO: July 23, 2012 PHOTO NUMBER: 2
CAMERA DIRECTION: Looking NW, SE corner

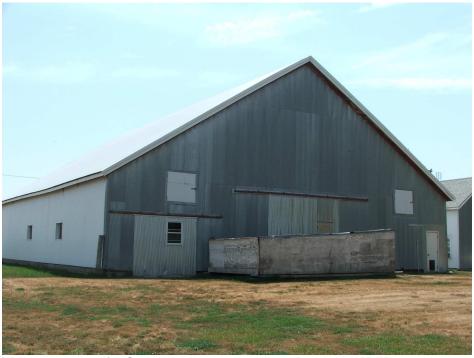
ROLL NUMBER: PHOTO NUMBER: CAMERA DIRECTION: Looking SW, NE corner

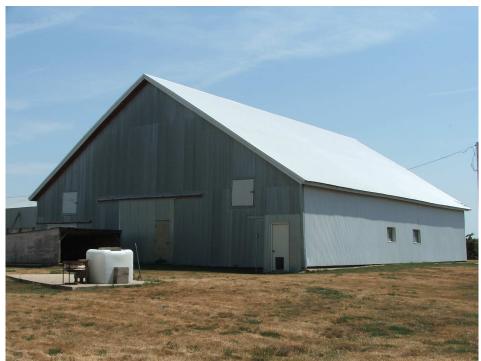
CAMERA DIRECTION: Looking SE, NW corner

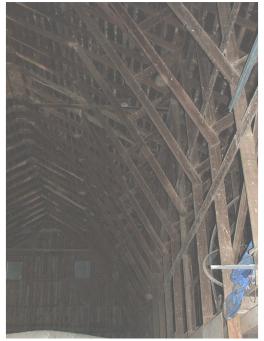
First floor, looking North, 2x6wall x 24' high, supports rafters, East

CAMERA DIRECTION: side

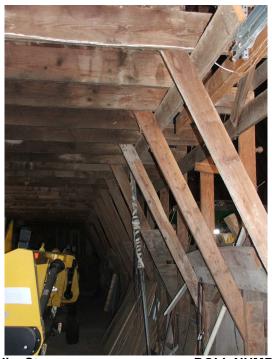
First floor, 2x6 wall 24' high supporting rafters,

CAMERA DIRECTION: West side

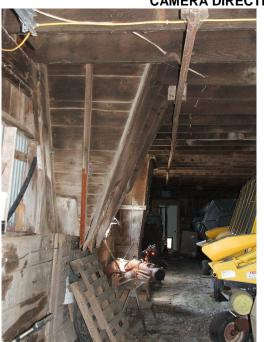
First floor, looking North, wall bracing to the CAMERA DIRECTION: hayloft floor, West side
