**SOUTH DAKOTA STATE HISTORIC PRESERVATION OFFICE
HISTORIC SITES SURVEY STRUCTURE FORM**

*SURVEY DATE: March 10, 2014 *ADDRESS: 30053 461st Ave.
*SURVEYOR: Jim Stone *COUNTY: Clay
*CITY: Centerville

CURRENT FUNCTION: Vacant FOUNDATION: Poured concrete
 CURRENT SUBFUNCTION: Vacant ROOF MATERIAL: Steel roofing over cedar shingles
 HISTORIC FUNCTION: Livestock barn ROOF SHAPE: Gambrel roof
 HISTORIC SUBFUNCTION: Hay and grain storage STRUCTURAL SYSTEM: Balloon framing
 OCCUPIED: Yes STYLE: Gambrel roof barn
 TYPE: Livestock barn
Yes with ACCESSIBLE: Yes with permission WALLS: 2x6 studs, 1x10 diagonal sheathing and 1/2"x6" cedar lap siding
 STORIES: 2 SIGNIFICANT PERSON: John Gaylord
 *DATE OF CONSTRUCTION: 1895 to 1910 CULTURAL AFFILIATION: ?

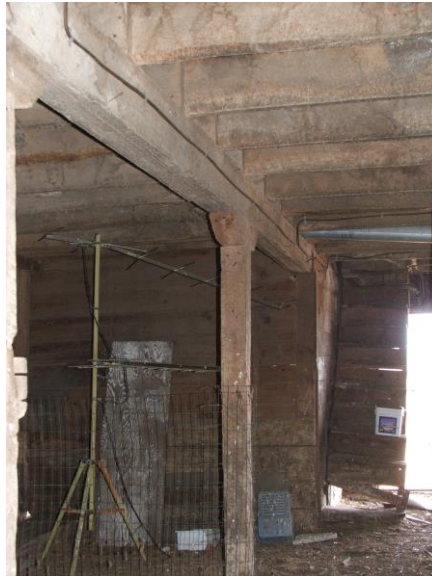
ROLL NUMBER: _____
PHOTO NUMBER: 5

First floor, looking NE at 6x6 posts, (3) 2x10's beams and 2x10 floor joists, note granary in NE corner.

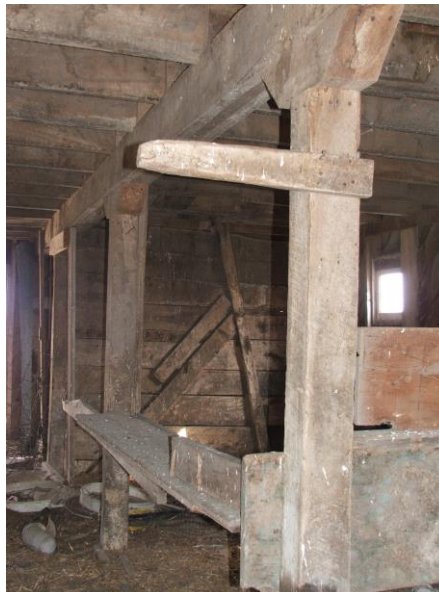
ROLL NUMBER: _____
PHOTO NUMBER: 6

First floor, looking SE, 6x6 posts, (3) 2x10's beam and 2x10 floor joists, tack room in SE corner.

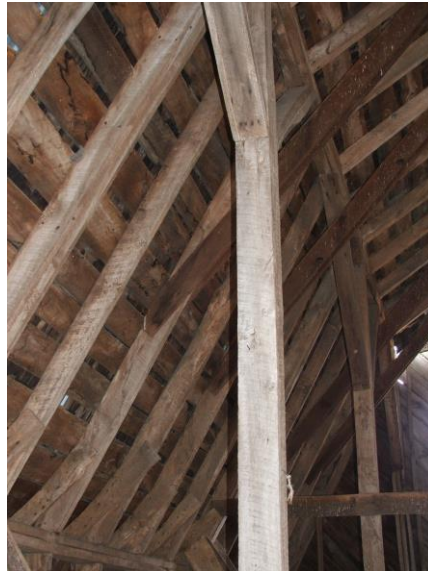
ROLL NUMBER: _____
PHOTO NUMBER: 7

CAMERA DIRECTION: Hayloft, looking SW, 6x6 posts, double 2x6 beam and 2x6 rafters.

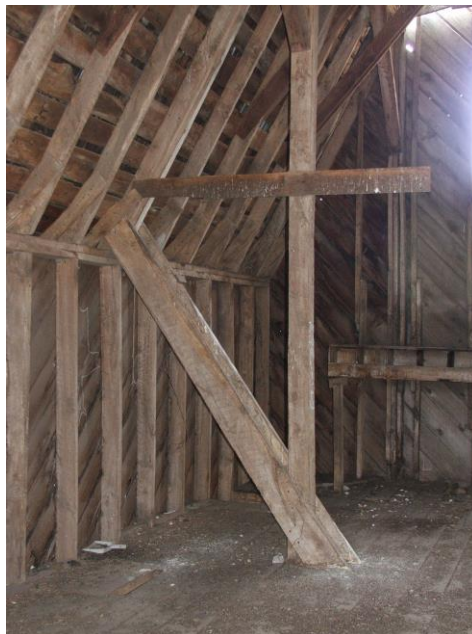
ROLL NUMBER: _____
PHOTO NUMBER: 8

CAMERA DIRECTION: Hayloft, looking SW, 6x6 post with (2) 2x10 bracing from bottom of rafter down to the bottom of posts and tied to floor joists.

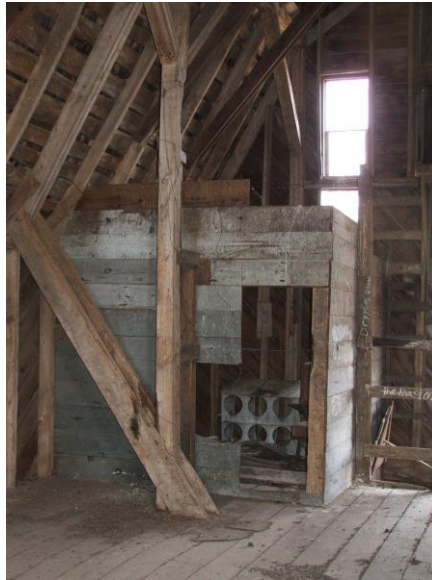
ROLL NUMBER: _____
PHOTO NUMBER: 9
CAMERA DIRECTION: Hayloft, looking NE, 9' x 9' granary in NE corner of hayloft.
