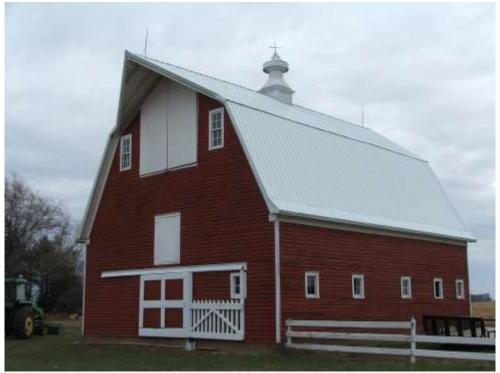
CAMERA DIRECTION: Looking NE, SW corner

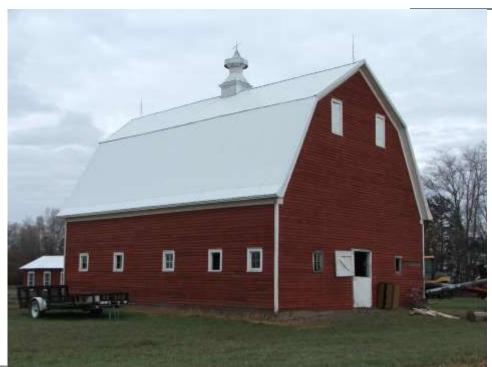
CAMERA DIRECTION: Looking NW, SE corner

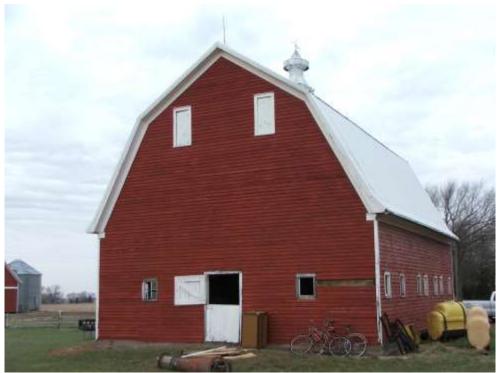
CAMERA DIRECTION: Looking SW, NE corner

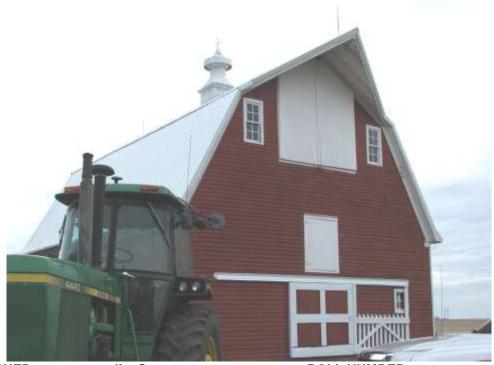
CAMERA DIRECTION: Looking SE, NW corner

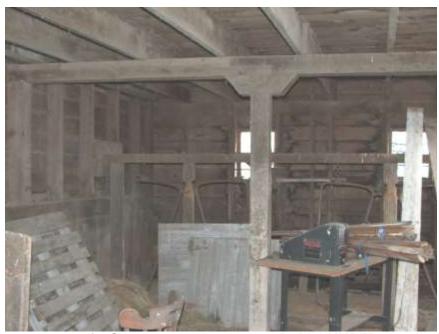
First floor, East 14', looking North, four milk

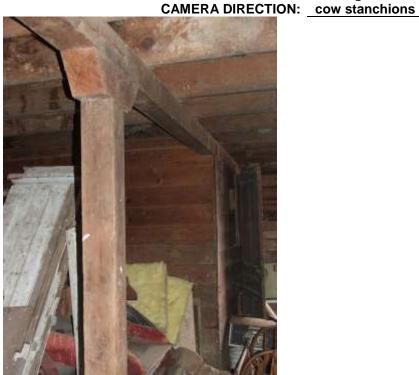
6

First floor, looking West, posts, beam and tack CAMERA DIRECTION: room in SW corner

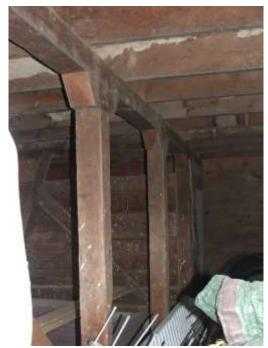
First floor, looking East, posts, beam and granary in NE corner of main

CAMERA DIRECTION: barn
