SITE INFORMATION

*SURVEY DATE	*ADDRESS: 31726 Meckling Road											
*SURVEYOR: Jim Stone				*COUNTY								
	*CITY	: Vermillion										
LOCATION DESCRIPTION: From Vermillion West on South Dakota Highway 50 about 1 mile, turn												
left (South) on South Dakota Highway 19, about 250' turn right (West) on Timber Road. Fallow Timber											_	
Road about 4-3/4 miles, turn Right (North) on Meckling Road, about ¼ mile on the right (East) side.											_	
LEGAL DESCRIPTION: W 500' of S 660' of NW ¼, NW ¼, 13 – 92 – 53 Norway Twp.											_	
												_
					Dahaa		٠		C A	1	_	
*QUARTER 1: NW 1/4				OWNER NAME:	Rebecca C. & Lars G. Aga, LE - Marion Kryger							
*QUARTER 2:				WNER ADDRESS: 31726 Meckling Road					_			
				OWNER CITY:						_		
*RANGE:				OWNER STATE:	South Dakota					_		
*SECTION:				OWNER ZIP:						_		
ACRES:	6.86			QUAD NAME:								
OWNER CODE 1:	•											
OWNER CODE 2: F	S L	Р										
OWNER CODE 3: F	S L	Р

STRUCTURE DETAILS									
SHPO ID:									
*PROPERTY NAME:		_							
OTHER NAME:									
	Farm machinery								
CURRENT FUNCTION:	storage and shop	FOUNDATION:	Poured concrete						
CURRENT SUBFUNCTION:	Storage	ROOF MATERIAL:	Steel						
H

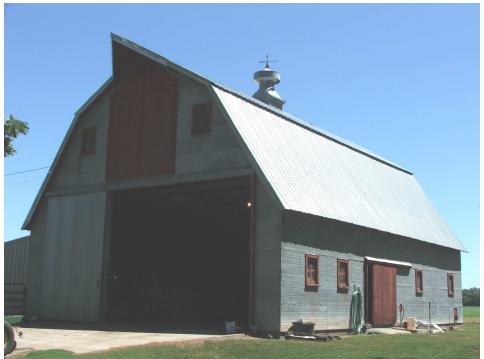
ROLL NUMBER: PHOTO NUMBER: Looking SE, NW

CAMERA DIRECTION: _ corner

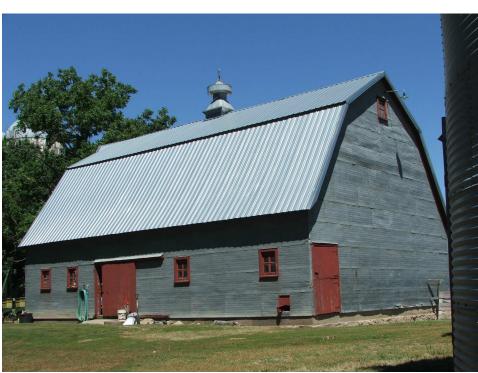
ROLL NUMBER: PHOTO NUMBER:

CAMERA DIRECTION: Looking NE, SW corner

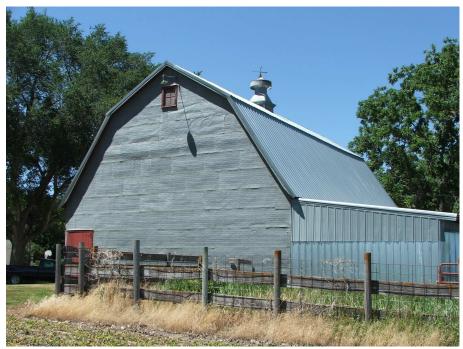
PHOTOGRAPHER: Jim Stone ROLL NUMBER: DATE OF PHOTO: June 21, 2012 PHOTO NUMBER: 3

CAMERA DIRECTION: Looking NW, SE corner

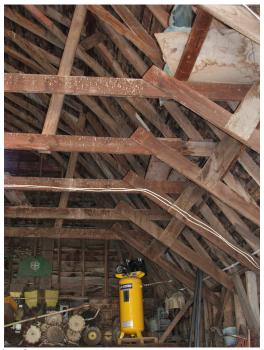
PHOTOGRAPHER: Jim Stone ROLL NUMBER:
DATE OF PHOTO: June 21, 2012 PHOTO NUMBER: 4
First floor, looking

South, rafter bracing for CAMERA DIRECTION: raised ceiling

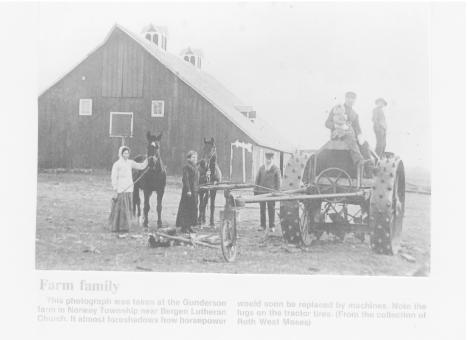
PHOTOGRAPHER: ? ROLL NUMBER: DATE OF PHOTO: 1912 PHOTO NUMBER: 6
Original barn, s

Original barn, salvaged material was used to build the new barn in

CAMERA DIRECTION: 1936.
