SITE INFORMATION

*SURVEY DATE: February 5, 2013 *ADDRESS: 30248 Colfax Ave. *SURVEYOR: Jim Stone *COUNTY: Clay

STRUCTURE DETAILS

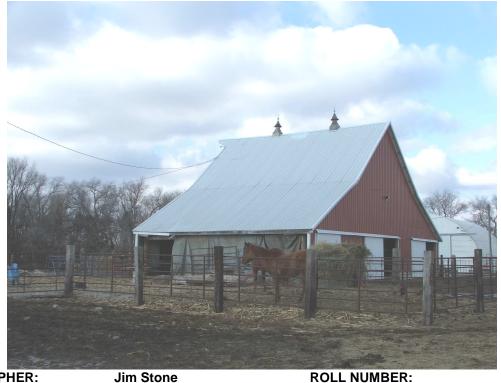
PHOTO NUMBER:
 2

CAMERA DIRECTION:
 Looking NW, SE corner

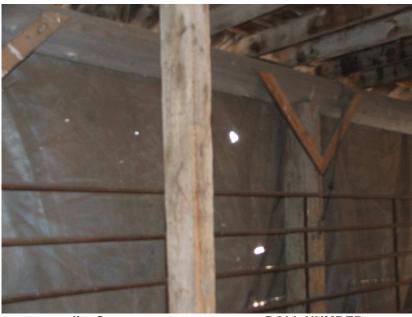
```
5
```

First floor, South lean-to, looking SW, note 10" posts and 10" round beam supporting roof CAMERA DIRECTION: and hayloft floor.

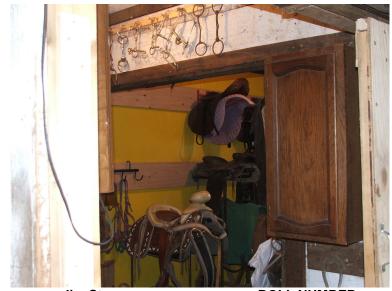
7

ALTERED/MOVED NOTES: Original site. Any evidence of milk cow stanchions has been removed. Foundation has been repaired with some poured concrete. Wood cupola was rotted out. Replaced with two metal cupalo's from another barn when steel was put on the roof. Walls are covered with steel roofing. Milk room in the SW corner of the center of barn has been remodeled into a tack room.

First floor, remodeled milk room into a tack room in the SW corner of the center of barn,

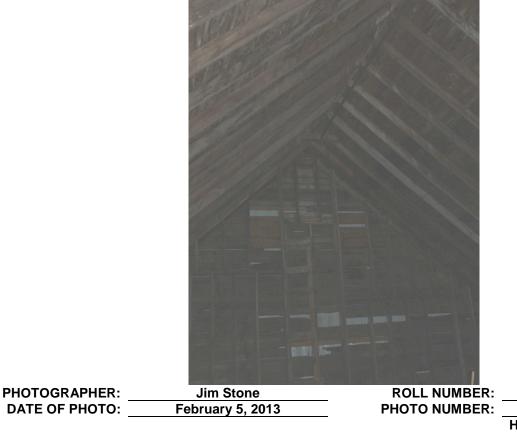
8 Hayloft, looking East, CAMERA DIRECTION: gable end and rafters.
