**SOUTH DAKOTA STATE HISTORIC PRESERVATION OFFICE
HISTORIC SITES SURVEY STRUCTURE FORM**

*ADDRESS: 30631 458th Ave.

CURRENT FUNCTION: Sheep barn FOUNDATION: Poured concrete
 CURRENT SUBFUNCTION: Straw storage ROOF MATERIAL: cedar shingles
 HISTORIC FUNCTION: Sheep barn ROOF SHAPE: Gable
 HISTORIC SUBFUNCTION: Hay storage STRUCTURAL SYSTEM: Balloon framing
 OCCUPIED: Yes STYLE: Gable roof barn
 TYPE: Sheep barn
 ACCESSIBLE: Yes with permission WALLS: 2x6, 1x6 drop siding & horizontal Galv. Corri. Steel

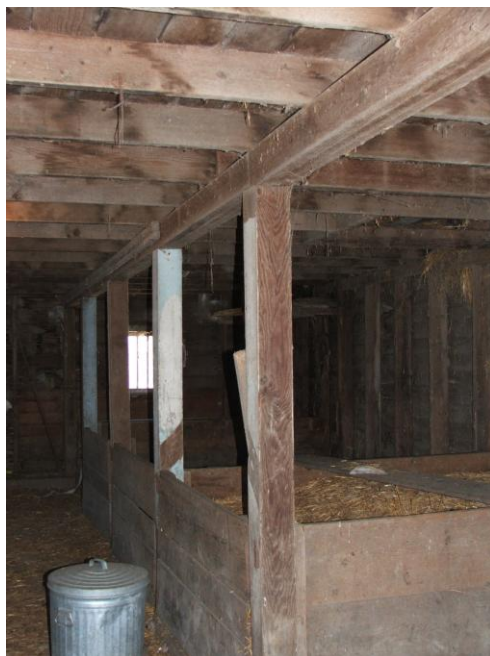
ROLL NUMBER: _____
PHOTO NUMBER: 5

INTERIOR NOTES: Has two rows 6x6 posts and (2) 2x6's for beam to support hayloft floor. Floor joists are 2x6's. Has twelve lambing pens, with removable panels and inswinging gates. With panels removed and gates folded back, the whole barn can be opened up into almost one large area.

CAMERA DIRECTION: First floor, looking West,
posts, beam and sheep
pens

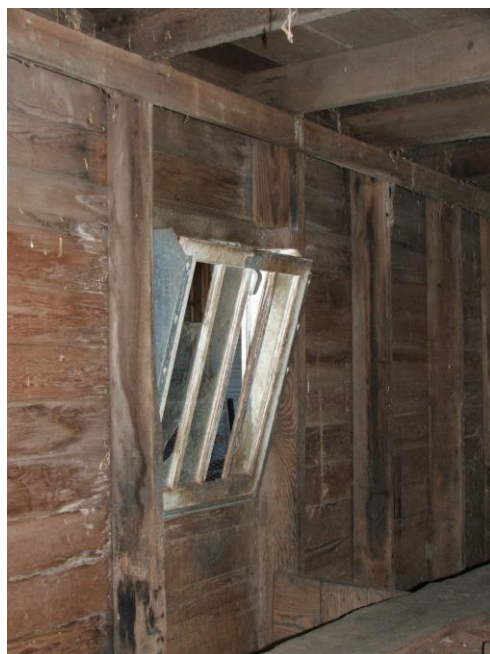
ROLL NUMBER: _____
PHOTO NUMBER: 6

OTHER NOTES: Windows were 4"x24" four light, with metal sides to allow adjustable opening at the top for ventilation. Walls are 2x6 with 1x6 #106 drop siding and horizontal galv. corrugated steel. Rafters are 2x6. 1x12 bracing from the top of wall in hayloft down to floor joists, 10', 10', 6', 10' O.C. from the East side. One metal cupola.

CAMERA DIRECTION: First floor, looking SW,
special metal window
sides on windows for
adj. ventilation

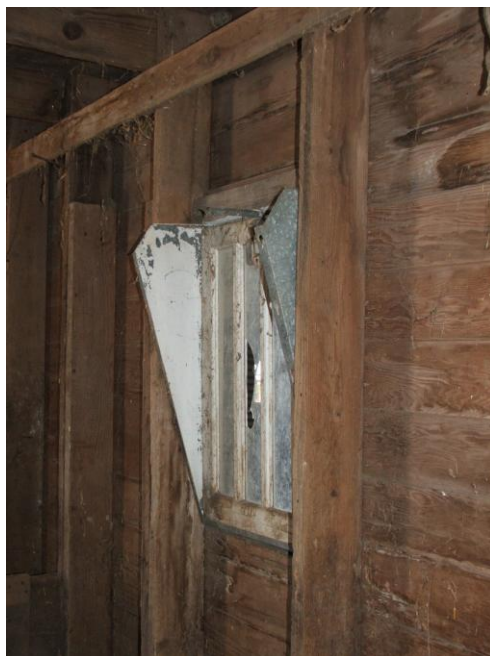
ROLL NUMBER: _____
PHOTO NUMBER: 7

CAMERA DIRECTION: First floor, looking SE,
special metal ventilation
system, in closed
position

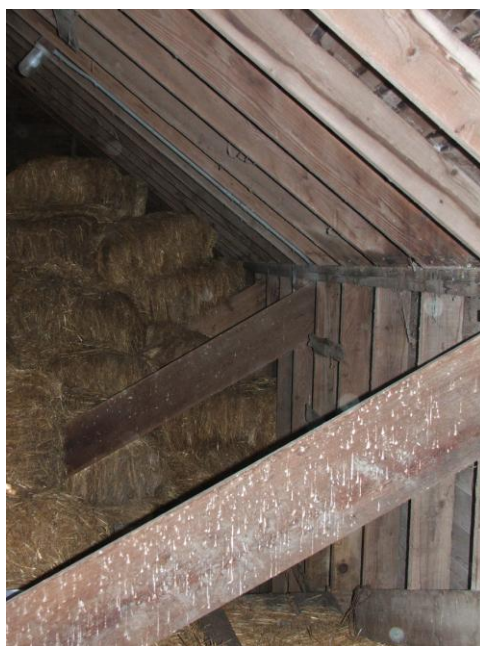
ROLL NUMBER: _____
PHOTO NUMBER: 8

CAMERA DIRECTION: Hayloft, looking West,
1x12 bracing from top of
wall down to floor joists

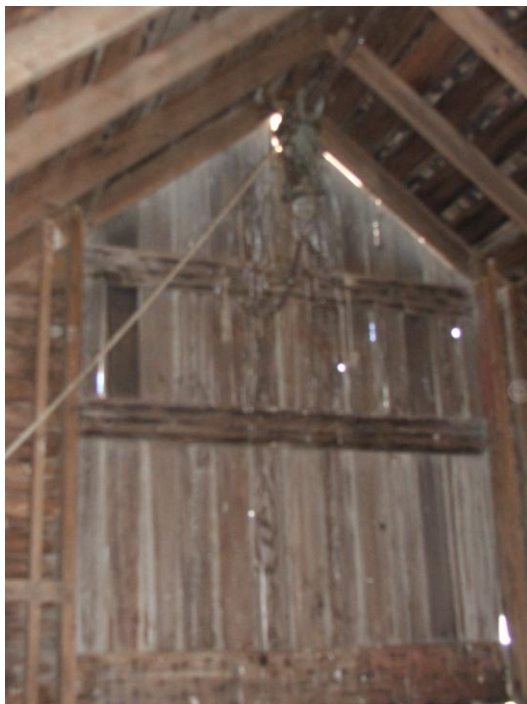
ROLL NUMBER: 9
PHOTO NUMBER: 9
CAMERA DIRECTION: Hayloft, looking East,
hayloft door & gable end

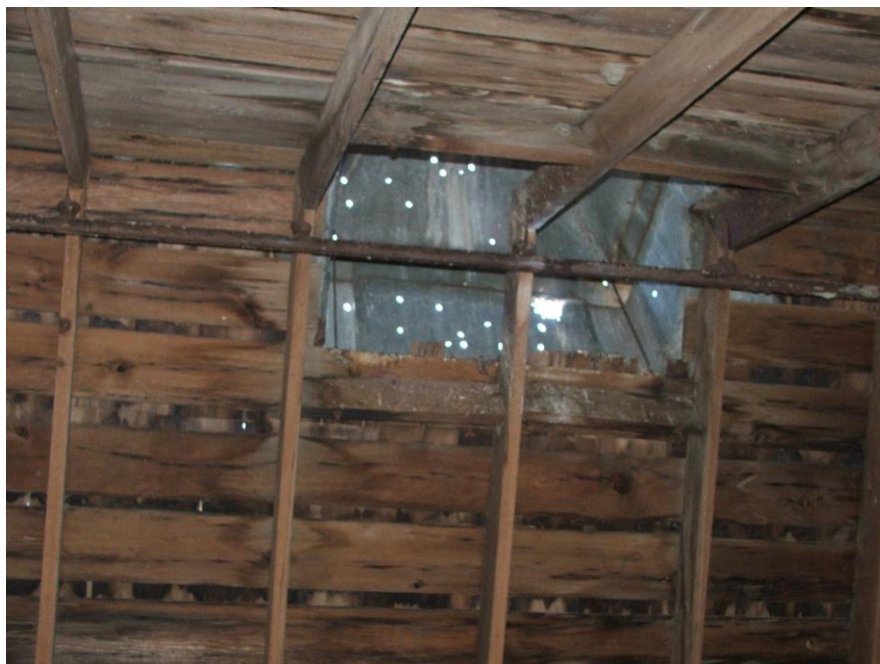
ROLL NUMBER: 10
PHOTO NUMBER: 10
CAMERA DIRECTION: Hayloft, looking up into
bottom of cupola
