**SOUTH DAKOTA STATE HISTORIC PRESERVATION OFFICE
HISTORIC SITES SURVEY STRUCTURE FORM**

*SURVEY DATE: July 26, 2012 *ADDRESS: 30631 458th Ave.
*SURVEYOR: Jim Stone *COUNTY: Clay
*CITY: Wakonda

SIGNIFICANCE NOTES: All steel oblong corncrib. 12'-6" wide x 51' long. Has six 10" vent tubes from floor through roof, equal spaced with swivel vents on roof to keep openings away from prevailing winds.

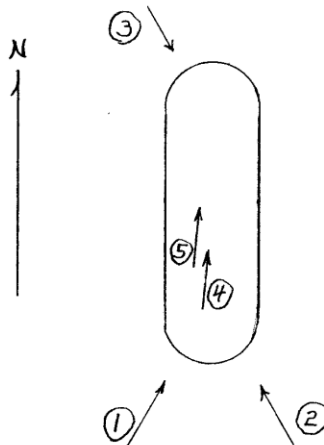
PHOTOGR

*PHYSICAL NOTES: Corncrib is in good condition. Carol Mayer called me July 25, 2012 and asked for this corncrib to be surveyed. She has hired a crew to dismantle it and haul it away on July 28th and July 29th, 2012. Carol Mayer claims that it is the only corncrib of its kind in South Dakota and there is only one in the state of Iowa.

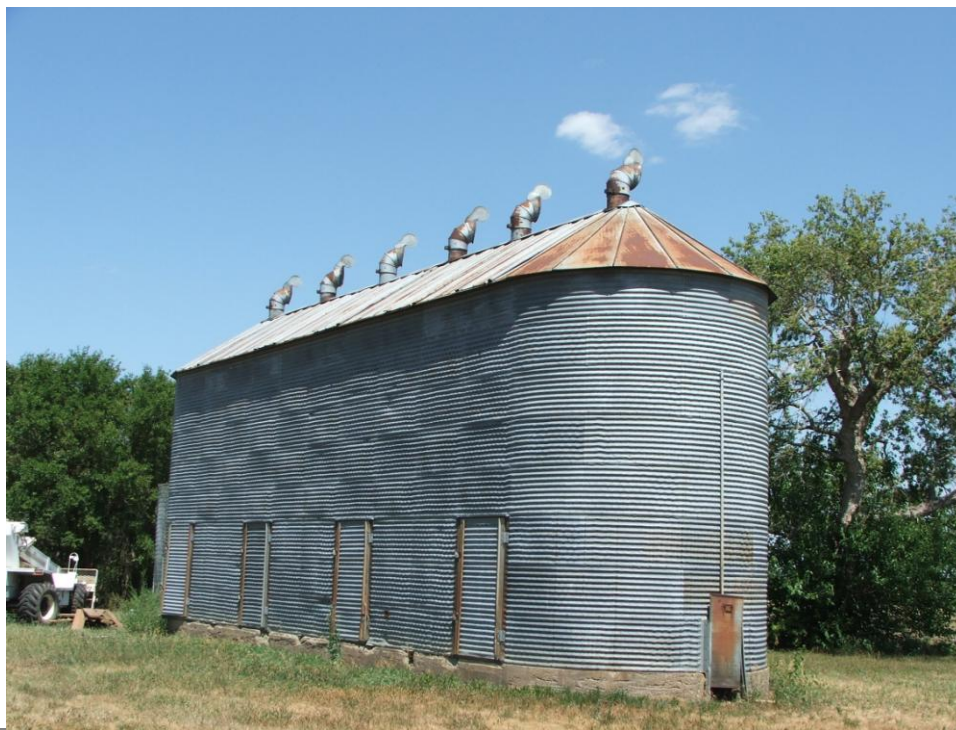
ROLL NUMBER: _____
PHOTO NUMBER: 1
CAMERA DIRECTION: Looking NE, SW corner

OTHER NOTES: Wall studs and all cross bracing is angle iron. Outside covering is galvanized, perforated steel to allow for ventilation. Has four access doors on the West wall and a small access door on each end to start emptying the crib. This is a very unusual style of an all steel corncrib.

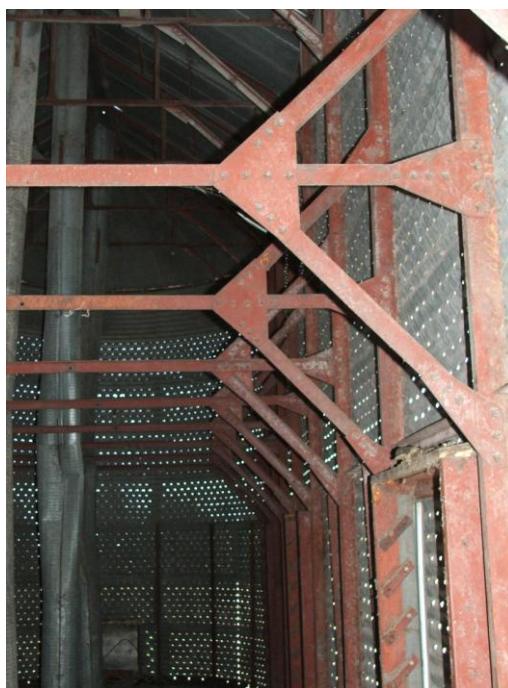
ROLL NUMBER: _____
PHOTO NUMBER: 4
CAMERA DIRECTION: Looking North, all steel studs and cross bracing, perforated steel sides

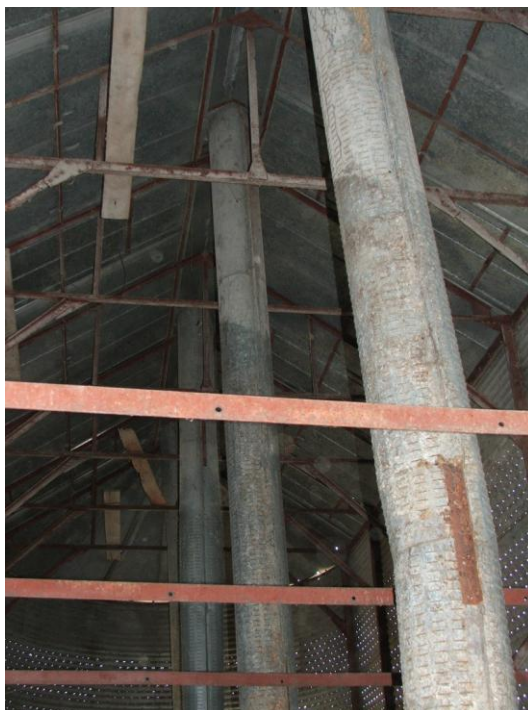
ROLL NUMBER: _____
PHOTO NUMBER: 5

INTERIOR NOTES: Poured concrete base with elevator gutter down the center. Short planks cover gutter and are removed as the bin is emptied. Has six 10" perforated ventilation tubes from the floor up through the roof. Swivel caps on the roof to keep the opening away from the prevailing wind.

CAMERA DIRECTION: Looking North, 10" perforated ventilation tubes, from floor through roof
