**SOUTH DAKOTA STATE HISTORIC PRESERVATION OFFICE
HISTORIC SITES SURVEY STRUCTURE FORM**

*SURVEY DATE: August 21, 2013 *ADDRESS: 29783 Frog Creek Road
*SURVEYOR: Jim Stone *COUNTY: Clay
*CITY: Centerville

CURRENT FUNCTION: Storage FOUNDATION: Poured concrete
 CURRENT SUBFUNCTION: Shop ROOF MATERIAL: Asphalt shingles over cedar shingles
 HISTORIC FUNCTION: Livestock barn ROOF SHAPE: Gothic round roof
 HISTORIC SUBFUNCTION: Hay & grain storage STRUCTURAL SYSTEM: Balloon framing
 STYLE: Gothic round roof barn
 OCCUPIED: Yes TYPE: Livestock barn
 ACCESSIBLE: Yes with permission WALLE: 2x6 studs, 1x8 shiplap, 1/2"x6" cedar lap siding
 STORIES: 2 SIGNIFICANT PERSON: Albert Paulson
 *DATE OF CONSTRUCTION: Early 1917 CULTURAL AFFILIATION: ?

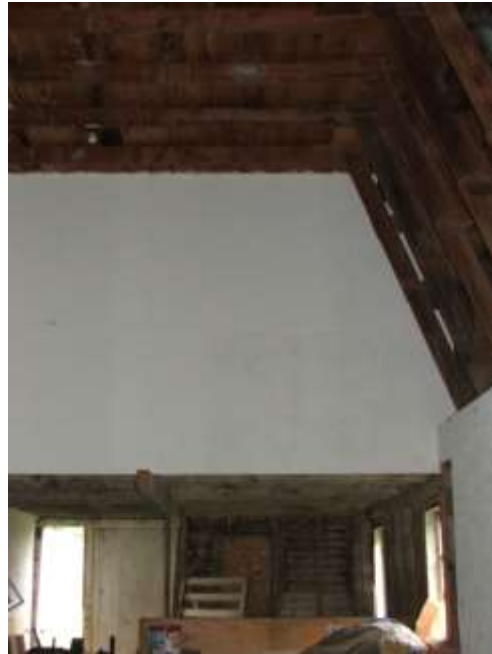
ROLL NUMBER: _____
PHOTO NUMBER: 5

**First floor, looking NE,
16- x 26- hayloft floor
raised to 16', walls lined.**

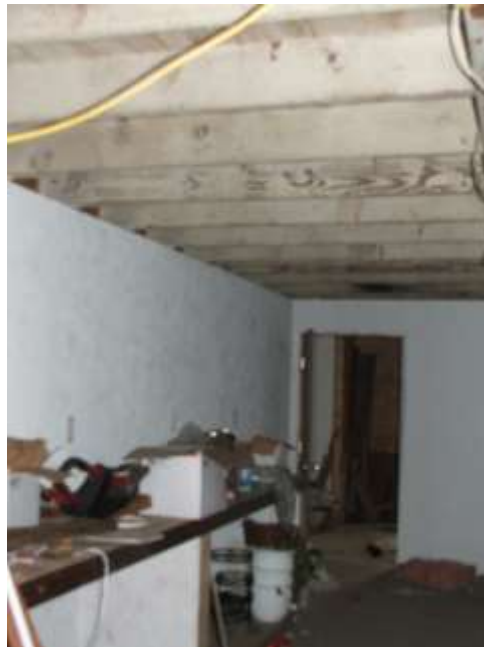
ROLL NUMBER: _____
PHOTO NUMBER: 6

ALTERED/MOVED NOTES: Original site. Roof covered with asphalt shingles over cedar shingles. All evidence of milk cow stanchions and horse stalls has been removed. Posts (4x6's ?) and 4X6 beams have been removed except 18' of beam in the NE corner. 2x4 solid wall added in center dividing East 16' from the West 12'. 16' x 26' of hayloft raised to 16' in the SE corner and a 10' x 10' roll up door installed in the South wall. 2x6 floor joists added to rest of the hayloft, 8' above present hayloft floor for a third floor. Flooring on the 2x8 joists in the 16' x 26' area in SE corner. The rest of 2x6 floor joists have no flooring. A 10' x 8' room added on the NW corner on the West wall, may have been a milk room.

**First floor, looking SE,
West side of 2x4 solid
wall dividing west 12'
from East 16'**

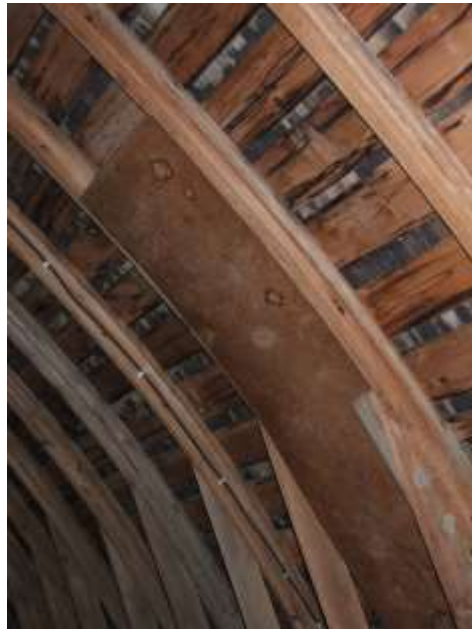
ROLL NUMBER: _____
PHOTO NUMBER: 7

Hayloft, looking SW, air chute between rafters, from first floor up to cupola.

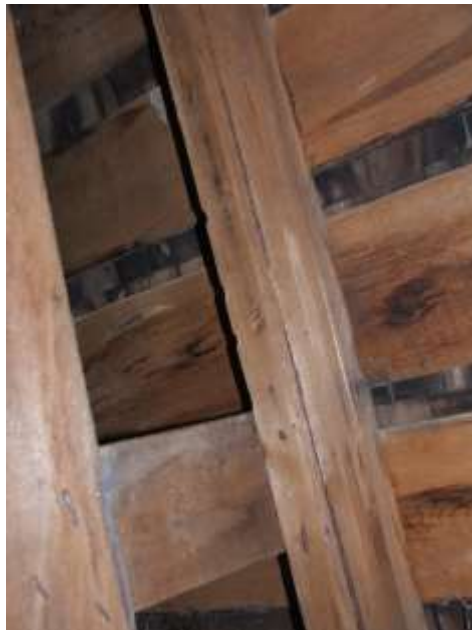
ROLL NUMBER: _____
PHOTO NUMBER: 8

OTHER NOTES: 2x6 stud walls with 1x8 shiplap and 1/2"x6" cedar lap siding on all four walls. Rafters are 7 plies of 3/4" x full 2" cedar. They appear to be manufactured. 2x6 bracing, 2' O. C., on each rafter down to the exterior wall studs at floor level. The windows are 9" x 12" six light on the first floor and 4" X 24" four light in hayloft. Original cupola still on roof.

Hayloft, looking SW, 7 plies of 3/4" x full 2" cedar laminated rafters, appear to be factory manufactured.

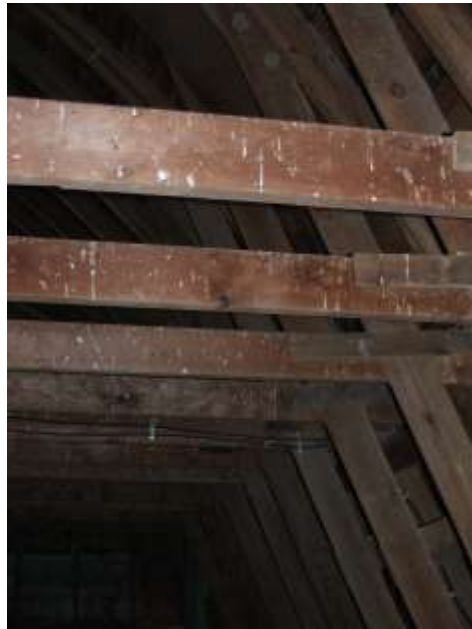
ROLL NUMBER: _____
PHOTO NUMBER: 9

**Hayloft, looking SW, 2x6
floor joists 8' above
hayloft floor, note 2x6
bracing for rafters.**

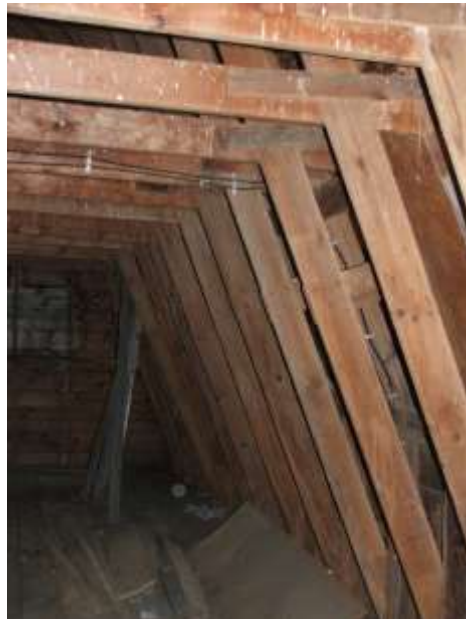
ROLL NUMBER: _____
PHOTO NUMBER: 10

**Hayloft, looking SW, 2x6
floor joists 8' above
hayloft floor, note 2x6
bracing for rafters,
2' O. C.**
