**SOUTH DAKOTA STATE HISTORIC PRESERVATION OFFICE
HISTORIC SITES SURVEY STRUCTURE FORM**

*SURVEY DATE: March 28, 2014 *ADDRESS: 29791 464th Ave.
*SURVEYOR: Jim Stone *COUNTY: Clay
*CITY: Centerville

CURRENT FUNCTION: Storage FOUNDATION: Poured concrete
 CURRENT SUBFUNCTION: Storage ROOF MATERIAL: Steel roofing over cedar shingles
 HISTORIC FUNCTION: Livestock barn ROOF SHAPE: Gambrel roof
 HISTORIC SUBFUNCTION: Hay and grain storage STRUCTURAL SYSTEM: Balloon framing
 OCCUPIED: Yes STYLE: Gambrel roof barn
 TYPE: Livestock barn
2x6 studs, 1x10 shiplap, 1/2" x 6" cedar lap siding and steel roofing

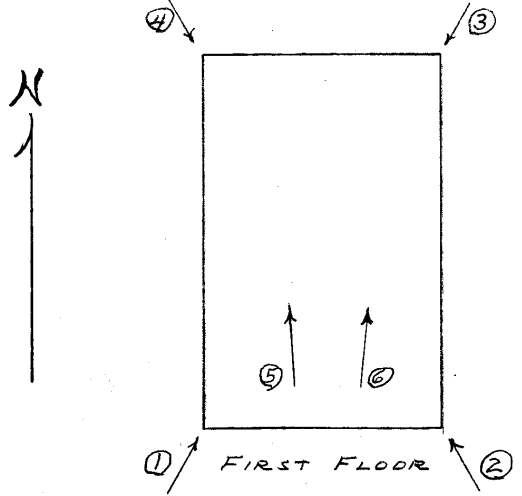
FIRST FLOOR

INTERIOR NOTES: Two rows of 6x6 posts, 6x6 beams and 2x8 floor joists for the hayloft floor. All of the 6x6 posts have been removed. 8' x 10' granary still in the SE corner.

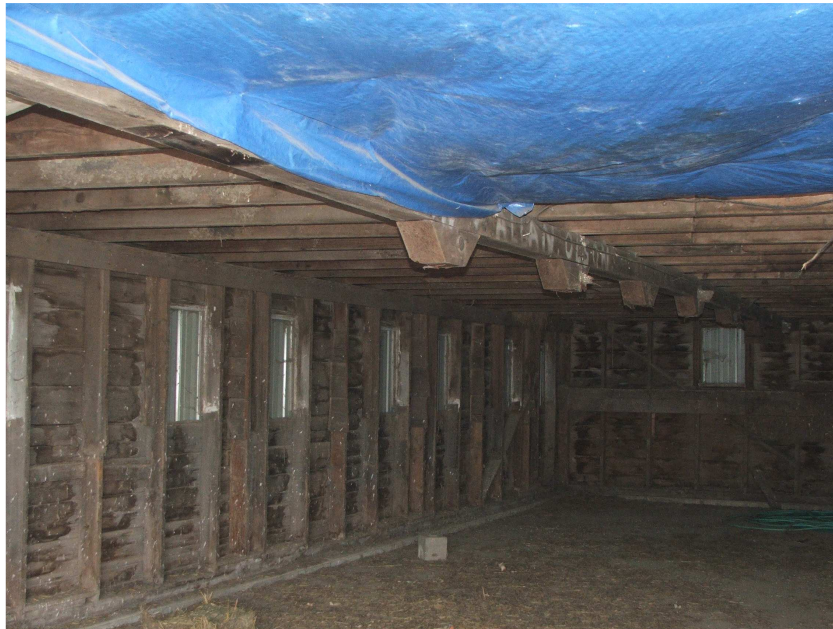
ROLL NUMBER: _____
PHOTO NUMBER: 5

CAMERA DIRECTION: First floor, looking NW at removed 6x6 posts, 6x6 beams and 2x8 floor joists, posts were 5' O.C.

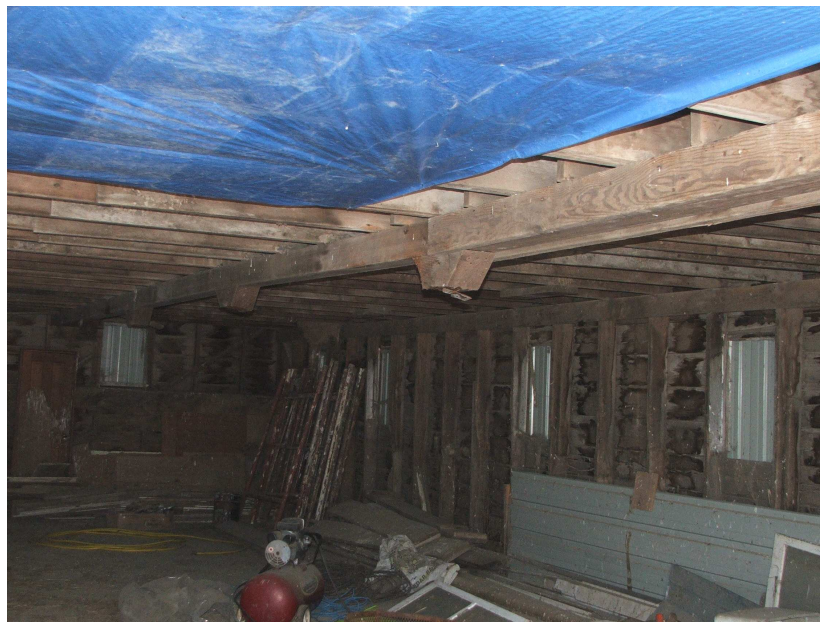
ROLL NUMBER: _____
PHOTO NUMBER: 6

CAMERA DIRECTION: First floor, looking NE, removed 6x6 posts, 6x6 beam and 2x8 floor joists, posts 8' and 9' O. C. on this side.
