**SOUTH DAKOTA STATE HISTORIC PRESERVATION OFFICE**  
**HISTORIC SITES SURVEY STRUCTURE FORM**

\*ADDRESS: 30631 458<sup>th</sup> Ave.

\*CITY: Wakonda

CURRENT FUNCTION: Granary

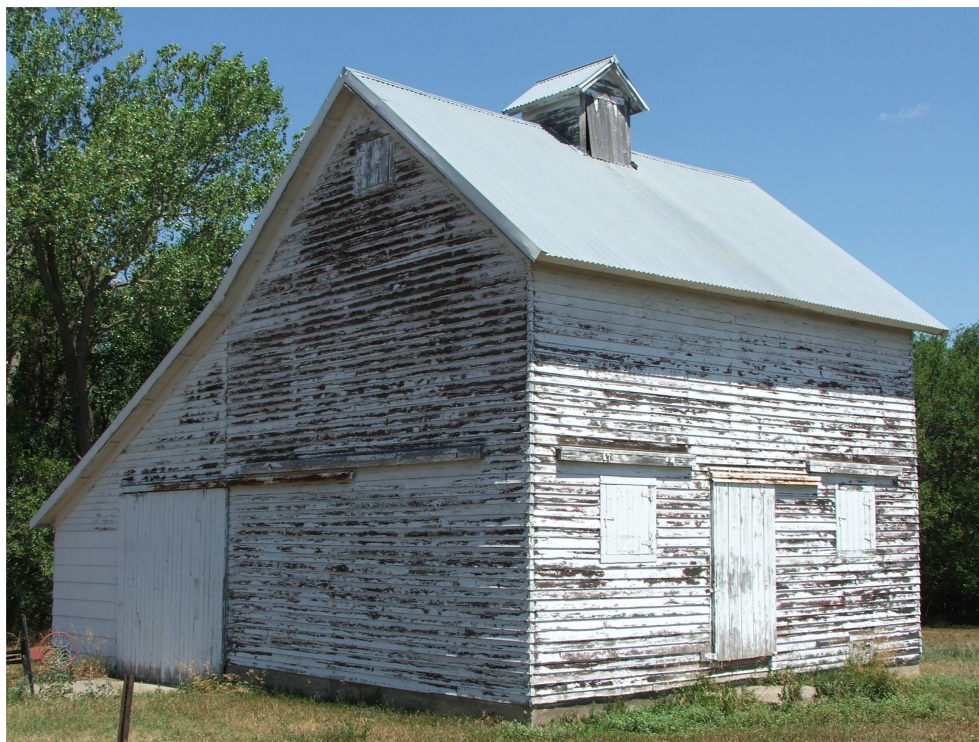
ROLL NUMBER: \_\_\_\_\_  
PHOTO NUMBER: 1  
CAMERA DIRECTION: Looking NE, SW corner

\*PHYSICAL NOTES: Granary is in very good condition. Has gravity flow chutes through floor joists to the exterior to empty bins in to an elevator.

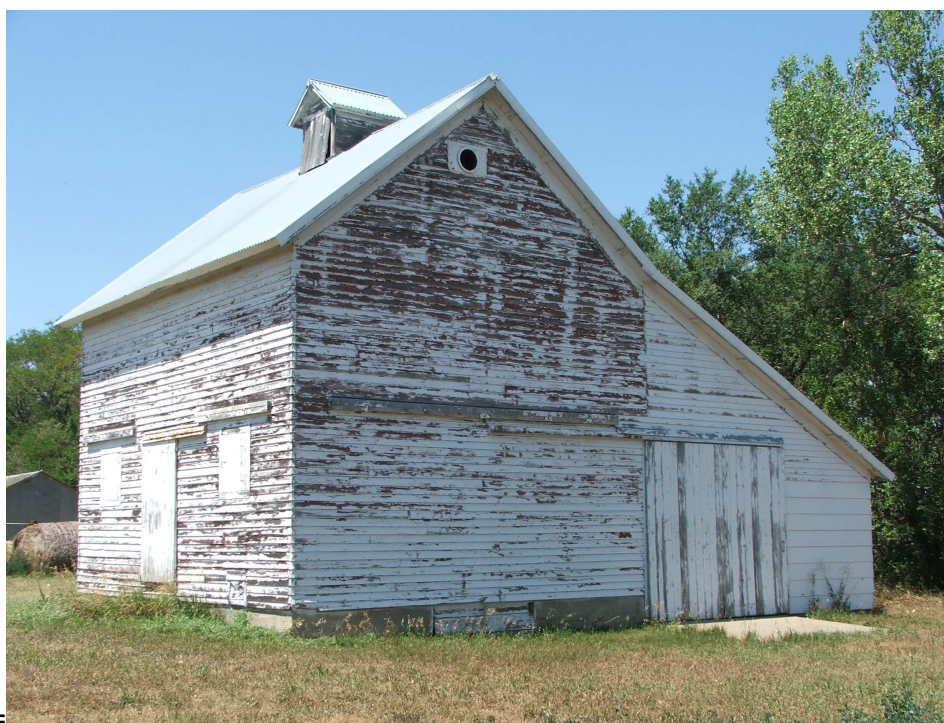
ROLL NUMBER: \_\_\_\_\_  
PHOTO NUMBER: 2  
CAMERA DIRECTION: Looking NW, SE corner

ALTERED/MOVED NOTES: Original site. 18' x 24 lean-to added on North side later.

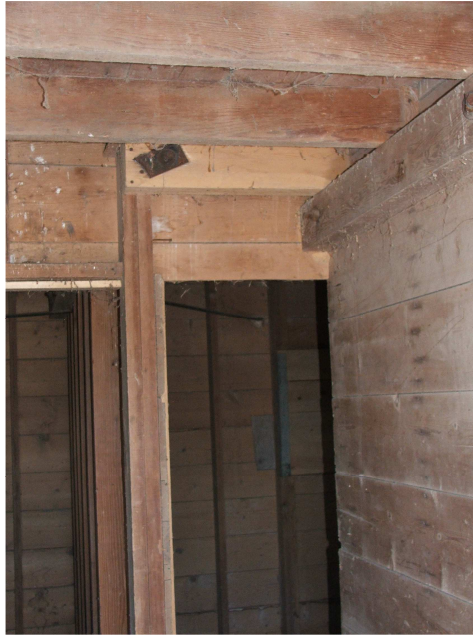
ROLL NUMBER: \_\_\_\_\_  
PHOTO NUMBER: 5

INTERIOR NOTES: Floor joists are 2x10 12" O.C. Two grain bins 11'-9"x 9'-9"x 14'-9" high, Two grain bins 9'-9"x 9'-9"x 14'-9" high. One 4'-6"x 7'-6"x 7'-2" high above entry area. Has a swivel spout above all bins that can be moved to fill any bin, from an elevator through opening at peak.

CAMERA DIRECTION: Looking North, Entry into grain bins, opening into two North bins

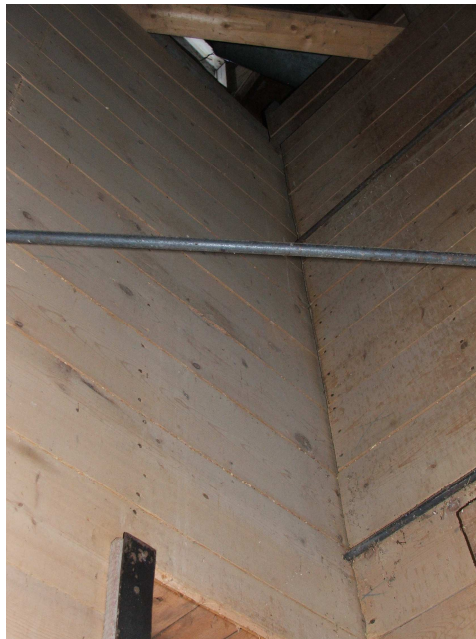
ROLL NUMBER: \_\_\_\_\_  
PHOTO NUMBER: 6

OTHER NOTES: Walls are 2x6 studs 16" O.C. with 1x10 shiplap on all walls and dividing walls for bins. Exterior walls have 1/2"x6" cedar lap siding. Rafters are 2x6. 3/4" steel rods on each corner of each bin about 7' above floor and 2x6 corner bracing at the top of each corner in each bin. Also 3/4" steel rods horizontally about 7' above floor. Steel rod bracing has 4x6's on outside of bin walls to hold walls.

CAMERA DIRECTION: Looking up corner of a bin, note 3/4" rods for corner bracing and 2x6 corner brace at top

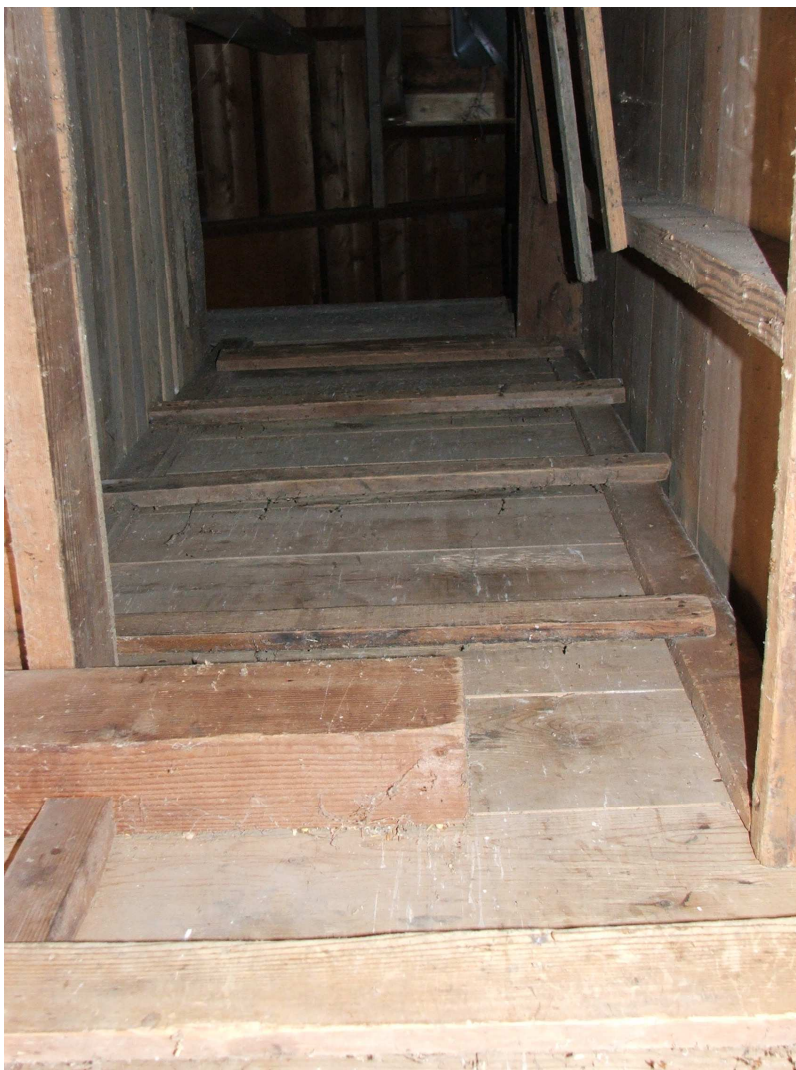
**ROLL NUMBER:** \_\_\_\_\_  
**PHOTO NUMBER:** 7

**CAMERA DIRECTION:** Looking up at access  
ladder to top of granary,  
to move swivel spout to  
fill any bin
