**SOUTH DAKOTA STATE HISTORIC PRESERVATION OFFICE
HISTORIC SITES SURVEY STRUCTURE FORM**

*SURVEY DATE: April 5, 2012 *ADDRESS: 30287 Frog Creek Road
*SURVEYOR: Jim Stone *COUNTY: Clay
*CITY: Wakonda

SHPO ID: _____
*PROPERTY NAME: Eilts swine barn
OTHER NAME: _____

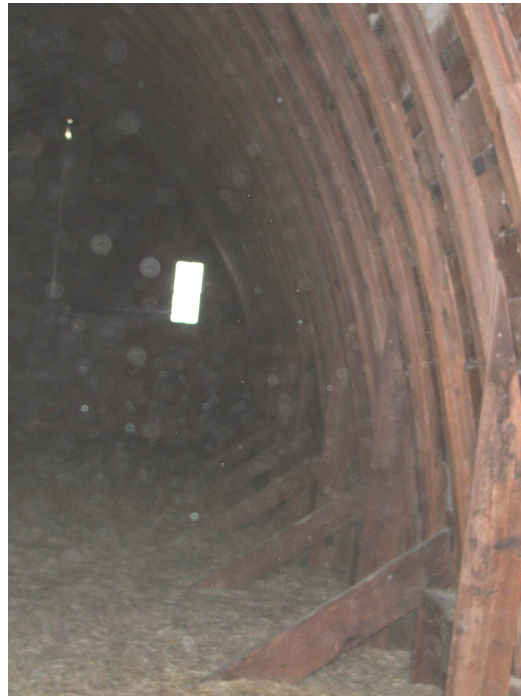
ROLL NUMBER: _____
PHOTO NUMBER: 5

*PHYSICAL NOTES: Rafters are 5 ply 1x4 gothic round with sheathing, cedar shingles and asphalt shingles. Two very ornate metal cupolas. Barn is in excellent condition

CAMERA DIRECTION: Hayloft, looking North,
note bracing from rafters
to floor joists

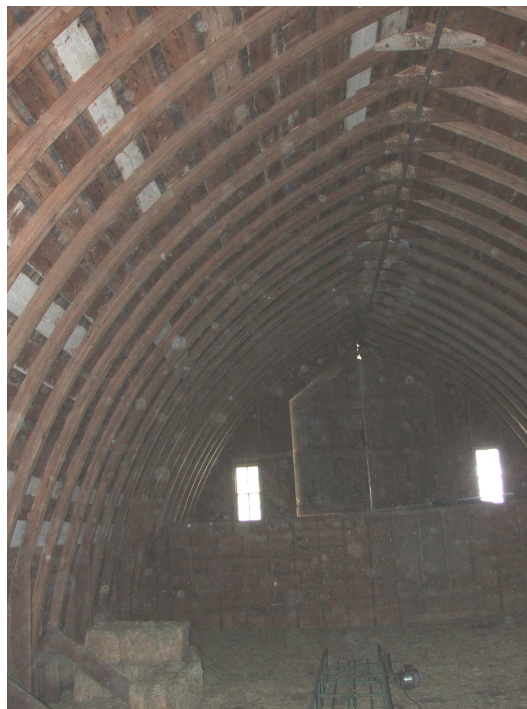
ROLL NUMBER: _____
PHOTO NUMBER: 6
CAMERA DIRECTION: Hayloft, looking North

INTERIOR NOTES: Two rows 3 ply 2x6 beam with 2x6 posts about 3' O.C. Beams are in 8'-2" from the exterior East and West walls leaving a 9'- 8" center alley. 2x8 floor joists for the hayloft floor.

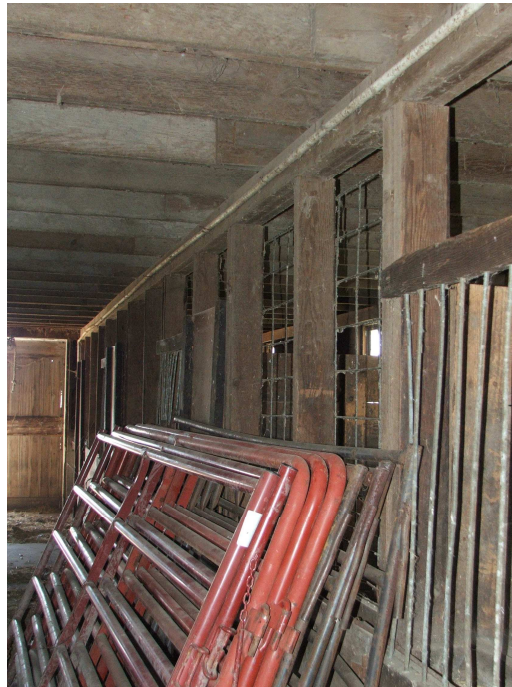
ROLL NUMBER: _____
PHOTO NUMBER: 8

CAMERA DIRECTION: First floor, looking North
