**SOUTH DAKOTA STATE HISTORIC PRESERVATION OFFICE  
HISTORIC SITES SURVEY STRUCTURE FORM**

\*SURVEY DATE: June 15, 2012 \*ADDRESS: \_\_\_\_\_  
\*SURVEYOR: Jim Stone \*COUNTY: Clay  
\*CITY: Wakonda

CURRENT FUNCTION: Cattle barn FOUNDATION: Poured concrete  
CURRENT SUBFUNCTION: Storage ROOF MATERIAL: Steel over cedar  
HISTORIC FUNCTION: Livestock barn ROOF SHAPE: shingles  
HISTORIC SUBFUNCTION: Hay storage STRUCTURAL SYSTEM: Gambrel  
STYLE: Balloon framing  
OCCUPIED: Yes TYPE: Gambrel roof barn  
Yes with permission TYPE: Livestock barn  
ACCESSIBLE: permission WALLS: 2x6 with sheathing,  
siding ? & steel

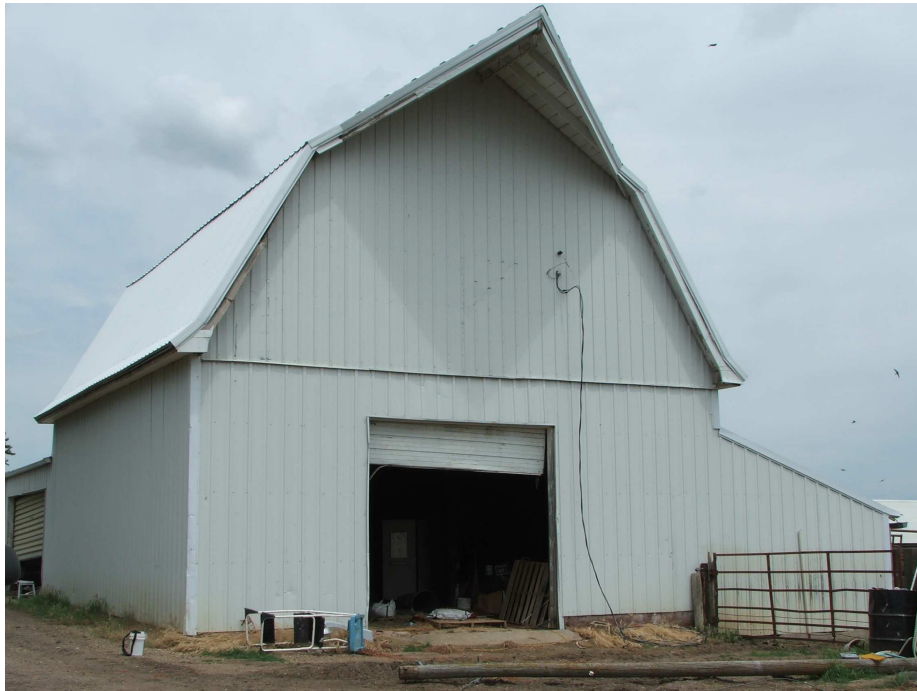
**ROLL NUMBER:** \_\_\_\_\_  
**PHOTO NUMBER:** 1  
**CAMERA DIRECTION:** Looking NE, SW corner

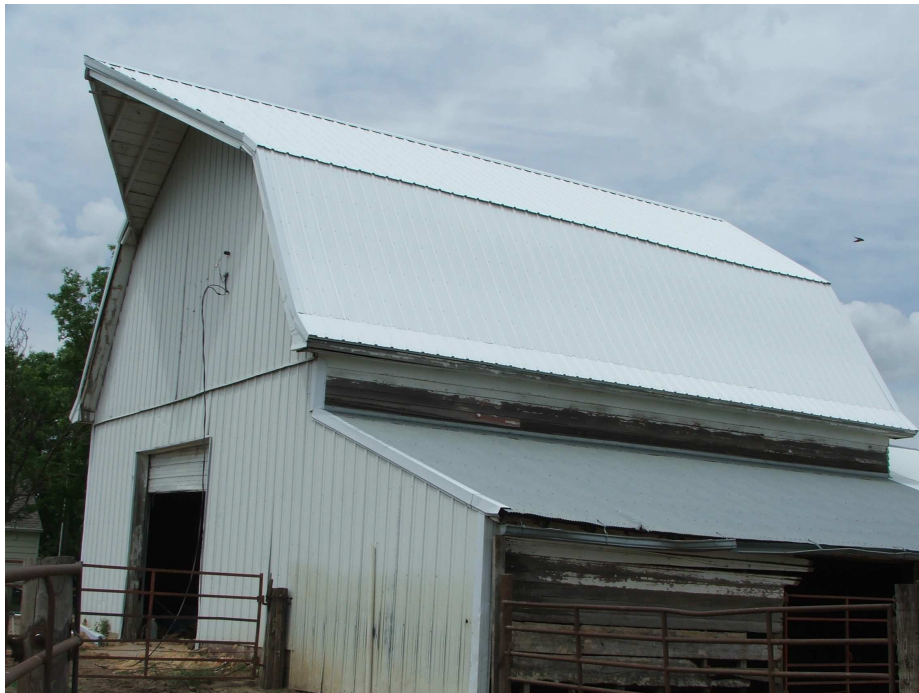
**ROLL NUMBER:** \_\_\_\_\_  
**PHOTO NUMBER:** 2  
**CAMERA DIRECTION:** Looking NW, SE corner

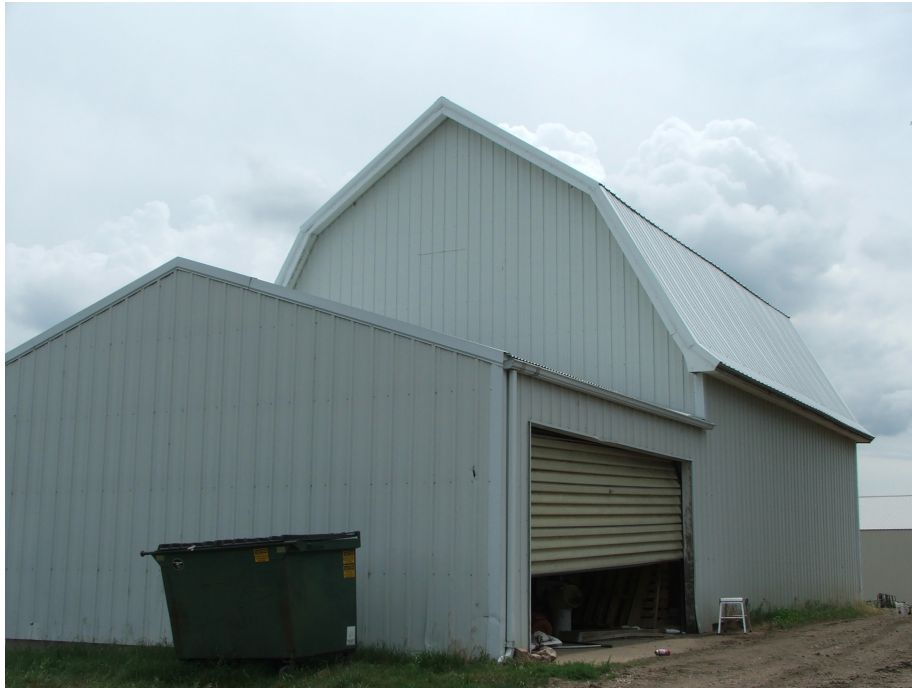
**ROLL NUMBER:** \_\_\_\_\_  
**PHOTO NUMBER:** 3  
**CAMERA DIRECTION:** Looking SE, NW corner

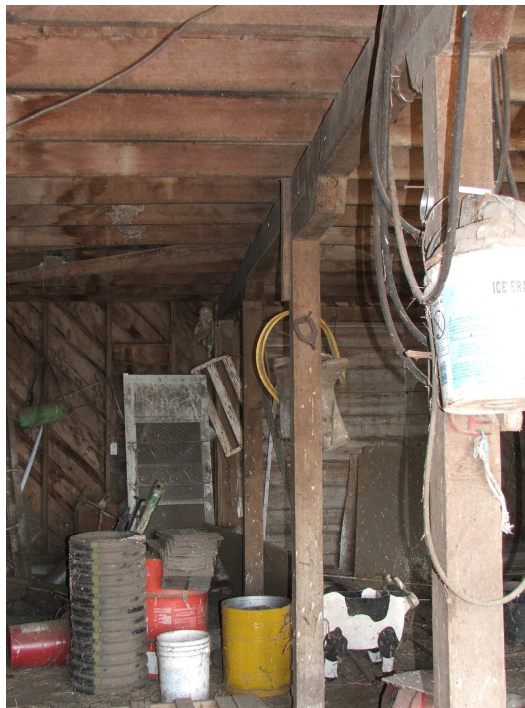
INTERIOR NOTES: Two rows of 6x6 posts and 6x8 beam support the hayloft floor. 2x8 floor joists for  
hayloft floor.

**ROLL NUMBER:** \_\_\_\_\_  
**PHOTO NUMBER:** 4  
**CAMERA DIRECTION:** First floor, looking North,  
6x6 posts & 6x8 beam

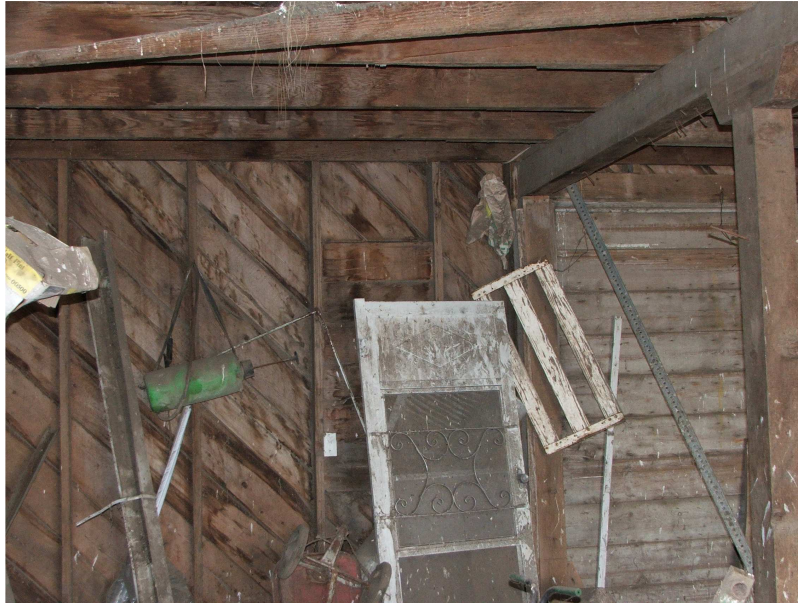
**ROLL NUMBER:** \_\_\_\_\_  
**PHOTO NUMBER:** 5

OTHER NOTES: 2x6 walls 13' high on the East and West sides. 2x6 walls 18' high on the gable ends,  
with 2x6 studs above to roof line. All walls have sheathing, horizontal on the East and West walls and  
diagonal sheathing on the gable end walls. I could not see the wood siding as it is covered with steel.  
2x6 rafters and 2x6 bracing.

**CAMERA DIRECTION:** First floor, looking North,  
diagonal sheathing on  
gable end wall

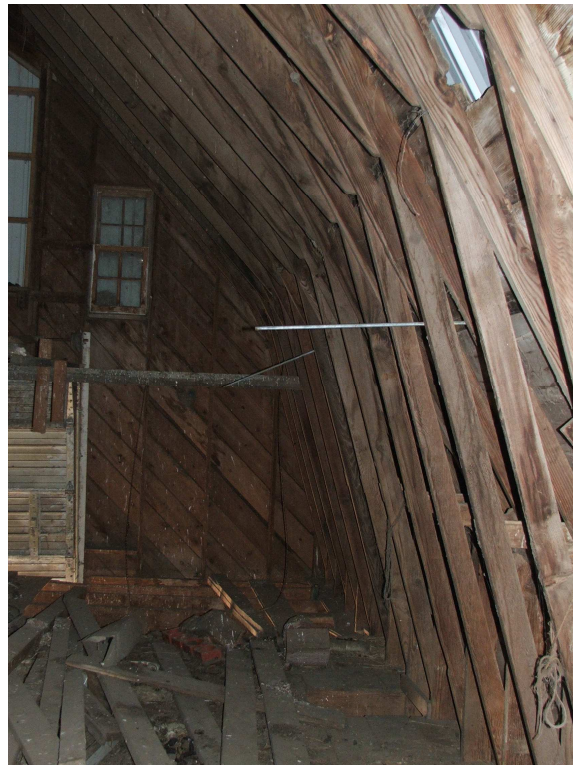
**ROLL NUMBER:** \_\_\_\_\_  
**PHOTO NUMBER:** 6

**CAMERA DIRECTION:** Hayloft, looking South,  
bottom rafter bracing

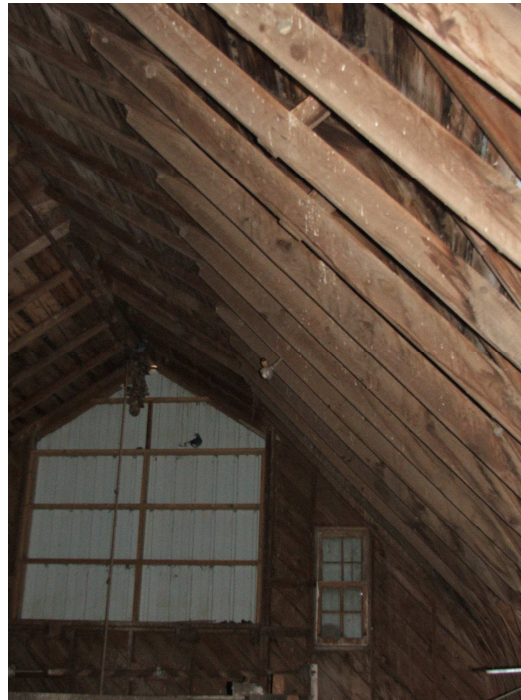
**ROLL NUMBER:** \_\_\_\_\_  
**PHOTO NUMBER:** 7  
**CAMERA DIRECTION:** Hayloft, looking South,  
middle rafter bracing

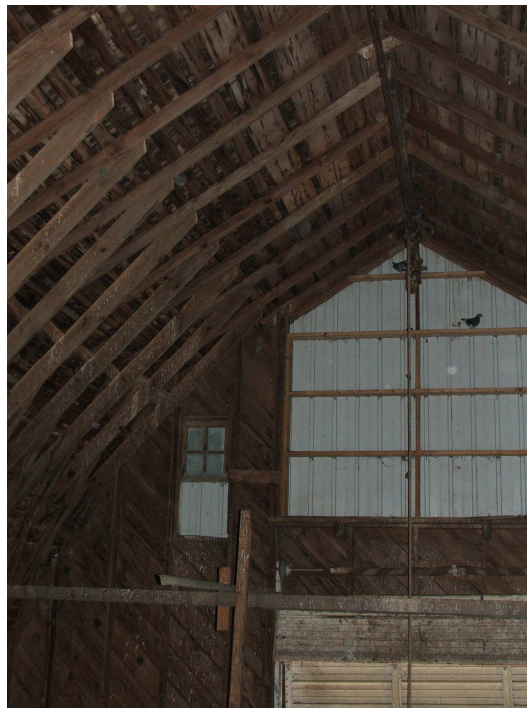
**ROLL NUMBER:** \_\_\_\_\_  
**PHOTO NUMBER:** 8  
**CAMERA DIRECTION:** Hayloft, looking South,  
top of rafter bracing
