**SOUTH DAKOTA STATE HISTORIC PRESERVATION OFFICE
HISTORIC SITES SURVEY STRUCTURE FORM**

*SURVEY DATE: June 21, 2013 *ADDRESS: 45534 299th Street
*SURVEYOR: Jim Stone *COUNTY: Clay
*CITY: Wakonda

CURRENT FUNCTION:	<u>Sheep barn</u>	FOUNDATION:	<u>Poured concrete</u>
CURRENT SUBFUNCTION:	<u>Hay storage</u>	ROOF MATERIAL:	<u>Steel roof over 2x4 purlins</u>
HISTORIC FUNCTION:	<u>Livestock barn</u>	ROOF SHAPE:	<u>Gable roof</u>
HISTORIC SUBFUNCTION:	<u>Hay and storage</u>	STRUCTURAL SYSTEM:	<u>Balloon framing</u>
OCCUPIED:	<u>Yes</u>	STYLE:	<u>Gable roof barn</u>
ACCESSIBLE:	<u>Yes with permission</u>	TYPE:	<u>Livestock barn</u> <u>2x6 studs, 1x6 #106 drop siding, some steel on first floor.</u>
STORIES:	<u>2</u>	SIGNIFICANT PERSON:	<u>Christ (Chris) E. Stockland</u>
*DATE OF CONSTRUCTION:	<u>Early 1900's</u>	CULTURAL AFFILIATION:	<u>Norwegian</u>

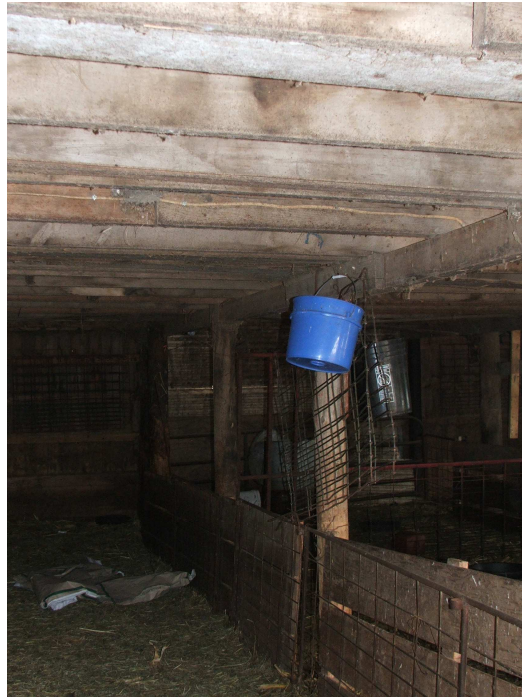
ROLL NUMBER: _____
PHOTO NUMBER: 5

CAMERA DIRECTION: First floor, looking NE, 8" round posts, 6x6 beam, 2x8 joists.

INTERIOR NOTES: Four rows of 8" round posts, and 6x6 beams to support the 2x8 joists for the hayloft floor.

OTHER NOTES: Original gable end 2x6 stud walls with 1x6 #106 drop siding on North and South walls of the barn. The East and West walls have been rebuilt, pole barn construction, with posts, girts and steel. All of the interior posts supporting 6x6 beams have been replaced with 8" round posts. All of the roof has been rebuilt with 2x6 rafters, 2x4 purlins and steel roofing.

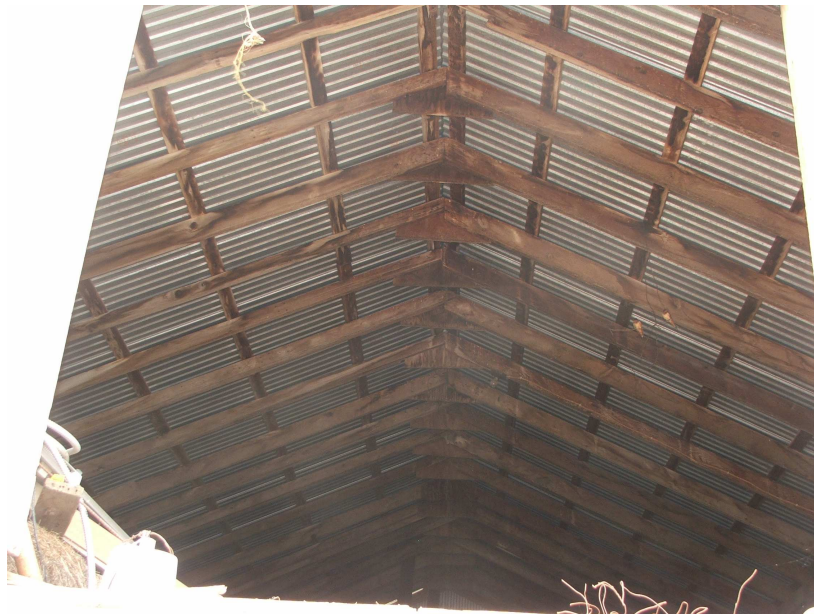
ROLL NUMBER: _____
PHOTO NUMBER: 6

CAMERA DIRECTION: Hayloft, looking up and North, roof completely rebuilt.
