**SOUTH DAKOTA STATE HISTORIC PRESERVATION OFFICE
HISTORIC SITES SURVEY STRUCTURE FORM**

*SURVEY DATE: June 21, 2013 *ADDRESS: 45534 299th Street
*SURVEYOR: Jim Stone *COUNTY: Clay
*CITY: Wakonda

| CURRENT FUNCTION: | <u>Sheep barn</u> | FOUNDATION: | <u>Poured concrete</u> |

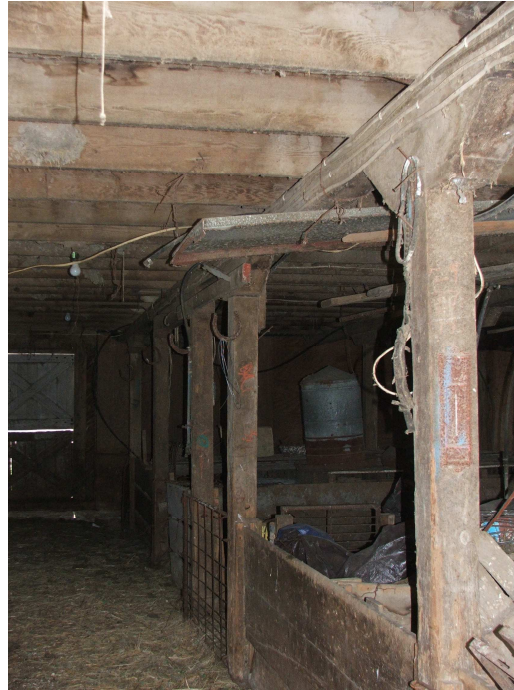
ROLL NUMBER: _____
PHOTO NUMBER: 5

CAMERA DIRECTION: First floor, looking NW,
6x6 post, 6x6 beam, 2x8
joists.

INTERIOR NOTES: Four rows of 6x6 posts, and 6x6 beams support the 2x8 joists for the hayloft floor. Milk cow stanchions were on the East side, but have been removed. All evidence of horse stalls has been removed, but owner said that they were on the West side. 6x6 posts 10' O. C., with a 6x6 beam support the hip. (2) 1x6 braces on two hip rafters in the center between the 10' O. C. posts.

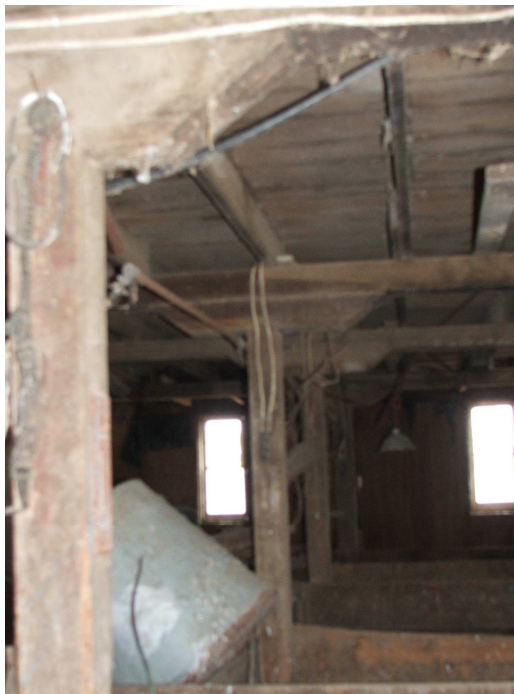
ROLL NUMBER: _____
PHOTO NUMBER: 6

CAMERA DIRECTION: First floor, looking, East,
four rows of 6x6 posts
and 6x6 beams.

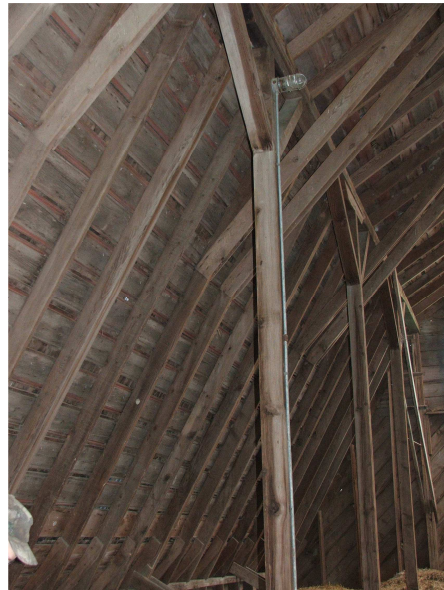
ROLL NUMBER: _____
PHOTO NUMBER: 7

Hayloft, looking NW, 6x6 posts and 6x6 beam supporting hip, note 1x6 bracing on two rafters centered between 10'

CAMERA DIRECTION: O.C. 6x6 posts.

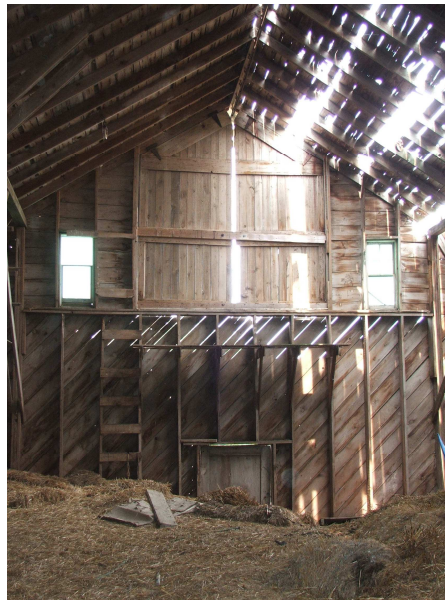
ROLL NUMBER: _____
PHOTO NUMBER: 8

Hayloft, looking North, 2x8 stud wall up to 26' with 2x6 studs above to rafters, note diagonal sheathing.

OTHER NOTES: 2x6 stud walls with horizontal sheathing and 1/2" x 6" cedar lap siding on the East and West walls. 2x8 stud walls 26' high on the gable ends with diagonal sheathing and 1/2"x 6" cedar lap siding, with 2x6 studs above to rafters. Rafters are 2x6's. Windows are 9"x12" four light over 9"x12" four light, double hung. Metal cupola is still in place, which dates the barn in the teens of the 1900's.
