**SITE INFORMATION**

SIGNIFICANCE NOTES: Built in the 1880's by Canute Weeks as a livestock barn Martin Weeks Jr. (owner) and the grandson of Canute Weeks wants to get the barn on the So. Dak. State Register and restore this barn.

SHPO ID: 2 CL 00500002

\*PROPERTY NAME: Canute Weeks livestock bank barn #2

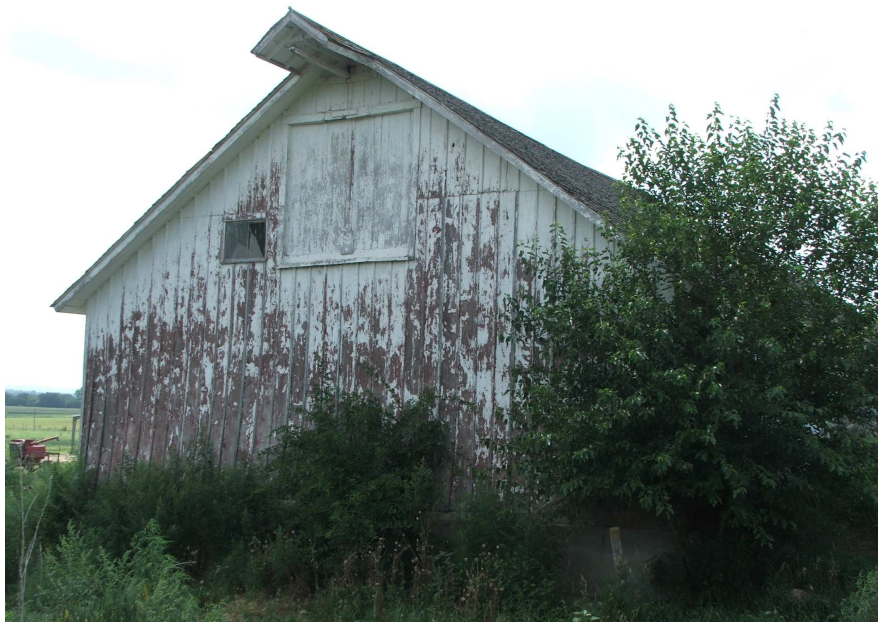
**ROLL NUMBER:** \_\_\_\_\_  
**PHOTO NUMBER:** 1  
**CAMERA DIRECTION:** Looking SW, NE corner

\*PHYSICAL NOTES: Barn needs leveling and straightening, roof needs to be replaced soon.

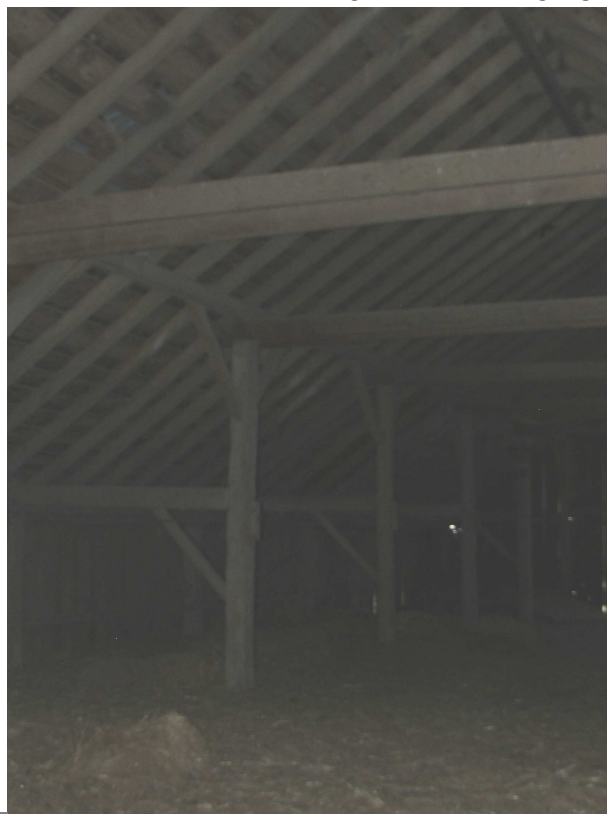
**ROLL NUMBER:** \_\_\_\_\_  
**PHOTO NUMBER:** 2  
**CAMERA DIRECTION:** Haymow looking west  
2x8's added later for  
bracing

The hayloft is also built with posts and beams. All of these are rough sawn 8 x 8 posts and 8 x 8 beams placed directly over posts in the basement. The hayloft has two rows of posts 9 feet in from the North and South walls. The posts are braced horizontally back to the outside wall posts with 8 x 8 beams. This brace is at the eave line about 8' from the floor. These beams are mortised and tendon, with round wooden pegs. On top of the interior rows of posts there is a 6 x 6 beam, which supports the mid point of the rafters. The rafters are 2 x 6 rough sawn cottonwood with rough sawn boards for roof sheathing. The roof is covered with cedar shingles. The walls are framed with 2 x 6 rough sawn horizontally between the posts and 12" siding boards applied vertically. Battens were applied over the cracks in the boards to keep out the weather and wind. There is a 4 x 4 mounted in the peak for a hay sling to raise hay up and back into the hayloft. Martin Weeks Jr. remembers a steel track mounted below the 4 x 4 for the trolley track. I could not see any holes where it might have been mounted. The hayloft door is on the East end.

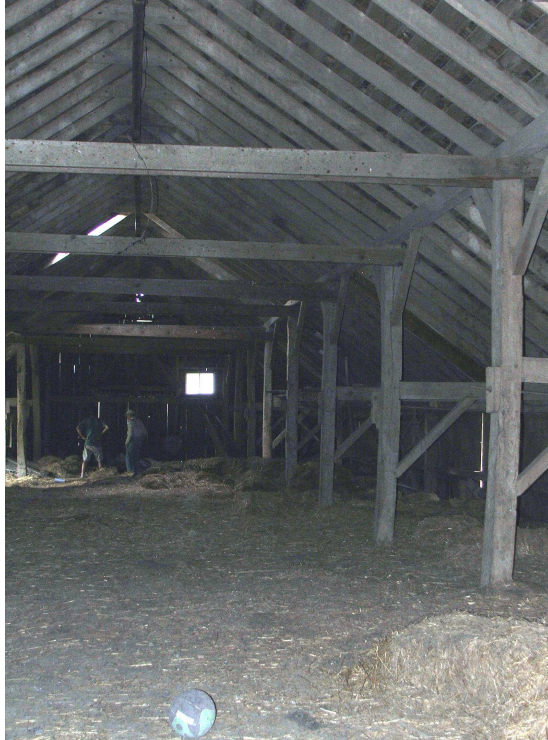
ROLL NUMBER: 3  
PHOTO NUMBER: \_\_\_\_\_  
CAMERA DIRECTION: Looking East at the SE corner & South side

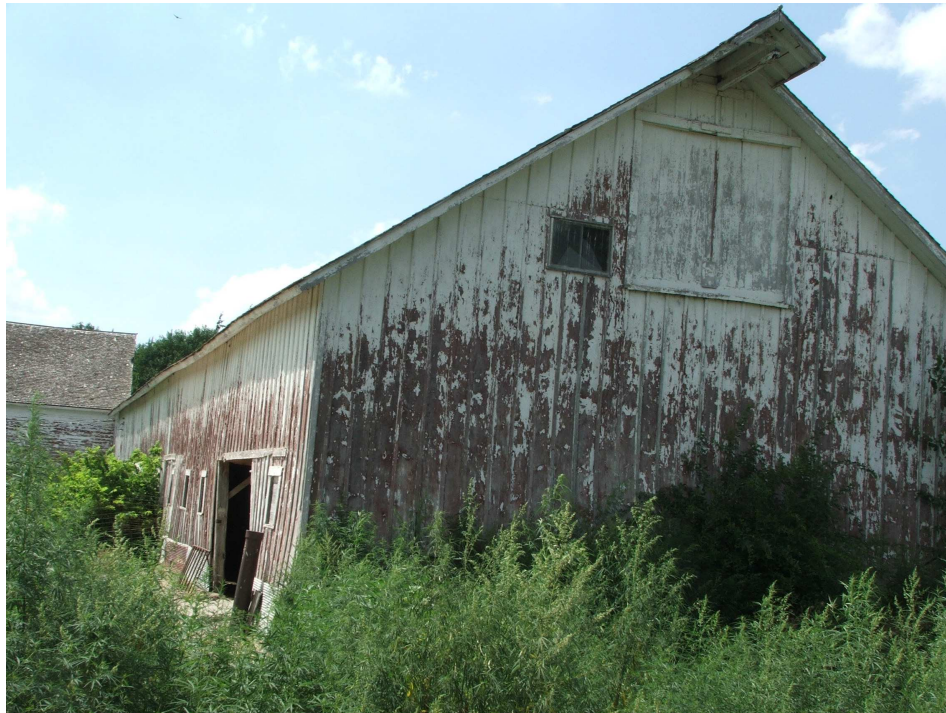
ROLL NUMBER: \_\_\_\_\_  
PHOTO NUMBER: 4  
CAMERA DIRECTION: Looking NW at the SE corner

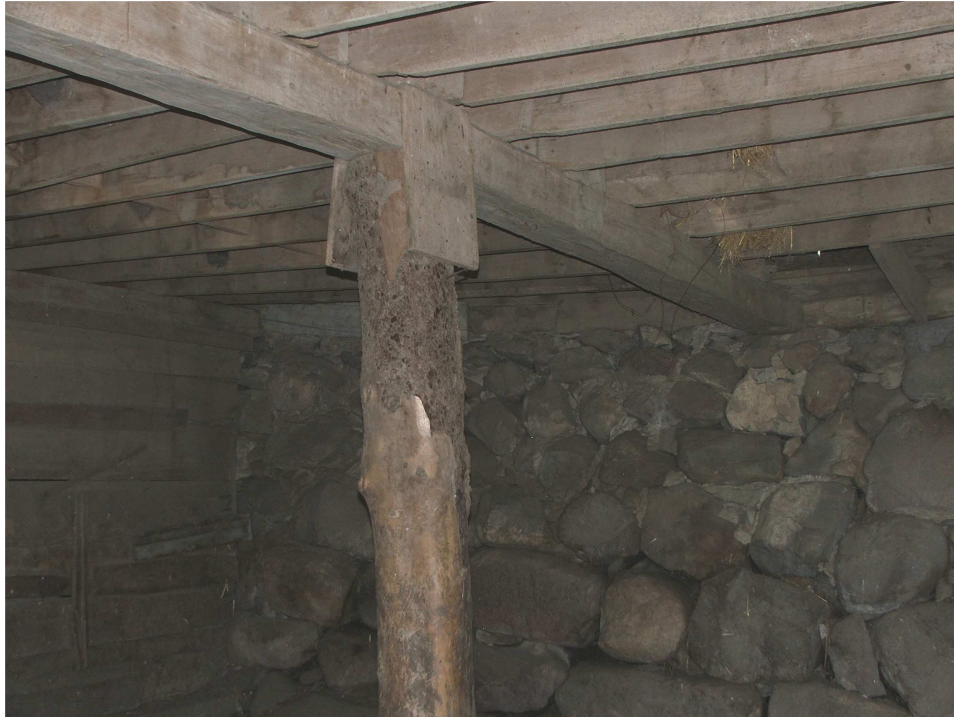
**ROLL NUMBER:** \_\_\_\_\_  
**PHOTO NUMBER:** 5  
**CAMERA DIRECTION:** Basement North foundation wall

He dug back into the bluff for the basement just like as he had for his first permanent barn. Again he hauled in native stone to build the West, North and East basement walls 8 foot high. The stones were mortared with sand and lime. The stones were large in his first barn but even larger in the lower part of this basement wall. I really wonder how he moved and placed these stones. The basement was 36 feet wide North and South and 116 feet long East and West. This barn is about 5 feet from the Southwest corner of this new barn and the Northeast corner of his first barn.

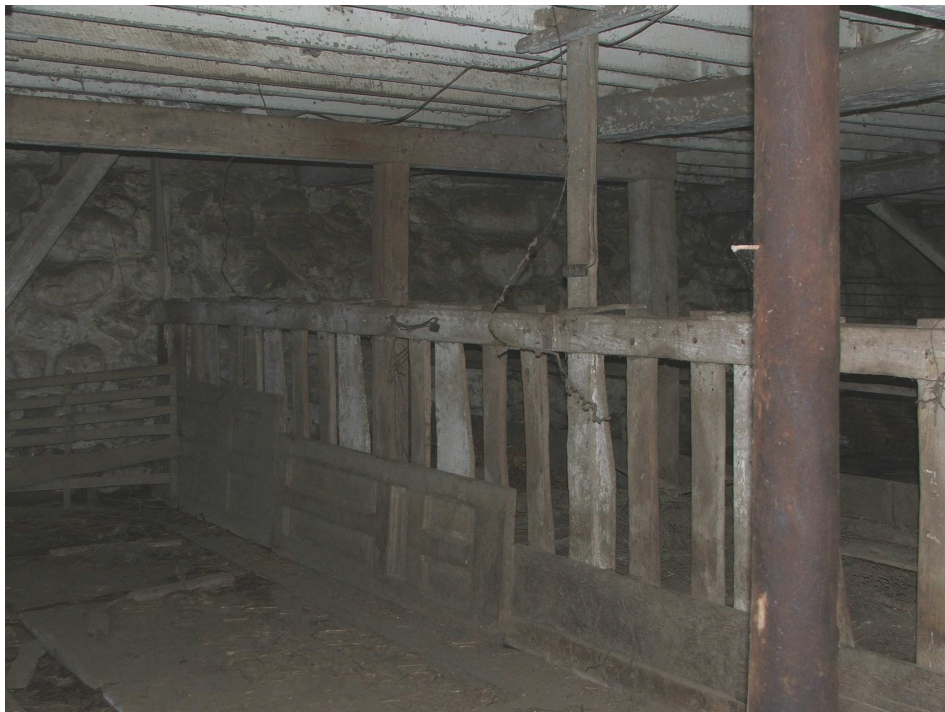
**ROLL NUMBER:** \_\_\_\_\_  
**PHOTO NUMBER:** 6  
**CAMERA DIRECTION:** Looking NE original milk cow stanchions

About 1920 Martin Weeks Sr. (Canute Week's son) was running the farm and also feeding a lot of cattle. His wife Josephine (Schoraga) wanted to start a dairy. She supervised most of the work on the dairy with the help of hired hands. The dairy was in the west end of the livestock barn. One of the rows of stanchions is still there. Eventually she had 5 rows of stanchions with each row holding 10 cows. A fifty-cow dairy would have been a very large operation at that time especially milking all of the cows by hand. Eventually they got electricity on the farm and installed milking machines.

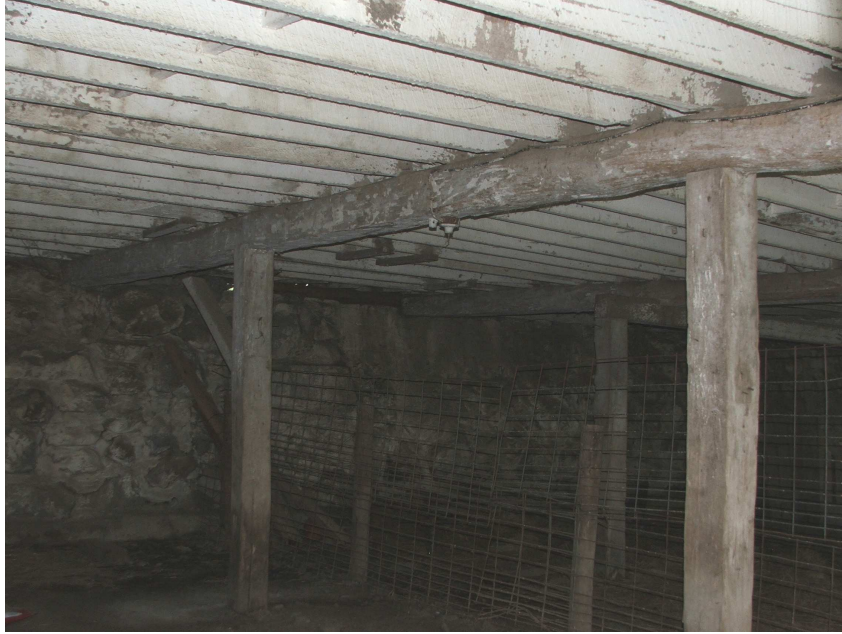
**ROLL NUMBER:** 7  
**PHOTO NUMBER:** 7  
**CAMERA DIRECTION:** Basement, looking NW,  
6x6 posts, log beams  
and 2x6 floor joists.

The South wall is post and beam with beams running North and South. Some of the posts are 8 x 8 rough sawn with 8 x 8 rough sawn beams. Some of the posts and beams are just round logs. The posts are 9 feet spacing the 36 foot depth and about 11 foot spacing the 116 foot length. The floor joists are 2 x 6 rough sawn cottonwood with boards for the hayloft floor.
