**SOUTH DAKOTA STATE HISTORIC PRESERVATION OFFICE
HISTORIC SITES SURVEY STRUCTURE FORM**

*SURVEY DATE: November 4, 2012 *ADDRESS: 4424 East Main Street
*SURVEYOR: Jim Stone *COUNTY: Clay
*CITY: Vermillion

CURRENT FUNCTION: <u>Livestock barn</u>	FOUNDATION: <u>Poured concrete foundation</u>
CURRENT SUBFUNCTION: <u>Hay and feed storage</u>	ROOF MATERIAL: <u>Steel roofing over cedar shingles</u>
HISTORIC FUNCTION: <u>Livestock barn</u>	ROOF SHAPE: <u>Gable</u>
HISTORIC SUBFUNCTION: <u>Hay and grain storage</u>	STRUCTURAL SYSTEM: <u>Balloon framing</u>
	STYLE: <u>Gable roof barn</u>
OCCUPIED: <u>Yes</u>	TYPE: <u>Livestock barn</u>
	<u>2x6 stud with 1x6 #106 drop siding and steel roofing</u>
ACCESSIBLE: <u>Yes with permission</u>	WALLS: _____
STORIES: <u>2</u>	SIGNIFICANT PERSON: <u>Carrie Burgess</u>
*DATE OF CONSTRUCTION: <u>1910-1920</u>	CULTURAL AFFILIATION: <u>?</u>

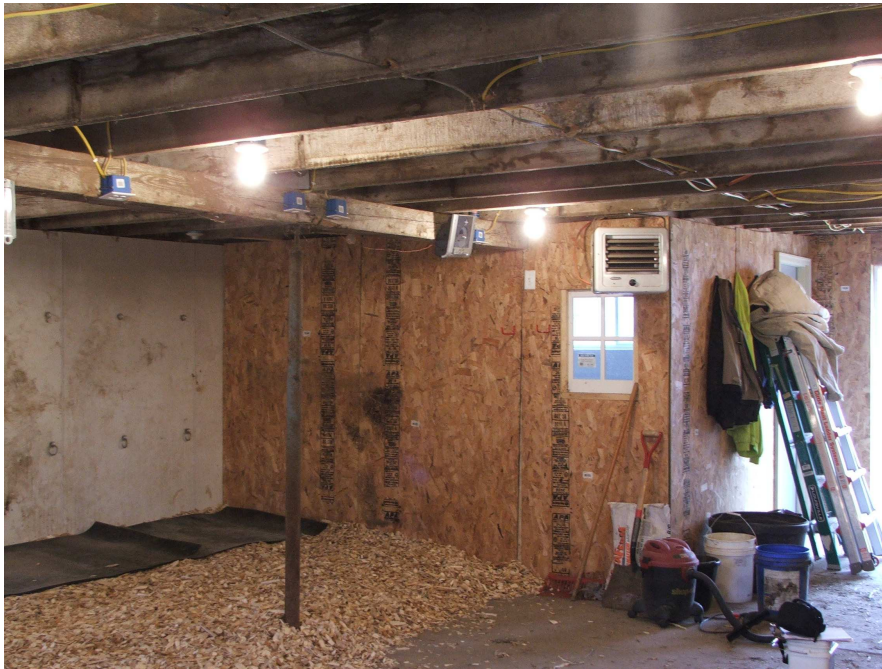
ROLL NUMBER: _____
PHOTO NUMBER: 5

ALTERED/MOVED NOTES: Original site. Any evidence of milk cow stanchions and horse stalls has been removed. Walls and roof have been covered with steel roofing. Office built in the SE corner. All walls have been insulated and lined. All walk doors have been replaced with insulated steel doors. All windows have been replaced with aluminum slider windows.

CAMERA DIRECTION: First floor, looking SE,
office built into SE
corner.

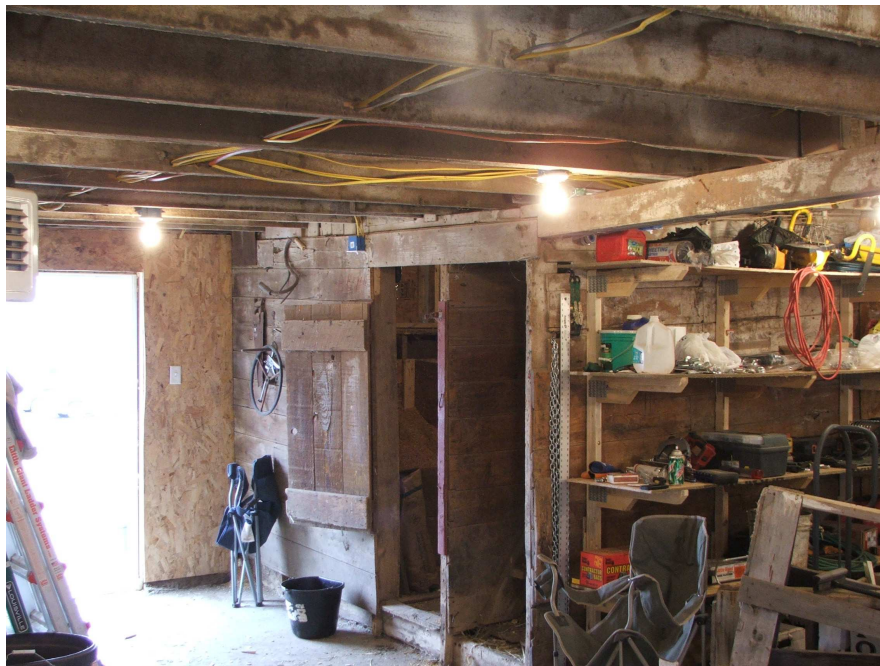
ROLL NUMBER: _____
PHOTO NUMBER: 6

INTERIOR NOTES: Has two rows of 6x6 posts with 6x6 for beams. 2x8 floor joists. Granary, feed room and stairs are still in the SW corner.

CAMERA DIRECTION: First floor, looking SW,
granary, feed room and
stairs in SW corner.

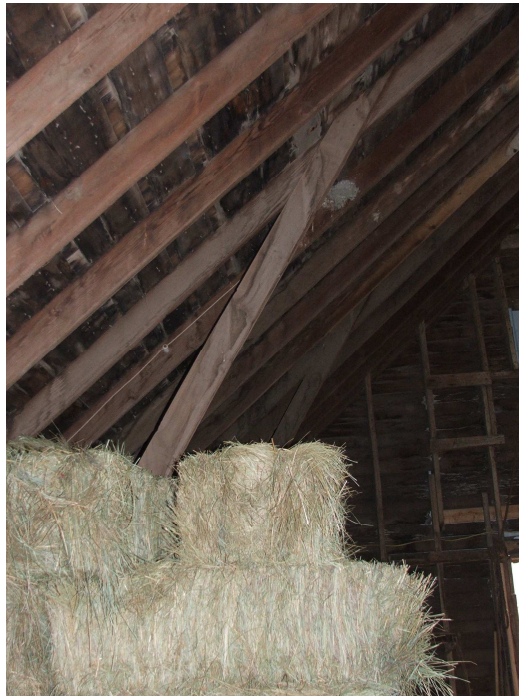
ROLL NUMBER: _____
PHOTO NUMBER: 7

OTHER NOTES: 2x6 stud walls with 1x6 T&G sheathing. It may be the siding as there is no additional siding on the outside of wall between the hayloft and West lean-to. All of the other walls are covered with steel and hides any evidence of original siding. In hayloft there is a 2x6 brace 8' O.C. from center of the rafter down to the bottom of wall, with 1x6 brace back to top of wall. All of the 2x6's, 2x8's and 6x6's are rough sawn cottonwood. The rafters in the hayloft are milled lumber, which is strange, as the rafters in lean-to are rough sawn.

CAMERA DIRECTION: Hayloft, looking North,
2x6 brace from rafter
down to floor

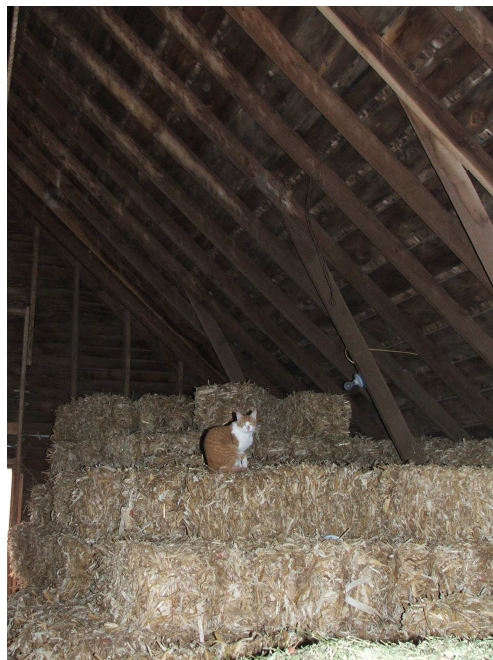
ROLL NUMBER: _____
PHOTO NUMBER: 8

CAMERA DIRECTION: Hayloft, looking North,
2x6 rafter bracing.
