**SOUTH DAKOTA STATE HISTORIC PRESERVATION OFFICE
HISTORIC SITES SURVEY STRUCTURE FORM**

*SURVEY DATE: October 28, 2012 *ADDRESS: 4235 East Main Street
*SURVEYOR: Jim Stone *COUNTY: Clay
*CITY: Vermillion

CURRENT FUNCTION:	<u>Rents out for horses in the summer</u>	FOUNDATION:	<u>Poured concrete foundation</u>
CURRENT SUBFUNCTION:	<u>Vacant</u>	ROOF MATERIAL:	<u>Asphalt shingles over cedar shingles</u>
HISTORIC FUNCTION:	<u>Livestock barn</u>	ROOF SHAPE:	<u>Gable</u>
HISTORIC SUBFUNCTION:	<u>Hay storage</u>	STRUCTURAL SYSTEM:	<u>Posts and Beams w/ 2x6 walls</u>
OCCUPIED:	<u>Yes</u>	STYLE:	<u>Gable roof barn</u>
ACCESSIBLE:	<u>Yes with permission</u>	TYPE:	<u>Livestock barn</u>
		WALLS:	<u>2x6 studs with sheathing and 1/2"x6" cedar lap siding</u>
STORIES:	<u>2</u>	SIGNIFICANT PERSON:	<u>Carrie L. Burgess</u>
*DATE OF CONSTRUCTION:	<u>About 1890</u>	CULTURAL AFFILIATION:	<u>?</u>

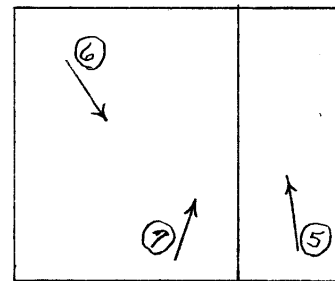
HAYLOFT

FIRST FLOOR

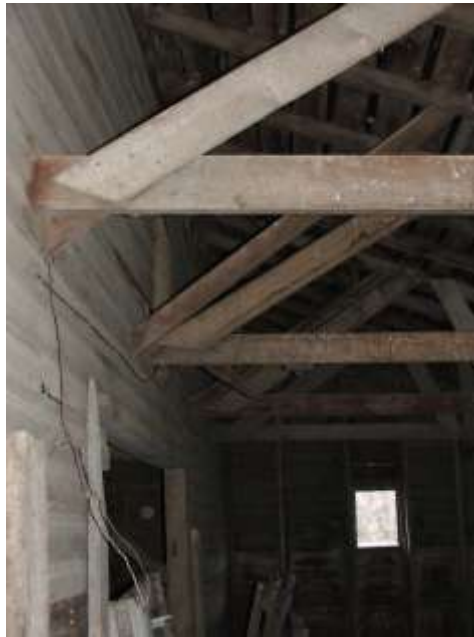
ROLL NUMBER: _____
PHOTO NUMBER: 5

CAMERA DIRECTION: First floor, looking North
in East lean-to, Trusses
6' O.C. supporting roof.

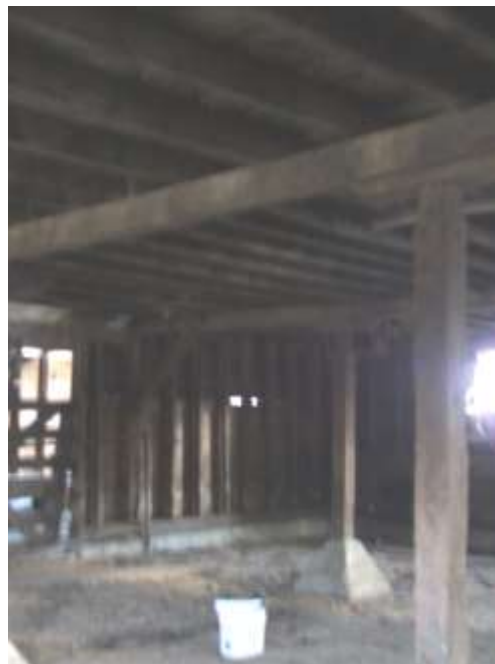
ROLL NUMBER: _____
PHOTO NUMBER: 6

CAMERA DIRECTION: First floor, looking SE,
6x6 posts and 6x6
beams supporting
hayloft floor.

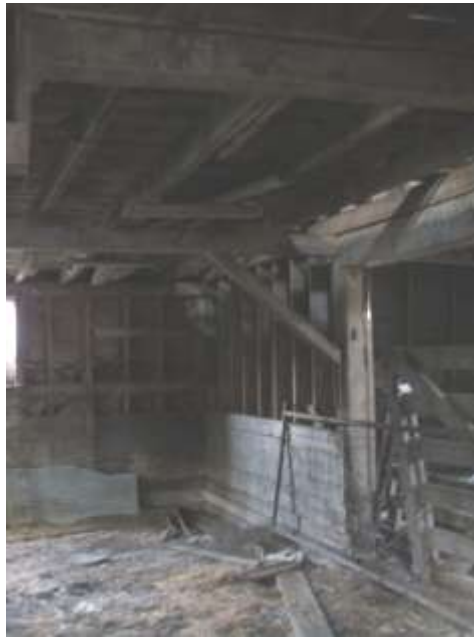
ROLL NUMBER: _____
PHOTO NUMBER: 7

CAMERA DIRECTION: First floor, looking NE,
6x6 posts and 6x6
beams in exterior walls

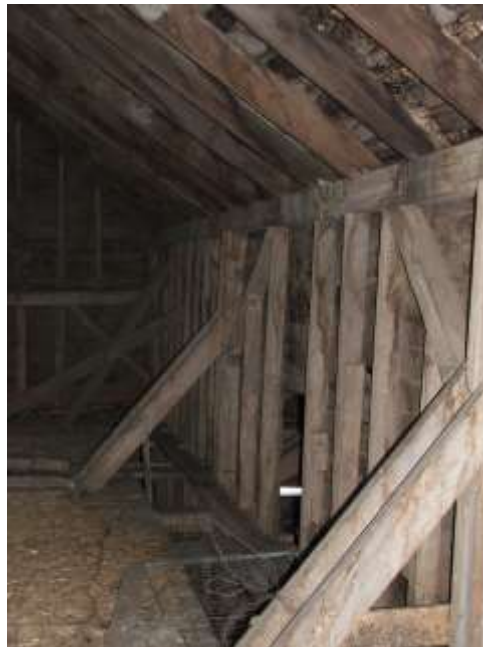
ROLL NUMBER: _____
PHOTO NUMBER: 8

CAMERA DIRECTION: Hayloft, looking NE, note
6x6 beam at top of wall &
(2) 2x8's bracing wall
down to beams under
floor.

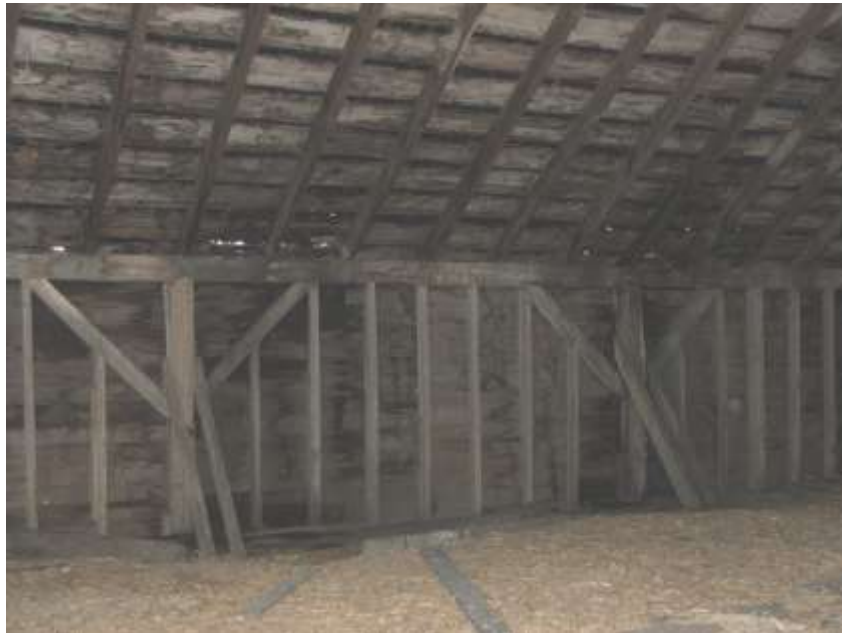
ROLL NUMBER: _____
PHOTO NUMBER: 9

**Hayloft, looking West,
note 6x6 posts, 6x6
beams at top of wall and
2x8 bracing 12' O.C.**

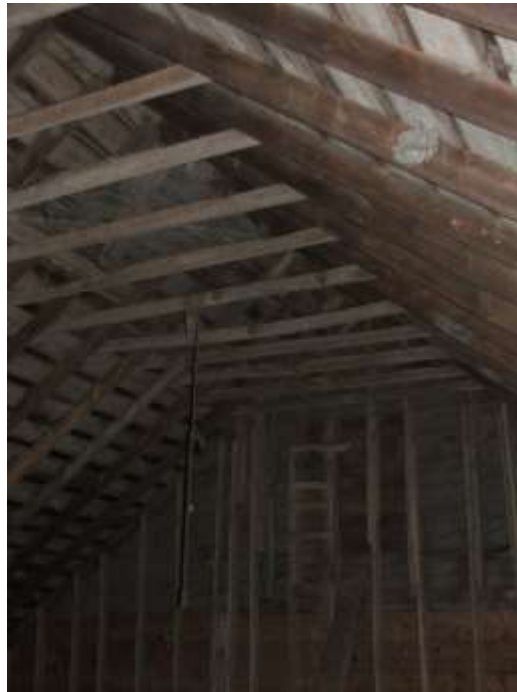
ROLL NUMBER: _____
PHOTO NUMBER: 9

**Hayloft, looking North,
Rafters and 2x6 bracing
at the peak, only bracing
on rafters.**
