**SOUTH DAKOTA STATE HISTORIC PRESERVATION OFFICE  
HISTORIC SITES SURVEY STRUCTURE FORM**

\*SURVEY DATE: November 23, 2011 \*ADDRESS: 46113 Timber Road  
\*SURVEYOR: Jim Stone \*COUNTY: Clay  
\*CITY: Vermillion

SHPO ID: 15 CL 0000570  
 \*PROPERTY NAME: Chris Sorensen barn  
 OTHER NAME: \_\_\_\_\_

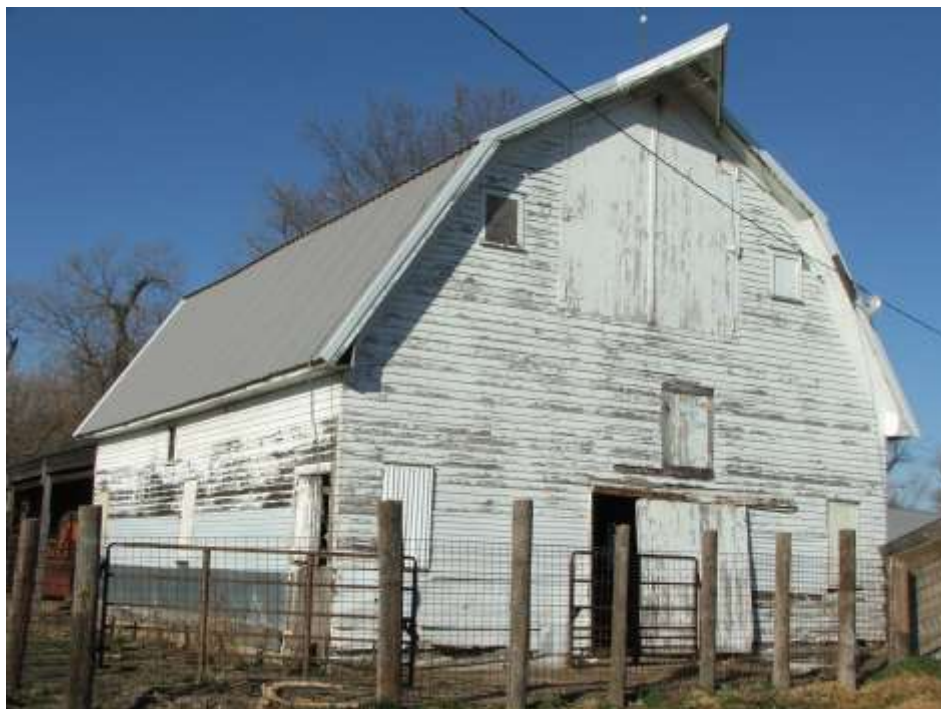
**ROLL NUMBER:** \_\_\_\_\_  
**PHOTO NUMBER:** 1  
**CAMERA DIRECTION:** Looking SW, NE corner

**\*PHYSICAL NOTES:** Barn is in fair condition. Needs siding, some of the siding is gone and the diagonal sheathing is starting to deteriorate. Interior studs, rafters, rafter bracing, 6x6 beams and 6x6 posts are in very good shape. All of the posts, beams, 2x6 framing and diagonal sheathing are rough sawn cottonwood.

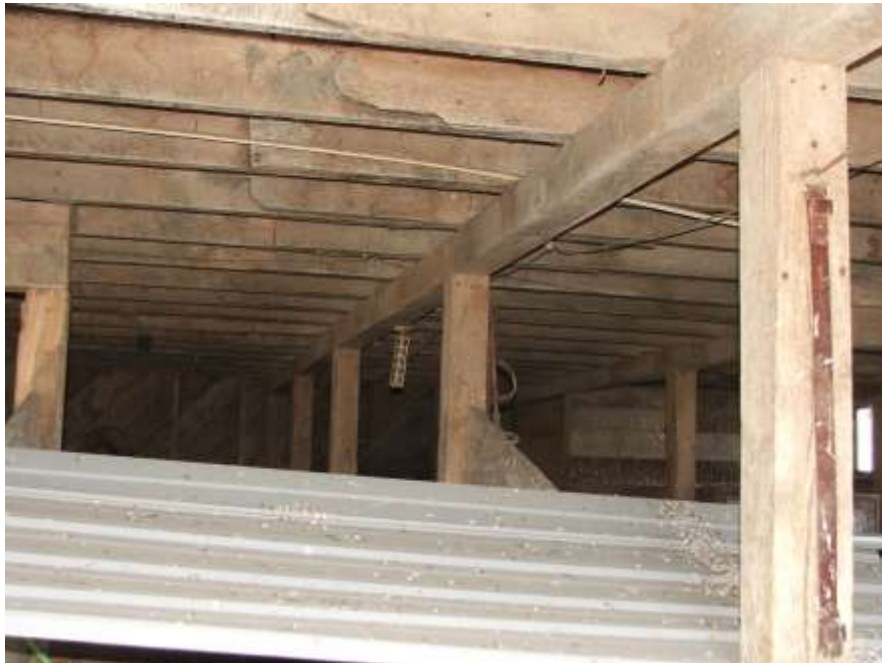
**ROLL NUMBER:** \_\_\_\_\_  
**PHOTO NUMBER:** 4

**INTERIOR NOTES:** (3) rows of 6x6 posts and 6x6 beams of rough sawn cottonwood running East to West. Beams are 7'- 6" O.C. with 2x10 rough sawn cottonwood floor joists which makes a very strong support for the hayloft floor, (actually is over built). Some of the original horse stalls are still in place, and also the milk cow stall.

**CAMERA DIRECTION:** First floor, looking NW,  
6x6 posts, 6x6 beams  
and 2x10 floor joists.

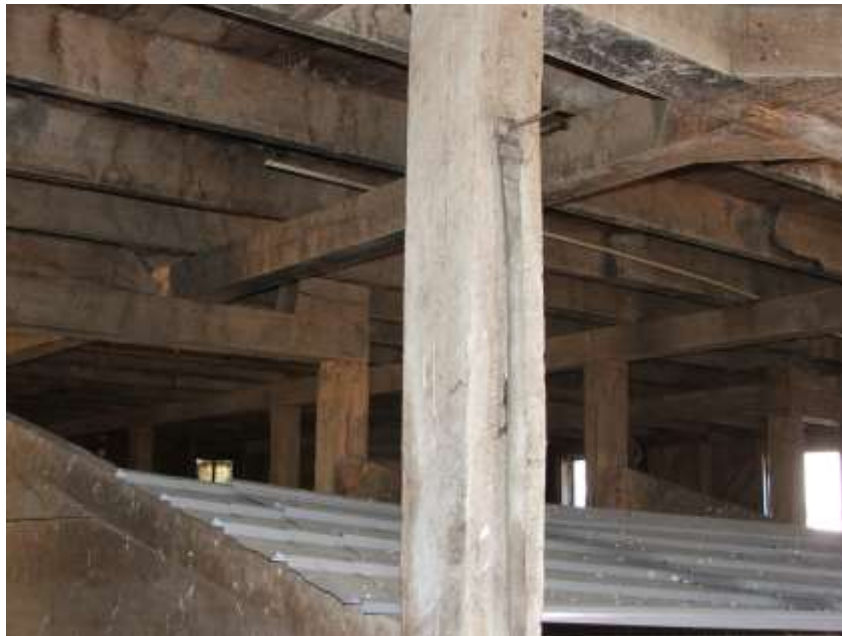
**ROLL NUMBER:** \_\_\_\_\_  
**PHOTO NUMBER:** 5

**CAMERA DIRECTION:** First floor, looking NW,  
6x6 posts 6x6 beams  
and 2x10 floor joists

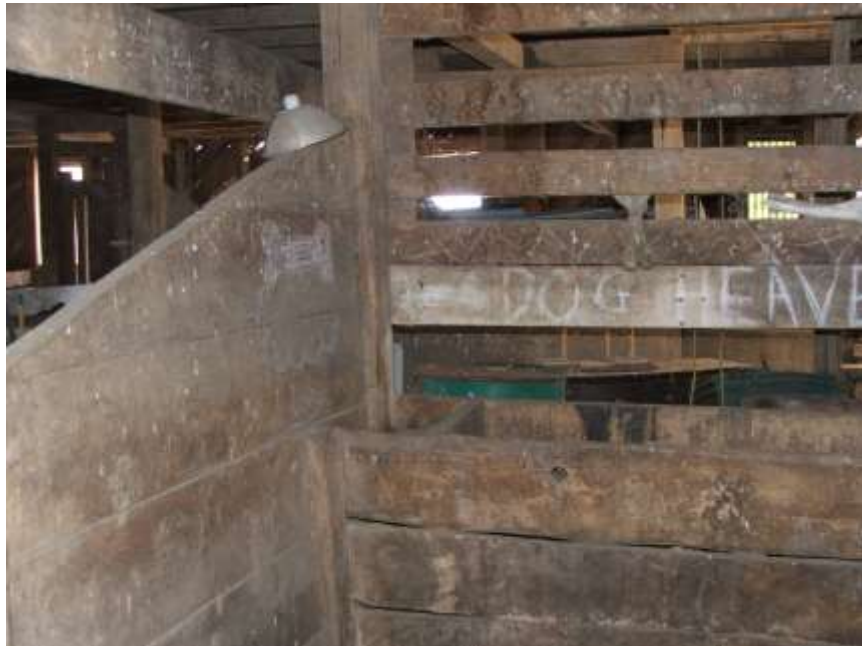
**ROLL NUMBER:** \_\_\_\_\_  
**PHOTO NUMBER:** 6  
**CAMERA DIRECTION:** First floor, looking East, milk cow stall

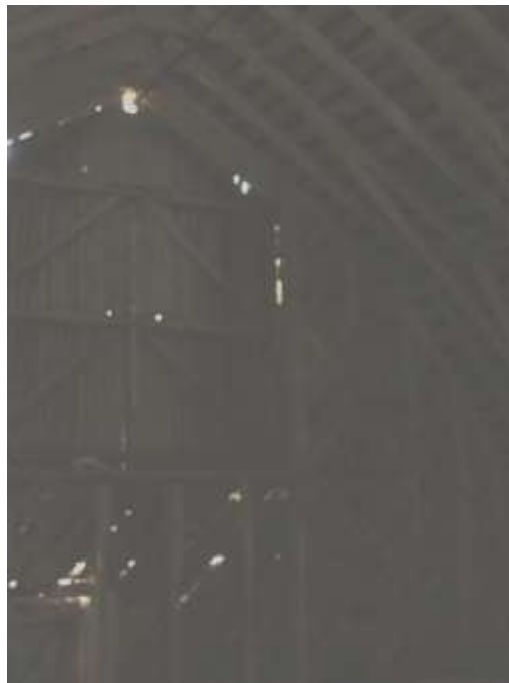
**ROLL NUMBER:** \_\_\_\_\_  
**PHOTO NUMBER:** 7  
**CAMERA DIRECTION:** Hayloft, looking East

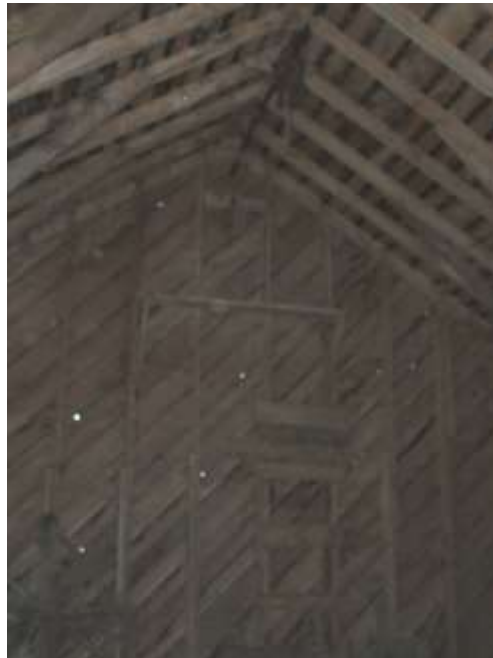
**ROLL NUMBER:** \_\_\_\_\_  
**PHOTO NUMBER:** 8  
**CAMERA DIRECTION:** Hayloft, looking West,  
note diagonal sheathing

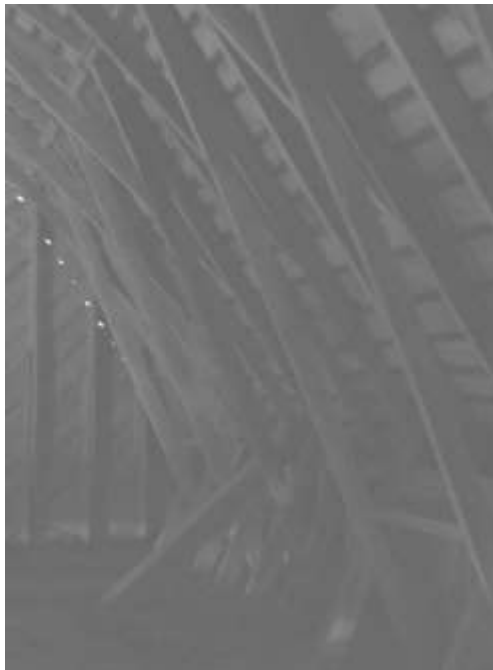
**OTHER NOTES:** First floor windows are four light (9x12) over four light (9x12) barn sash which are moveable as a double hung window for ventilation. Five four light (9x12) barn sash in hayloft. One swinging door on North, East and South sides and a sliding door on the East.  
Rafters are modified braced rafter trusses.

**ROLL NUMBER:** \_\_\_\_\_  
**PHOTO NUMBER:** 9  
**CAMERA DIRECTION:** Hayloft, looking NW, 2x6  
rafters and 2x6 roof  
bracing
