**SOUTH DAKOTA STATE HISTORIC PRESERVATION OFFICE
HISTORIC SITES SURVEY STRUCTURE FORM**

*SURVEY DATE: March 7, 2013 *ADDRESS: 46975 309th Street
*SURVEYOR: Jim Stone *COUNTY: Clay
*CITY: Beresford

CURRENT FUNCTION: Vacant FOUNDATION: Poured concrete
 CURRENT SUBFUNCTION: Vacant ROOF MATERIAL: Steel roofing
 HISTORIC FUNCTION: Elevator / corncrib ROOF SHAPE: Gable
 HISTORIC SUBFUNCTION: Grain storage STRUCTURAL SYSTEM: Balloon framing
 OCCUPIED: Yes STYLE: Elevator / corn crib
 TYPE: Elevator / corncrib
 ACCESSIBLE: Yes with permission WALLS: 2x6 studs, 1x6 beveled crib boards

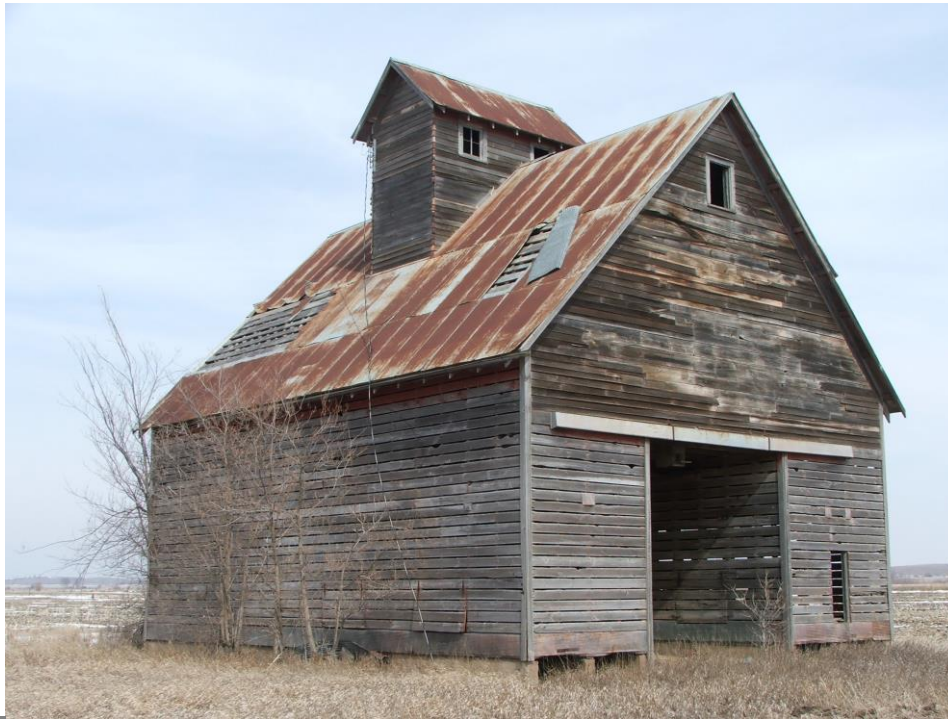
ROLL NUMBER: _____
PHOTO NUMBER: 1
CAMERA DIRECTION: Looking NE, SW corner

*PHYSICAL NOTES: Corncrib is in fair condition. Some to the roofing has blown off. Chain on grain leg is broken.

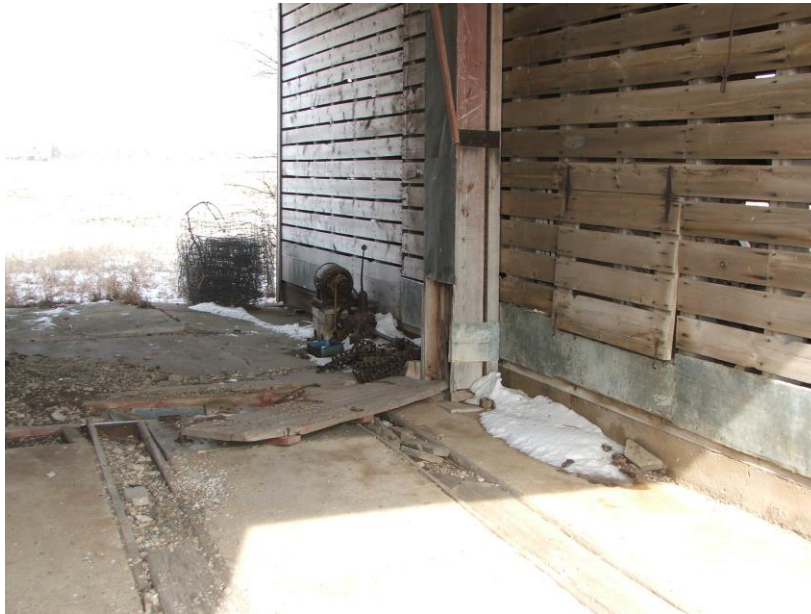
ROLL NUMBER: _____
PHOTO NUMBER: 5

INTERIOR NOTES: Has grain pit in floor of driveway and a hoist to tilt wagons for unloading. Has a grain leg to elevate ear corn up and into side corncribs or grain into four grain bins above driveway. Two interior walls are double 2x6's, 24" O. C., 21 feet high with 1x6 boards. Double 3x12's support the granaries above the driveway. 8" foundations, three on each side support the 2x10 floor joists for floor in the corncribs. A (3) HP, single phase, Westinghouse electric motor was the power to run elevator. It was connected to an automotive transmission to set speed or power running elevator.

CAMERA DIRECTION: First floor, looking NE in driveway, electric motor and transmission, grain leg and hoist.

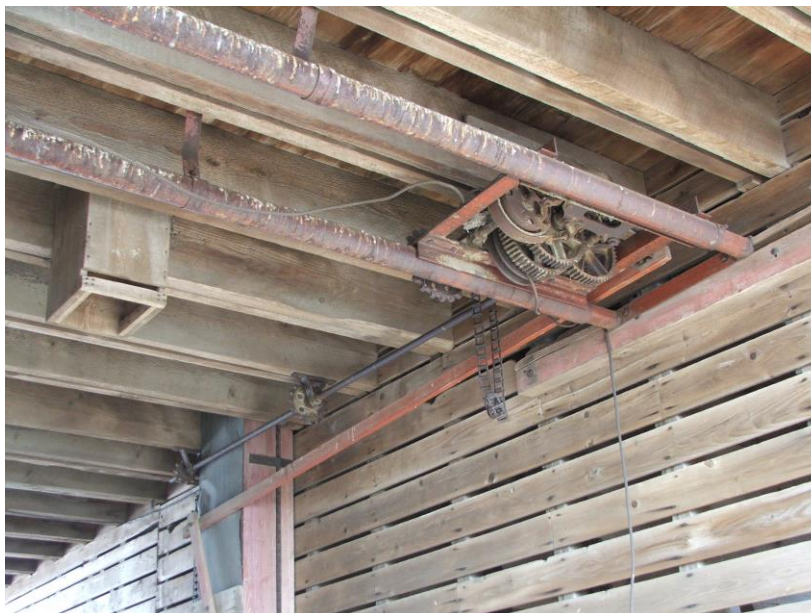
ROLL NUMBER: _____
PHOTO NUMBER: 6

CAMERA DIRECTION: First floor, looking NE in driveway, hoist to tilt wagons for unloading, note double 3x12's above.

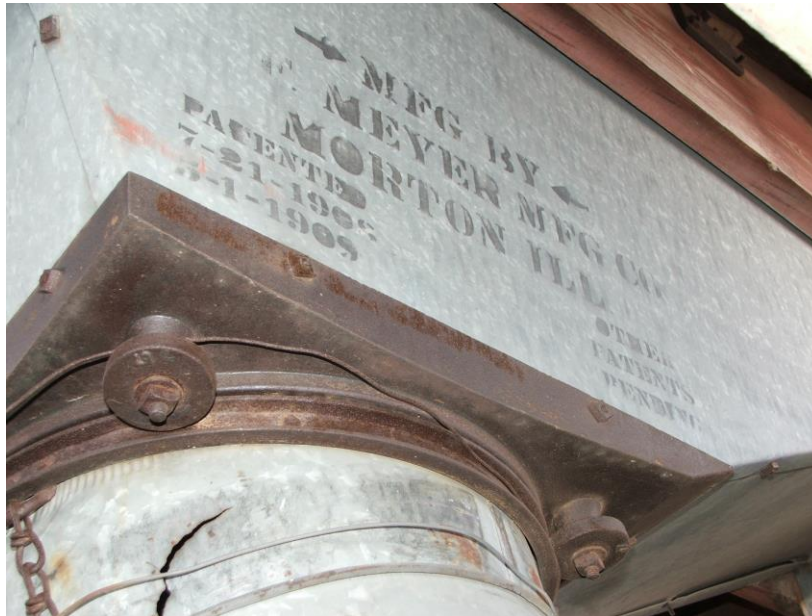
ROLL NUMBER: 7
PHOTO NUMBER: 7

Third floor, looking NE,
top of grain leg and
spout to direct flow of
grain

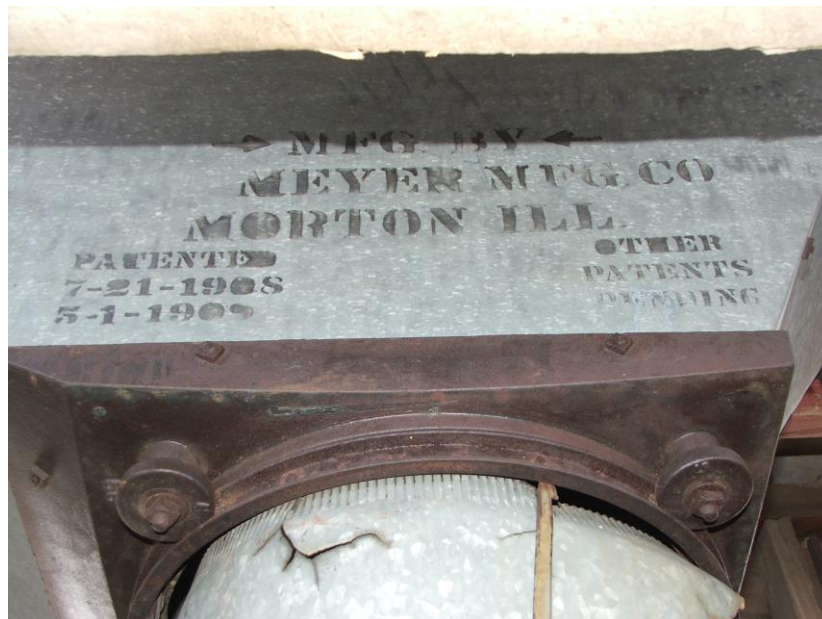
ROLL NUMBER: 8
PHOTO NUMBER: 8

Third floor, looking
South, top of grain leg
and spout, note
manufacture and
patents.

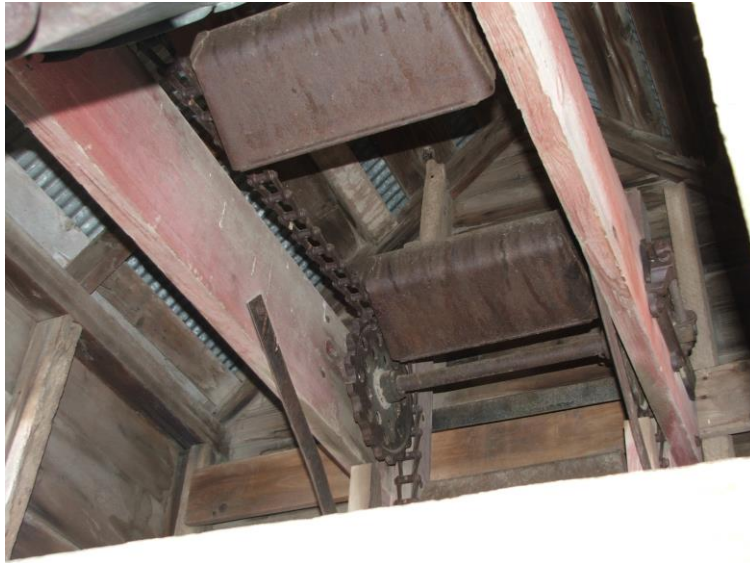
ROLL NUMBER: _____
PHOTO NUMBER: 9

CAMERA DIRECTION: Third floor, looking East, top of grain leg on down side, cups are 16" long, 8" deep and 6" wide.
