**SOUTH DAKOTA STATE HISTORIC PRESERVATION OFFICE
HISTORIC SITES SURVEY STRUCTURE FORM**

*SURVEY DATE: July 17, 2012 *ADDRESS: 31418 452nd Ave.
*SURVEYOR: Jim Stone *COUNTY: Clay
*CITY: Gayville

CURRENT FUNCTION:	<u>Beef cattle barn</u>	FOUNDATION:	<u>Poured concrete</u>
CURRENT SUBFUNCTION:	<u>Hay storage</u>	ROOF MATERIAL:	<u>Steel over cedar shingles</u>
HISTORIC FUNCTION:	<u>Beef cattle barn</u>	ROOF SHAPE:	<u>Gambrel</u>
HISTORIC SUBFUNCTION:	<u>Hay storage</u>	STRUCTURAL SYSTEM:	<u>Balloon framing</u>
		STYLE:	<u>Gambrel roof barn</u>
			<u>Western feeder</u>
OCCUPIED:	<u>Yes</u>	TYPE:	<u>barn</u>
	<u>Yes with</u>		<u>2x6, 1x6 drop</u>
ACCESSIBLE:	<u>permission</u>	WALLS:	<u>siding</u>

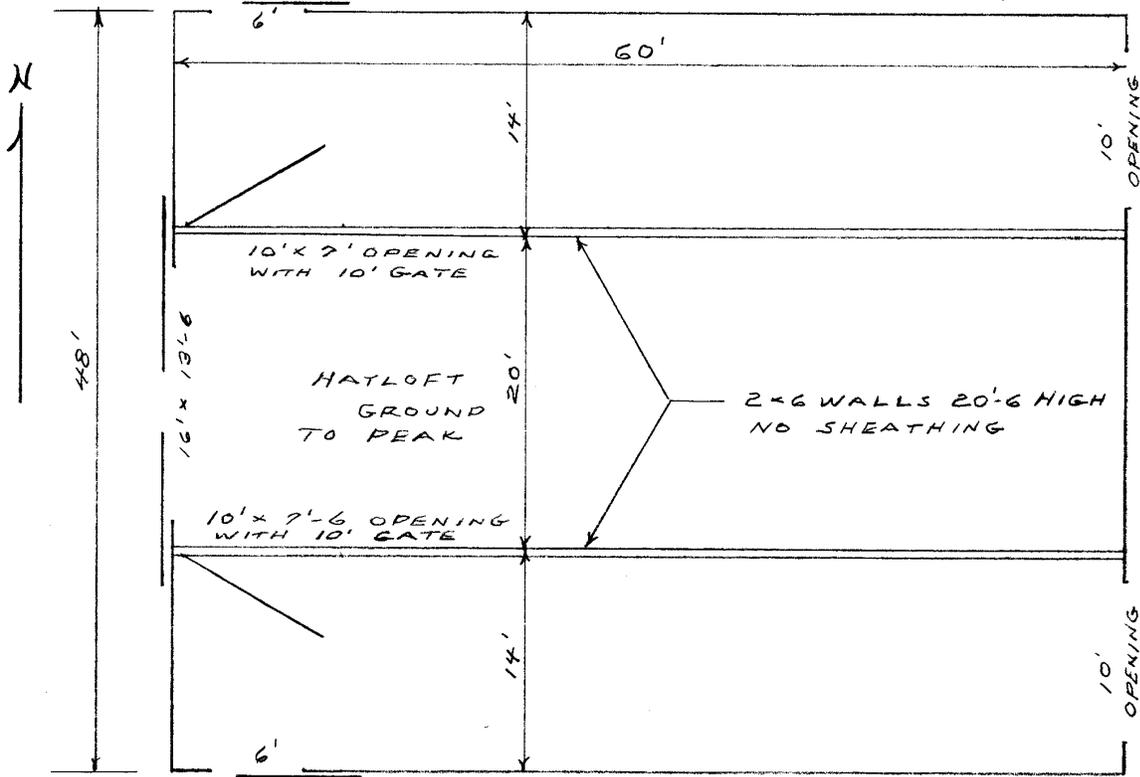
SKETCH MAP

INTERIOR NOTES: Two 2x6 walls 20'-6" high in 14' from the outer walls, 20 O.C. in center of barn. No sheathing on these walls except the bottom 4'. This is for hay storage, from the ground up 26'-6" to the peak. There are haylofts over the 14' areas on each side. Barn can hold over 100 tons of loose hay.

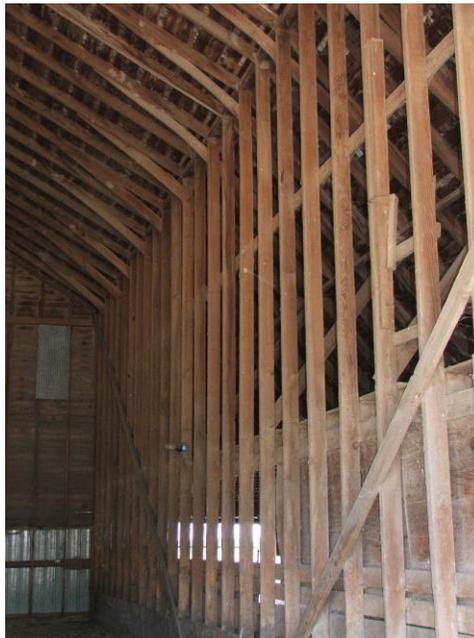
ROLL NUMBER: _____
PHOTO NUMBER: 4
CAMERA DIRECTION: First floor, looking East, South 2x6 wall 20'-6" high, supports the hip

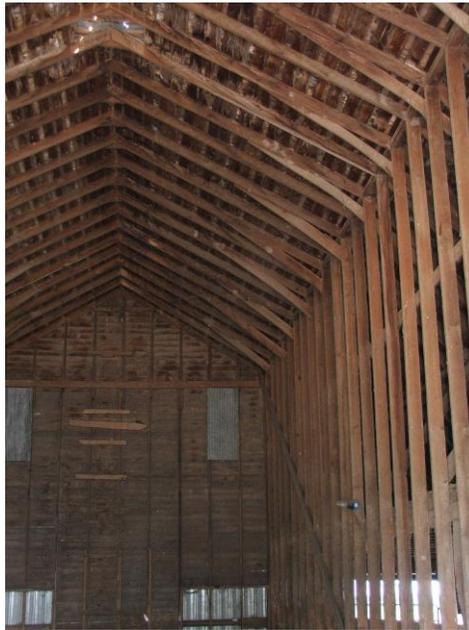
ROLL NUMBER: _____
PHOTO NUMBER: 5

CAMERA DIRECTION: First floor, looking East,
20'-6" wall, diagonal
bracing and East gable
end
