**SOUTH DAKOTA STATE HISTORIC PRESERVATION OFFICE
HISTORIC SITES SURVEY STRUCTURE FORM**

*SURVEY DATE: May 31, 2012 *ADDRESS: 45622 299th Street
*SURVEYOR: Jim Stone *COUNTY: Clay
*CITY: Wakonda

CURRENT FUNCTION:	<u>Shop</u>	FOUNDATION:	<u>Poured concrete Steel over cedar</u>
CURRENT SUBFUNCTION:	<u>Tractor storage</u>	ROOF MATERIAL:	<u>shingles</u>
HISTORIC FUNCTION:	<u>Livestock barn</u>	ROOF SHAPE:	<u>Gambrel</u>
HISTORIC SUBFUNCTION:	<u>Hay storage</u>	STRUCTURAL SYSTEM:	<u>Balloon framing</u>
		STYLE:	<u>Gambrel roof barn</u>
OCCUPIED:	<u>Yes</u>	TYPE:	<u>Livestock barn</u>
	<u>Yes with</u>		<u>2x6 with 1x6 #106</u>
ACCESSIBLE:	<u>permission</u>	WALLS:	<u>drop siding</u>

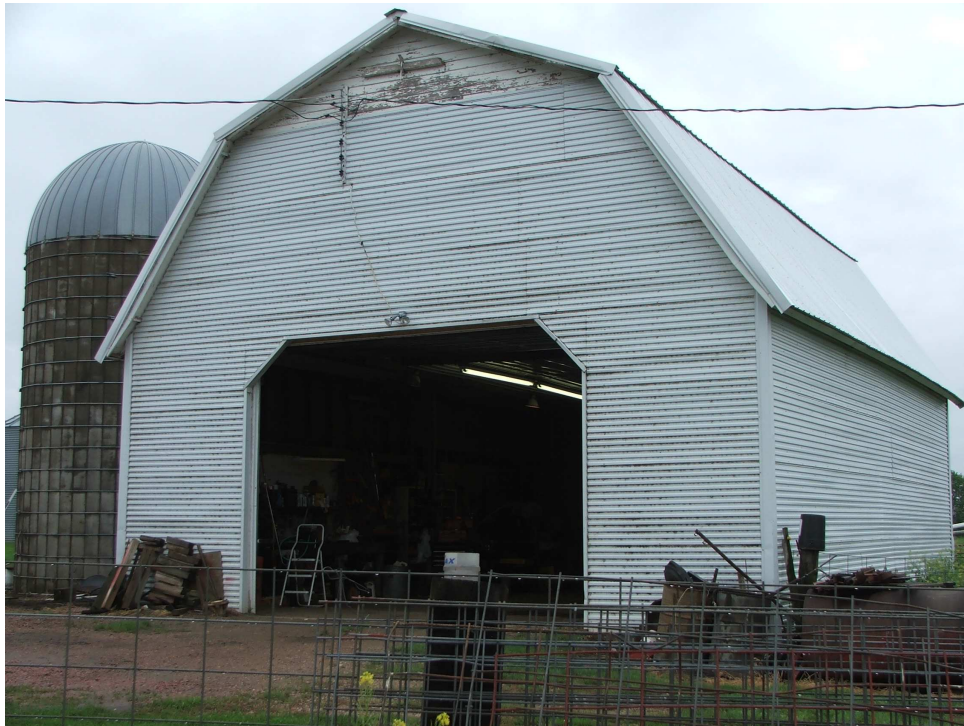
ROLL NUMBER: _____
PHOTO NUMBER: 1
CAMERA DIRECTION: Looking SE, NW corner

ALTERED/MOVED NOTES: Original site. Horse stalls, milk cow stanchions and calf pens have been removed. Hayloft floor raised to 12'-6" and covered with steel roofing for a ceiling. Walls and roof are covered with steel roofing. Metal cupola removed. Windows and door are covered with steel roofing. 16' x 12' insulated steel door installed in the North wall for access to shop.

***PHYSICAL NOTES:** Barn is in good condition. The owner planned the conversion very well and now the barn is very useful in the farming operation.

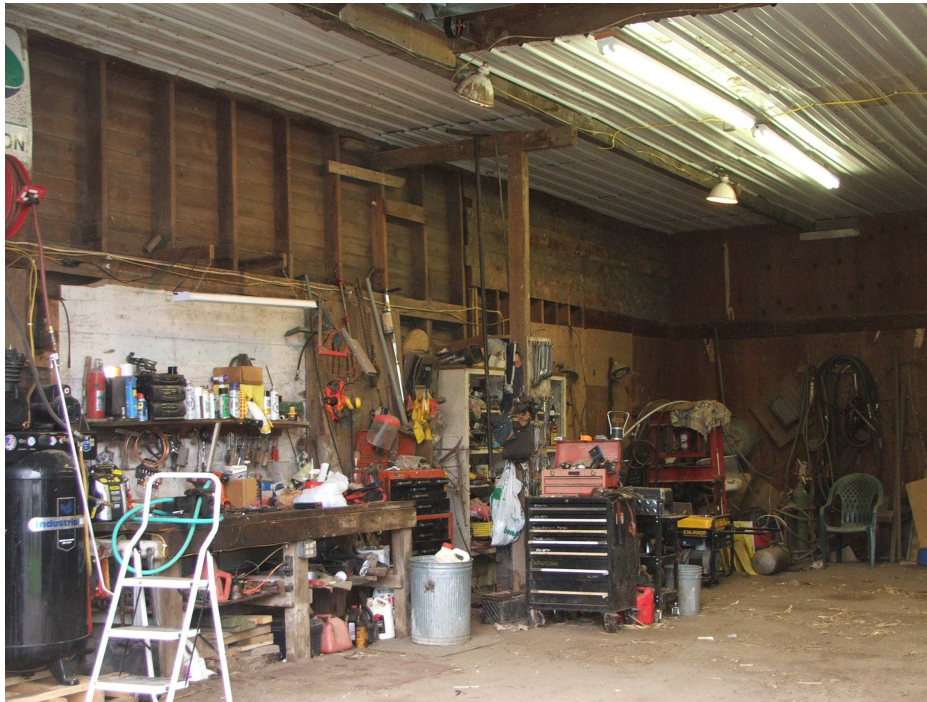
ROLL NUMBER: _____
PHOTO NUMBER: 5

INTERIOR NOTES: Everything has been removed. Owner said that there were two rows of 4x6 posts and 4x6 beams. 2x10 floor joists for hayloft floor. Owner showed where horse stalls, milk cow stanchions and calf pens were. He also said that the calf pens were replaced with two granaries.

CAMERA DIRECTION: Looking SE into shop area

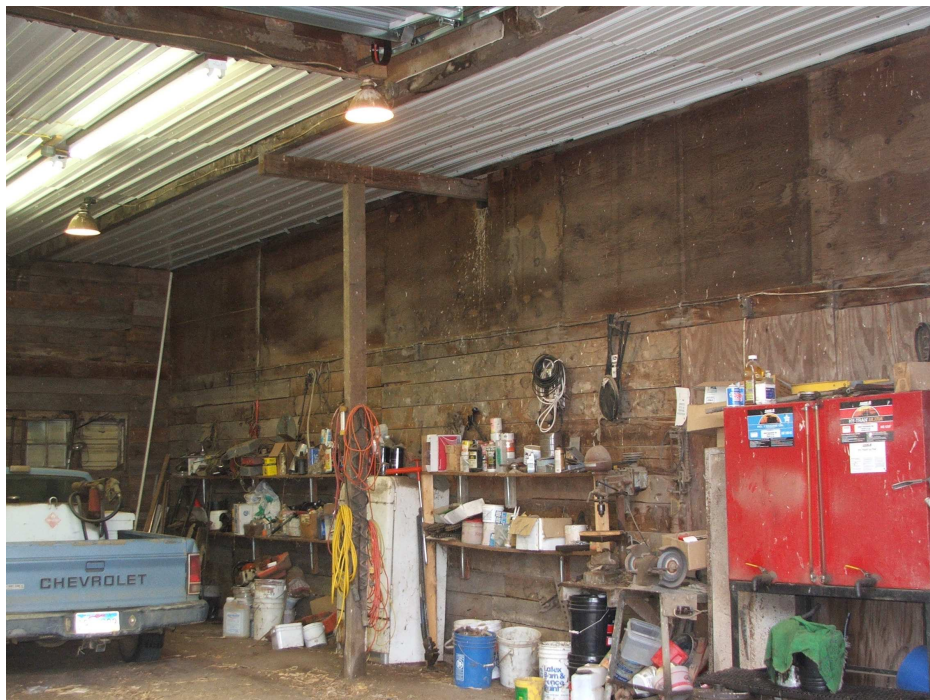
ROLL NUMBER: _____
PHOTO NUMBER: 6

CAMERA DIRECTION: Looking SW into shop area
