**SOUTH DAKOTA STATE HISTORIC PRESERVATION OFFICE
HISTORIC SITES SURVEY STRUCTURE FORM**

*SURVEY DATE: February 8, 2013 *ADDRESS: 46520 301th Street
*SURVEYOR: Jim Stone *COUNTY: Clay
*CITY: Beresford

CURRENT FUNCTION: Storage FOUNDATION: Poured concrete
 CURRENT SUBFUNCTION: Storage ROOF MATERIAL: Cedar shingles
 HISTORIC FUNCTION: Livestock barn ROOF SHAPE: Gable
 HISTORIC SUBFUNCTION: Hay & grain storage STRUCTURAL SYSTEM: Balloon framing
 OCCUPIED: Yes STYLE: Gable roof barn
 TYPE: Livestock barn
2x6 studs, 1 x 8
diagonal sheathing
& 1/2"x6" cedar lap
siding

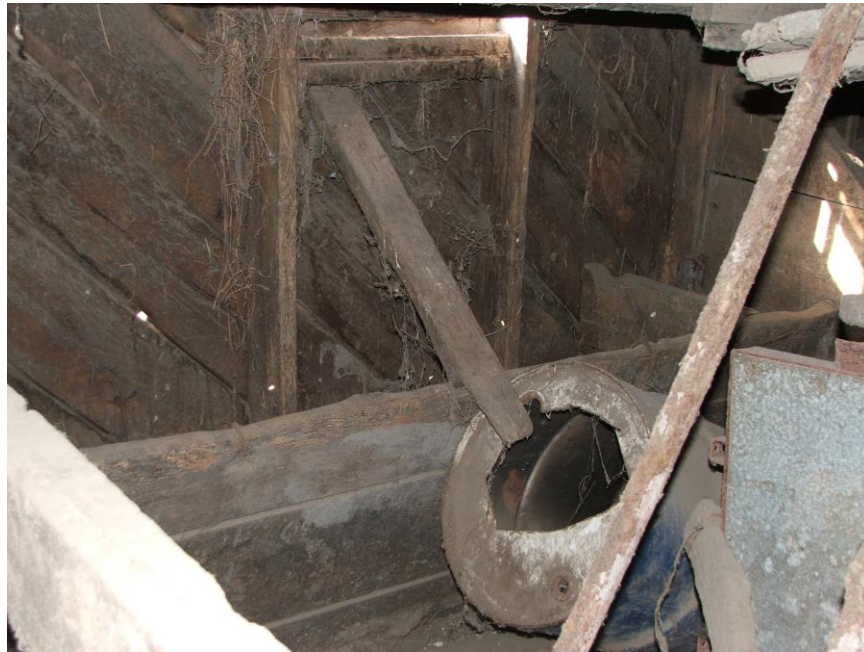
ROLL NUMBER: _____
PHOTO NUMBER: 5

CAMERA DIRECTION: First floor, West wing,
looking NW, milk cow
stall on West wall

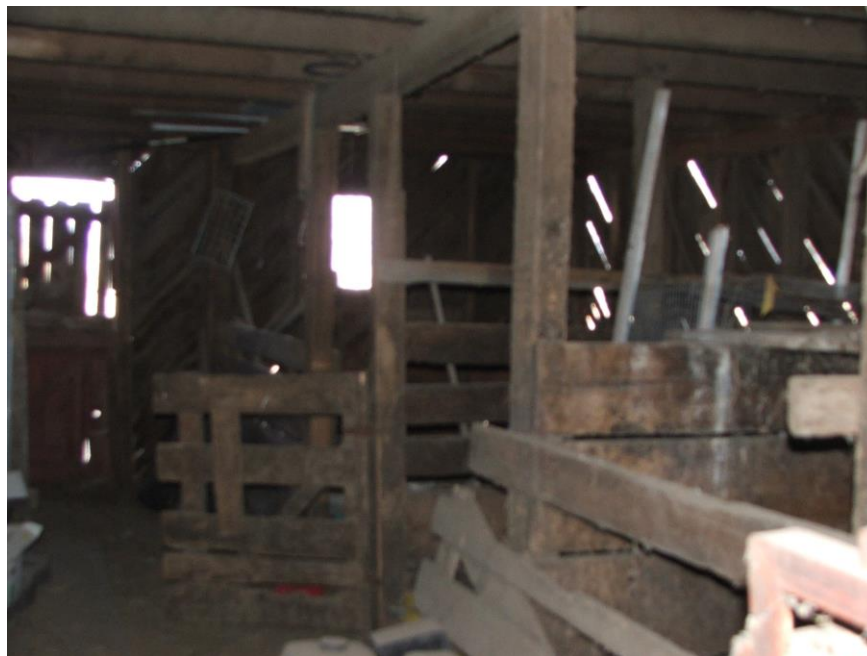
ROLL NUMBER: _____
PHOTO NUMBER: 6

CAMERA DIRECTION: First floor, west wing,
looking NW, milk cow
stall and pen in NW
corner

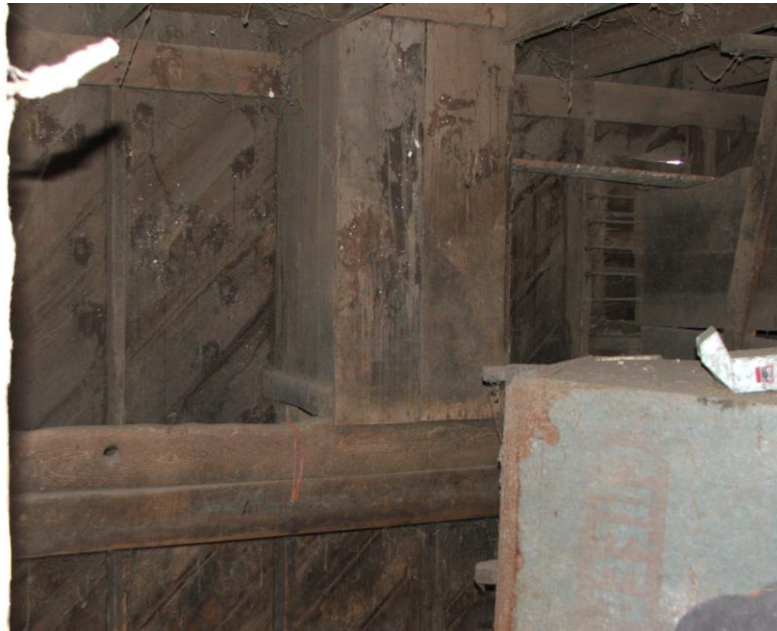
ROLL NUMBER: _____
PHOTO NUMBER: 7

CAMERA DIRECTION: First floor, East wing, looking North in to double horse stall, note hay chute.

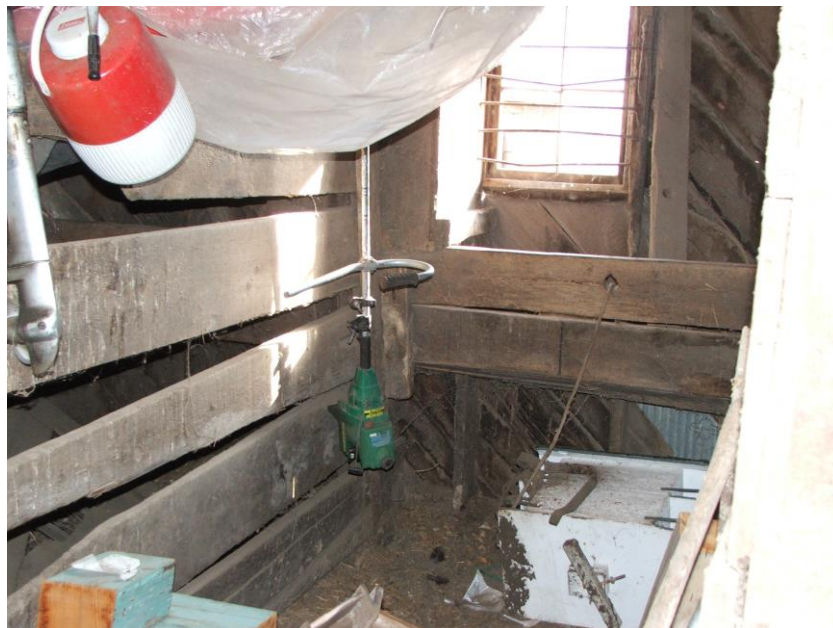
ROLL NUMBER: _____
PHOTO NUMBER: 8

CAMERA DIRECTION: First floor, East wing, looking South into single horse stall, note hay chute on left.

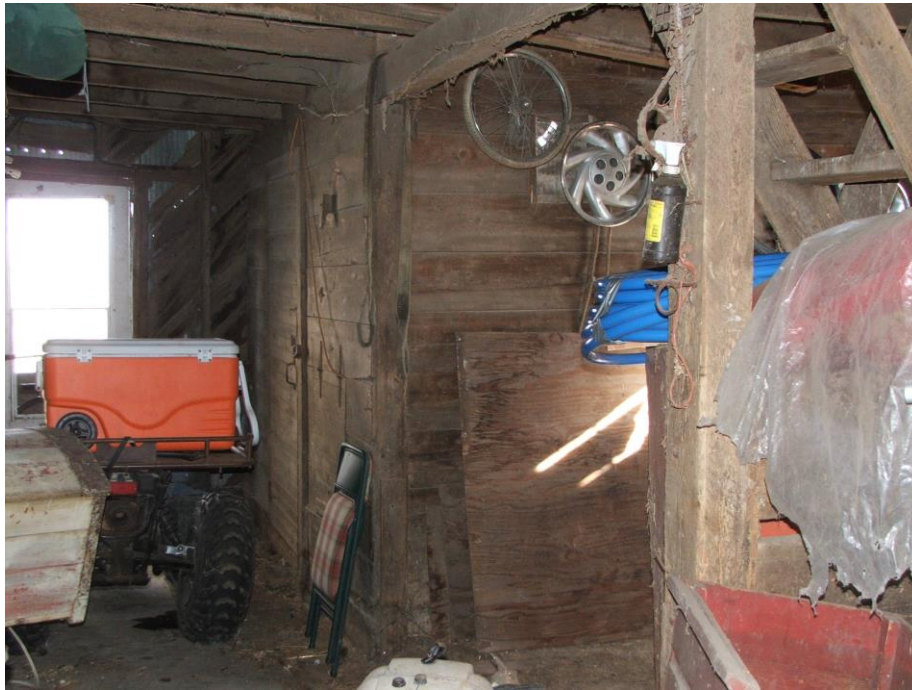
ROLL NUMBER: _____
PHOTO NUMBER: 9
CAMERA DIRECTION: First floor, East wing,
looking SE, granary in
the SE corner

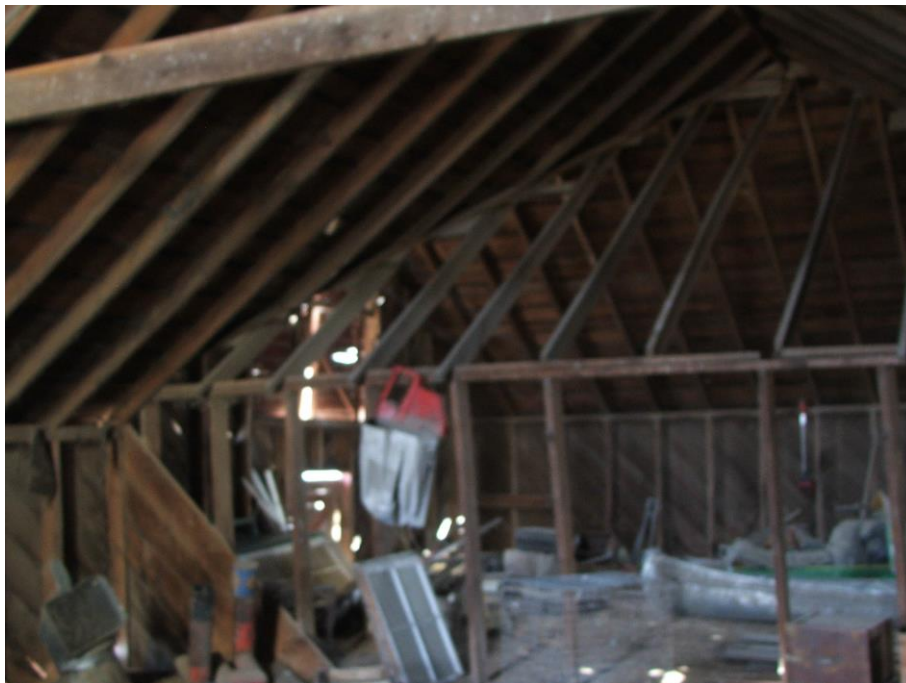
ROLL NUMBER: _____
PHOTO NUMBER: 10
CAMERA DIRECTION: Hayloft, looking SW into
West wing

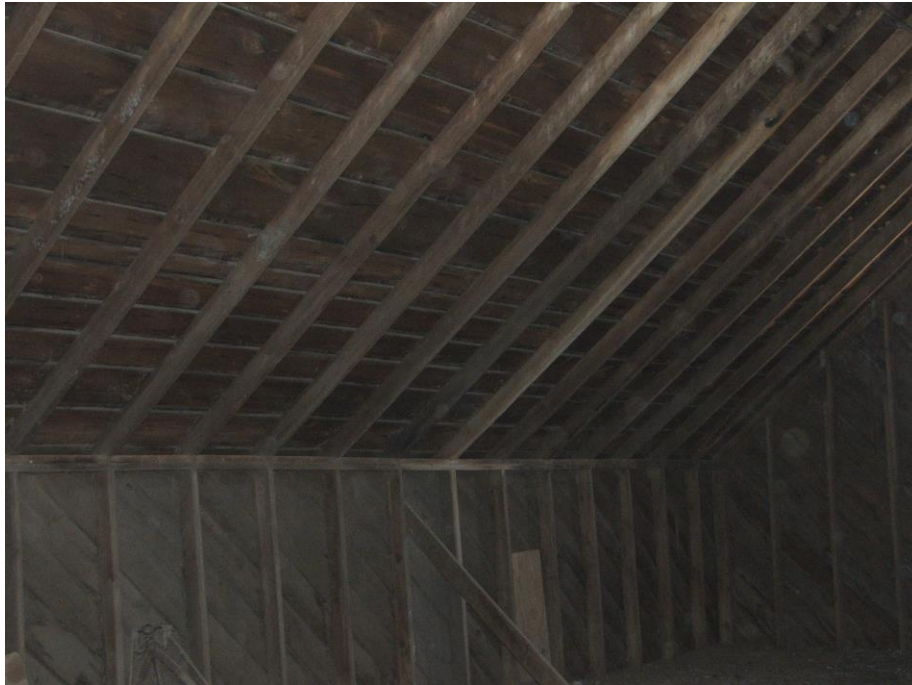
ROLL NUMBER: _____
PHOTO NUMBER: 11

OTHER NOTES: 2x6 stud walls with 1x8 diagonal sheathing and 1/2"x 6" cedar lap siding on all exterior walls. Rafters and bracing are 2x6's. All of the 2x6 studs, floor joists, rafters and bracing, 4x6 sills, posts and beams and 2 x 12 plank flooring are rough sawn cottonwood. Windows are 9"x12" four light. No evidence of a cupola is visible.

CAMERA DIRECTION: Hayloft, looking NW in West wing, 2x6 rafters, studs and bracing, note diagonal sheathing on both walls.
