**SOUTH DAKOTA STATE HISTORIC PRESERVATION OFFICE
HISTORIC SITES SURVEY STRUCTURE FORM**

*SURVEY DATE: August 5, 2013 *ADDRESS: 30369 455th Ave.
*SURVEYOR: Jim Stone *COUNTY: Clay
*CITY: Wakonda

CURRENT FUNCTION: <u>Calving barn</u>	FOUNDATION: <u>Native stone and poured concrete</u>
CURRENT SUBFUNCTION: <u>Storage</u>	ROOF MATERIAL: <u>Steel roofing over cedar shingles</u>
HISTORIC FUNCTION: <u>Horse barn</u>	ROOF SHAPE: <u>Gambrel roof</u>
HISTORIC SUBFUNCTION: <u>Hay & grain storage</u>	STRUCTURAL SYSTEM: <u>Balloon framing</u>
OCCUPIED: <u>No</u>	STYLE: <u>Gambrel roof barn</u>
ACCESSIBLE: <u>Yes with permission</u>	TYPE: <u>Horse barn</u>
	<u>2x6 & 2x8 studs, 1x6 T&G diagonal sheathing and steel roofing</u>
STORIES: <u>2</u>	WALLS: _____
*DATE OF CONSTRUCTION: <u>19-teens's</u>	SIGNIFICANT PERSON: <u>Frank E. Rederick</u>
	CULTURAL AFFILIATION: <u>?</u>

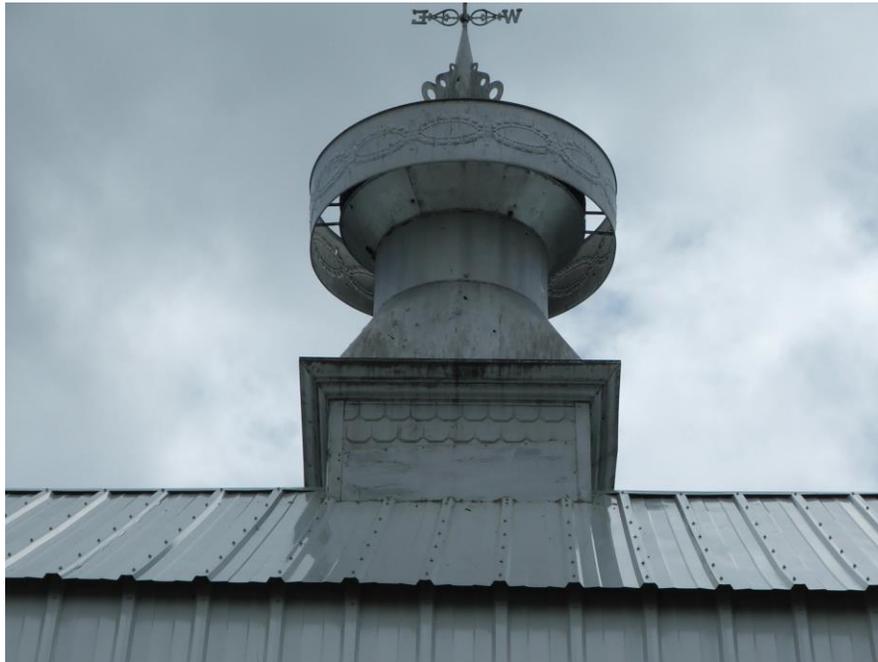
ROLL NUMBER: _____
PHOTO NUMBER: 5

CAMERA DIRECTION: Looking South & up,
very ornate cupola from
the 19-teens

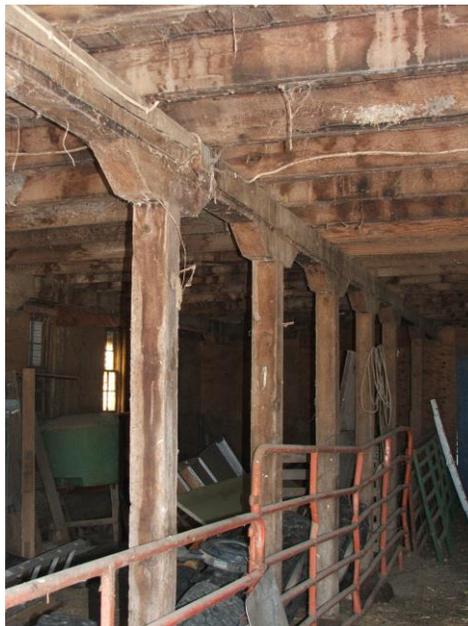
ROLL NUMBER: _____
PHOTO NUMBER: 6

CAMERA DIRECTION: First floor, looking SW,
6x6 posts, 6x8 beam, 2x8
floor joists, horse stalls
were between posts.

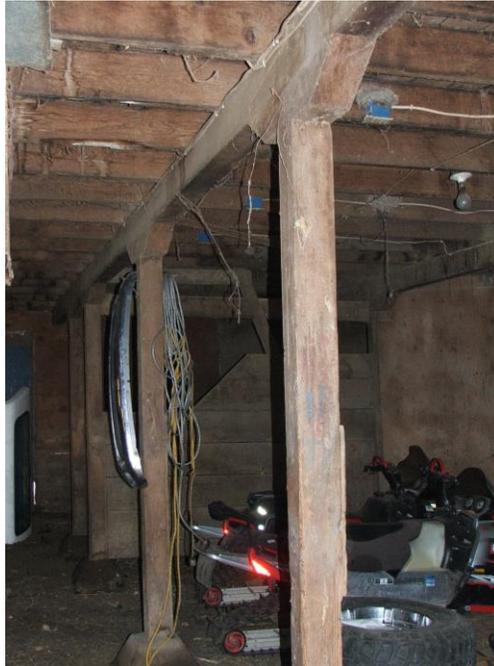
ROLL NUMBER: _____
PHOTO NUMBER: 7

**First floor, looking NW,
6x6 posts, 6x8 beam, 2x8
floor joists, horse stalls
were between 6x6 posts.**

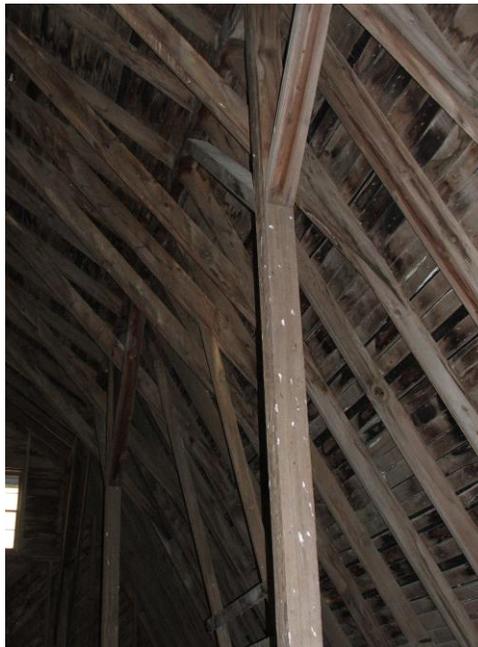
ROLL NUMBER: _____
PHOTO NUMBER: 8

**Hayloft, looking SE, 6x6
posts, 6x6 beam, 2x6
rafters, note 6x6 rafter
behind 6x6 post.**

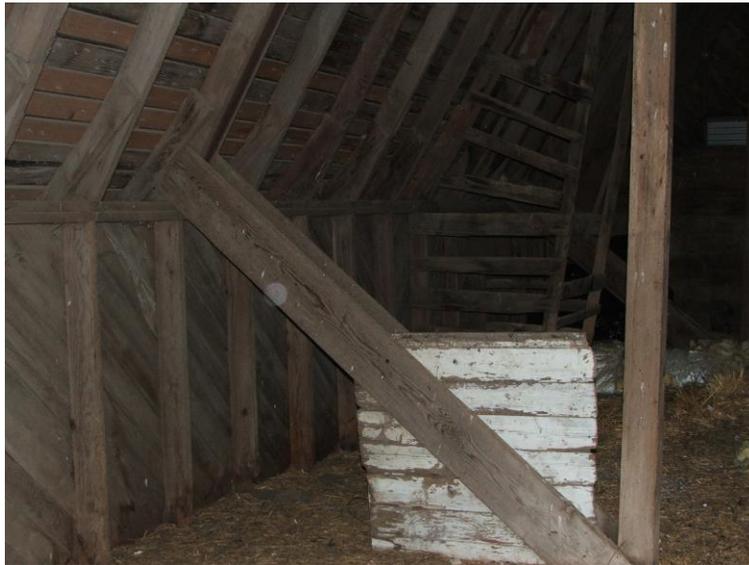
ROLL NUMBER: _____
PHOTO NUMBER: 9

Hayloft, looking NE, (2) 2x10's bracing from bottom of 6x6 rafter down to bottom of 6x6 post and nailed to floor joists.

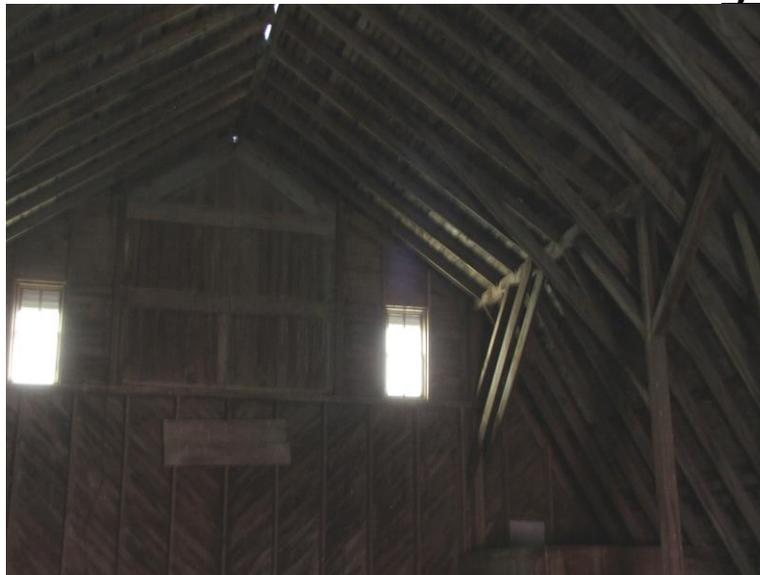
ROLL NUMBER: _____
PHOTO NUMBER: 10

Hayloft, looking SE, note top of 2x8 stud wall with 1x6 diagonal sheathing, 2x6 studs above, hayloft door and (4) diagonal braces from wall up to 6x6 beam.
