**SOUTH DAKOTA STATE HISTORIC PRESERVATION OFFICE  
HISTORIC SITES SURVEY STRUCTURE FORM**

\*SURVEY DATE: December 27, 2013 \*ADDRESS: 31023 So. Dak. Hwy 19  
\*SURVEYOR: Jim Stone \*COUNTY: Clay  
\*CITY: Vermillion

CURRENT FUNCTION: Swine FOUNDATION: Poured concrete  
 CURRENT SUBFUNCTION: Straw storage ROOF MATERIAL: Cedar shingles  
 HISTORIC FUNCTION: Livestock barn ROOF SHAPE: Gambrel roof  
 HISTORIC SUBFUNCTION: Hay storage STRUCTURAL SYSTEM: Balloon framing  
 OCCUPIED: Yes STYLE: Gambrel roof barn  
 Yes with TYPE: Livestock barn  
 ACCESSIBLE: Yes with permission WALLS: 2x6 & 2x8 studs, 1x6 # 106 drop siding

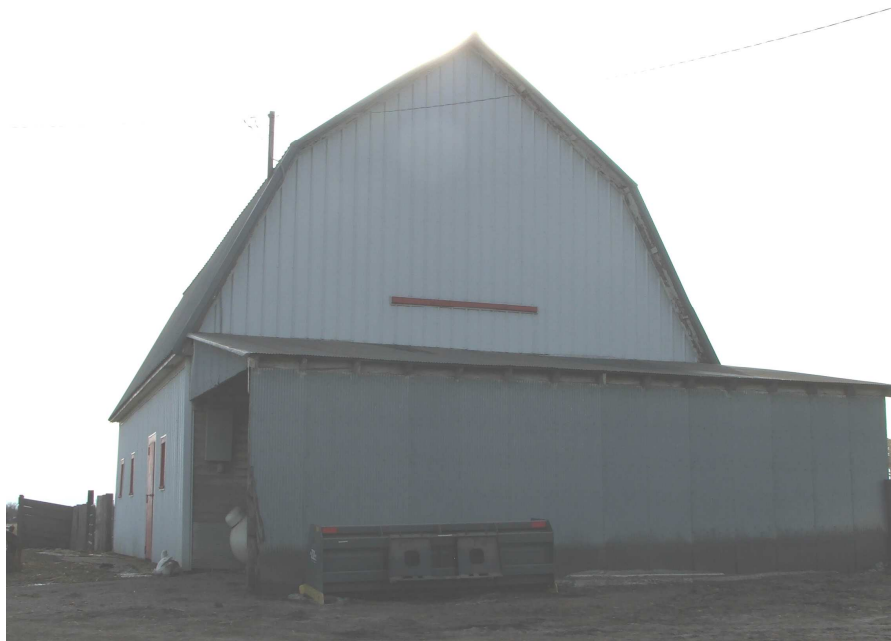
**ROLL NUMBER:** \_\_\_\_\_  
**PHOTO NUMBER:** 3

ALTERED/MOVED NOTES: Original site. Any evidence of horse stalls and milk cow stanchions in the main barn has been removed. 15' x 28' lean-to has been added on the North side. Pen dividers swine have been added. Steel roofing applied on the roof and walls. The interior walls are lined with 1x8 shiplap on all four walls up to hayloft floor. Could not see if the walls are insulated.

**CAMERA DIRECTION:** Looking SW, NE corner,  
15' x 28' lean-to on North  
side

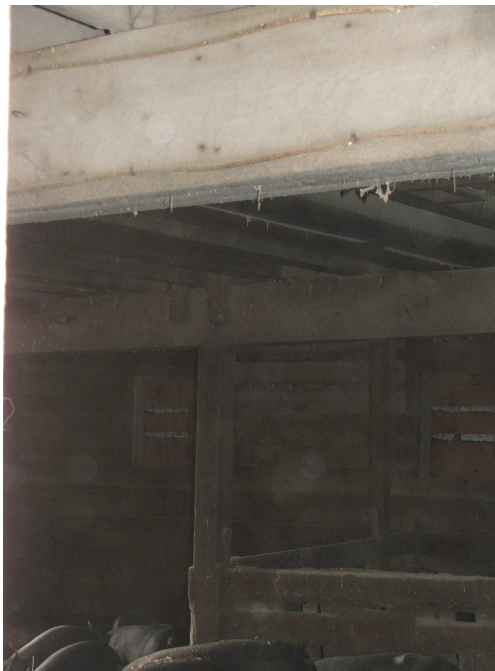
**ROLL NUMBER:** \_\_\_\_\_  
**PHOTO NUMBER:** 4

INTERIOR NOTES: Two rows of 6x6 posts, (3) 2x12's for beams and 2x10 floor joists for the hayloft floor.

**CAMERA DIRECTION:** Looking SW, 6x6 posts,  
(3) 2x12's for beams and  
2x10 floor joists.

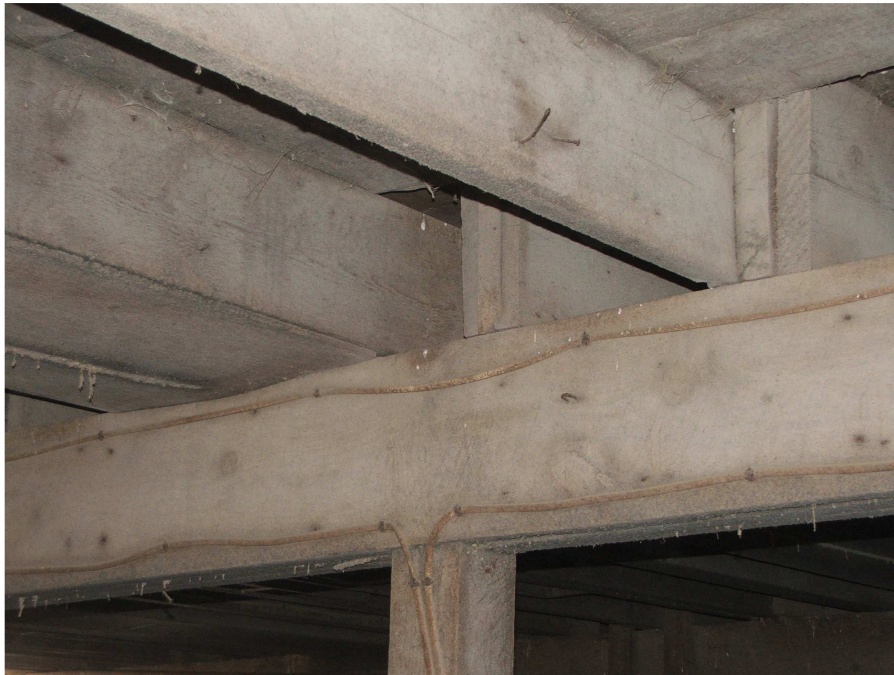
**ROLL NUMBER:** \_\_\_\_\_  
**PHOTO NUMBER:** 5

**CAMERA DIRECTION:** First floor, looking SW at 6x6 posts, (3) 2x12's for beams and 2x10 floor joists.
