**SOUTH DAKOTA STATE HISTORIC PRESERVATION OFFICE
HISTORIC SITES SURVEY STRUCTURE FORM**

*SURVEY DATE: November 17, 2012 *ADDRESS: 30819 462nd Ave.
*SURVEYOR: Jim Stone *COUNTY: Clay
*CITY: Wakonda

CURRENT FUNCTION:	<u>Machinery storage</u>	FOUNDATION:	<u>Poured concrete foundation</u>
CURRENT SUBFUNCTION:	<u>Storage</u>	ROOF MATERIAL:	<u>Cedar shingles</u>
HISTORIC FUNCTION:	<u>Horse barn</u>	ROOF SHAPE:	<u>Gable roof</u>
HISTORIC SUBFUNCTION:	<u>Hay and grain storage</u>	STRUCTURAL SYSTEM:	<u>Balloon framing</u>
		STYLE:	<u>Gable roof barn</u>
OCCUPIED:	<u>Yes</u>	TYPE:	<u>Livestock barn</u>
	<u>Yes with</u>		<u>2x6 studs with 1x8</u>
ACCESSIBLE:	<u>permission</u>	WALLS:	<u>#106 drop siding</u>

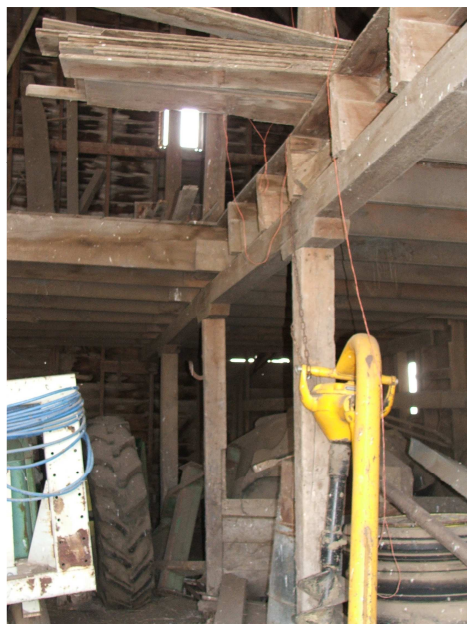
INTERIOR NOTES: Has two rows of 6x6 posts with 6x6 for a beam. Floor joists are 2x8's on each side
with 2x12's in the center 16' of barn. This makes the center 16' of the hayloft floor 4" higher than the
sides. 4x6 posts in hayloft 8' O.C. with 2x6 beam to support the center of 2x6 rafters. 2x6 brace from the
top of wall in hayloft to 4x6 posts. 4x4 diagonal brace from top of the wall down to the bottom of 4x6
post in hayloft.

ROLL NUMBER: _____
PHOTO NUMBER: 4
CAMERA DIRECTION: First floor, looking South, 6x6 posts, 6x6 beam, 2x12 floor joists center and 2x8 joists on right side.

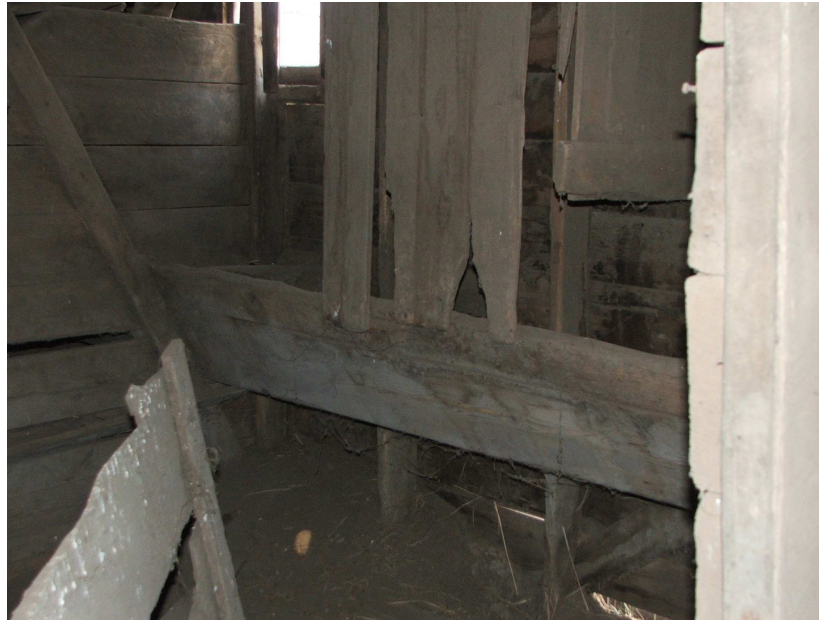
ROLL NUMBER: _____
PHOTO NUMBER: 5

OTHER NOTES: 2x6 stud walls with 1x8 #106 drop siding. Had a 4'x4' wooden cupola which is rotting
out. Horse stalls are still in place on East side. There is a hay chute from hayloft down to the center of
each stall. I don't understand the purpose of the chute. Unless it protected the horses from the sharp
tines on the pitch fork. Date 1884 is painted on the East wall of the barn.

**First floor, looking NE,
manager in horse stall,
note hay chute from
hayloft.**

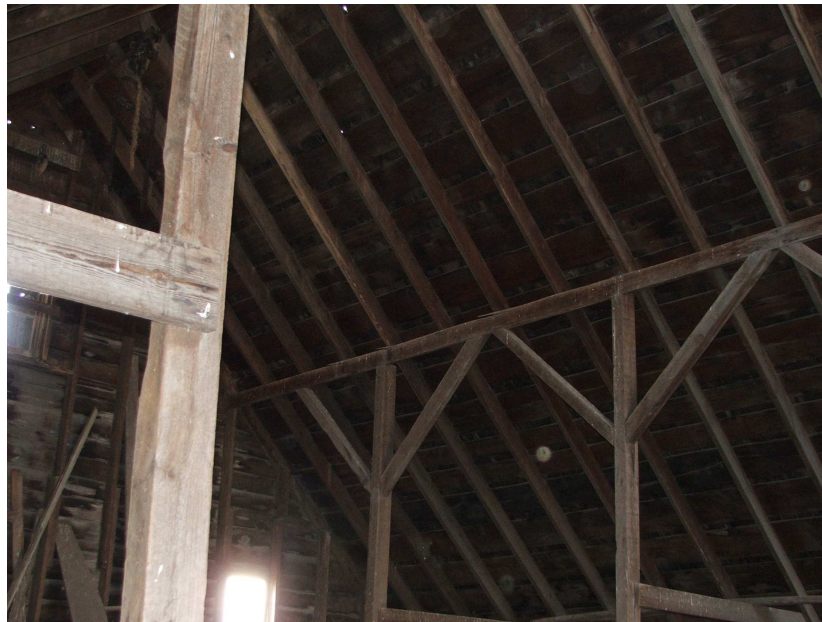
ROLL NUMBER: _____
PHOTO NUMBER: 6

**Hayloft, looking SE, 4x6
posts, 2x6 beam
supporting center of
rafters.**
