**SOUTH DAKOTA STATE HISTORIC PRESERVATION OFFICE
HISTORIC SITES SURVEY STRUCTURE FORM**

*SURVEY DATE: February 18, 2012 *ADDRESS: 46074 306th Street
*SURVEYOR: Jim Stone *COUNTY: Clay
*CITY: Wakonda

SHPO ID: _____
*PROPERTY NAME: Henry Abild barn
OTHER NAME: _____

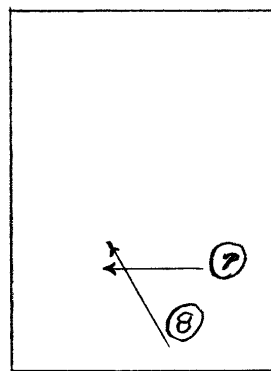
HAYLOFT

INTERIOR NOTES: Two rows 6x6 posts and 6x6 beams running North and South. 2x10 floor joists for the hayloft floor. 6x6 posts and 6x6 beams in hayloft to support hip of roof. 2x6 rafters with double 2x6 rafter behind each 6x6 post. Two 2x10 braces from the bottom of double 2x6 rafter to bottom of 6x6 post.

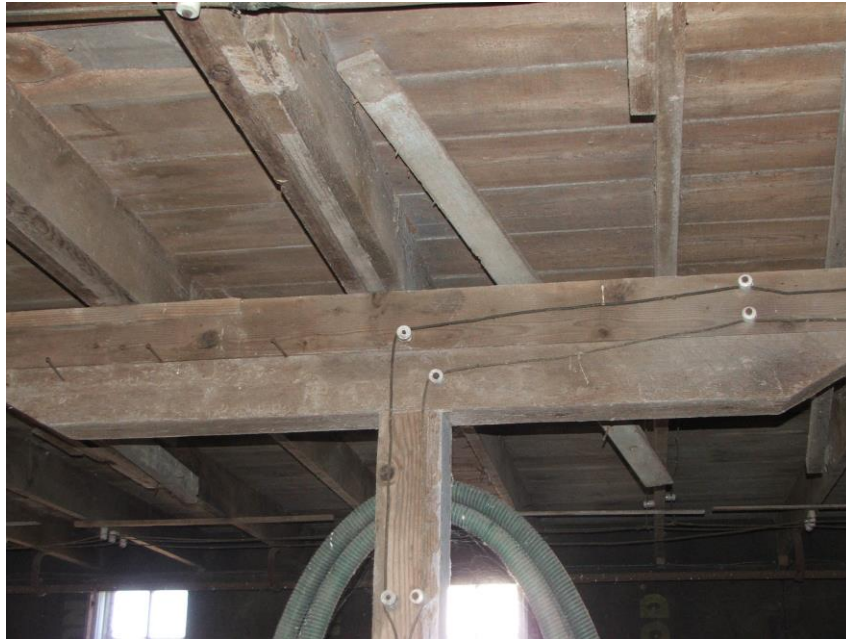
ROLL NUMBER: _____
PHOTO NUMBER: 5

CAMERA DIRECTION: First floor, looking West.
Note 2x4 mortised into
top left of 6x6 beam

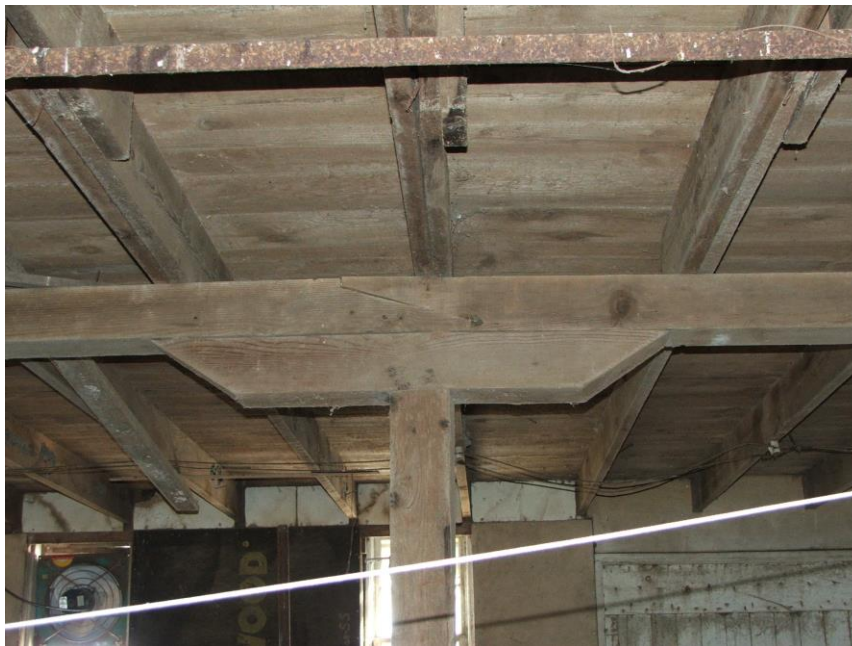
ROLL NUMBER: _____
PHOTO NUMBER: 6

CAMERA DIRECTION: First floor, looking West.
Note the scarf joint 6x6
splice

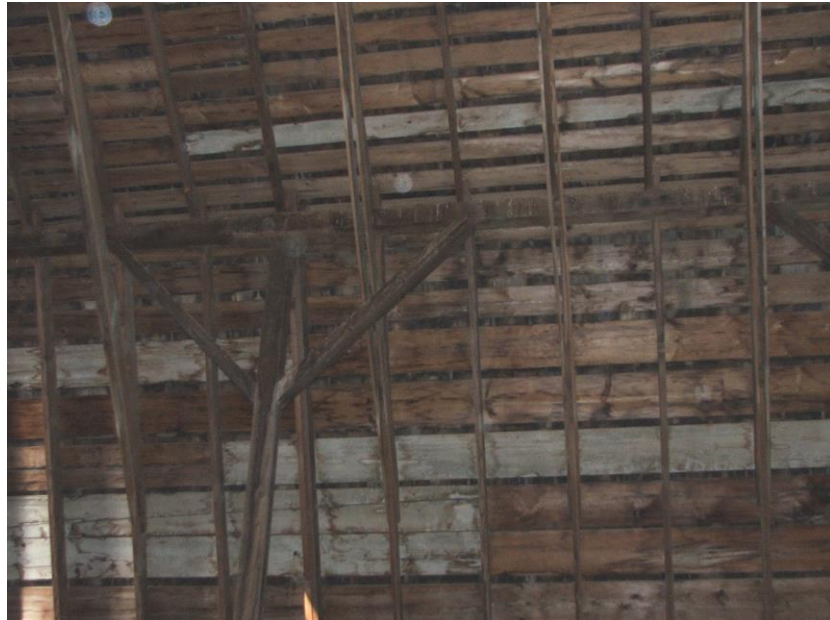
ROLL NUMBER: _____
PHOTO NUMBER: 7

***PHYSICAL NOTES:** Rafters are braced with 2x6 on each side at the hip, but are only braced six foot O.C. by the posts and four foot O. C. on the rest of the rafters. Modified braced rafter. 10' x 8' granary in hayloft at the center of North wall. Barn in excellent condition. Appears to have been maintained as needed.

CAMERA DIRECTION: Hayloft, looking West.
Note braced rafter & 6x6
post support at hip

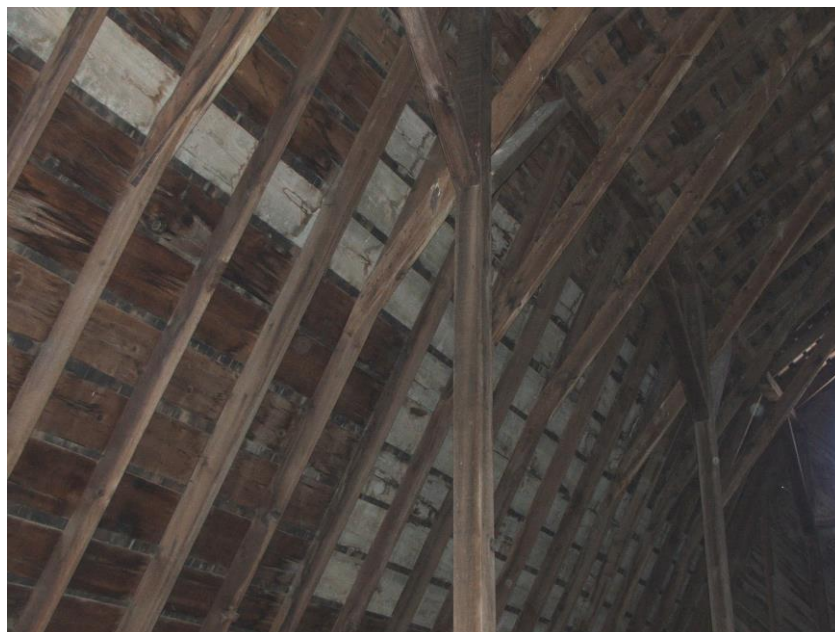
ROLL NUMBER: _____
PHOTO NUMBER: 8

CAMERA DIRECTION: Hayloft looking NW. note
hip support, braced
rafter & 6x6 post

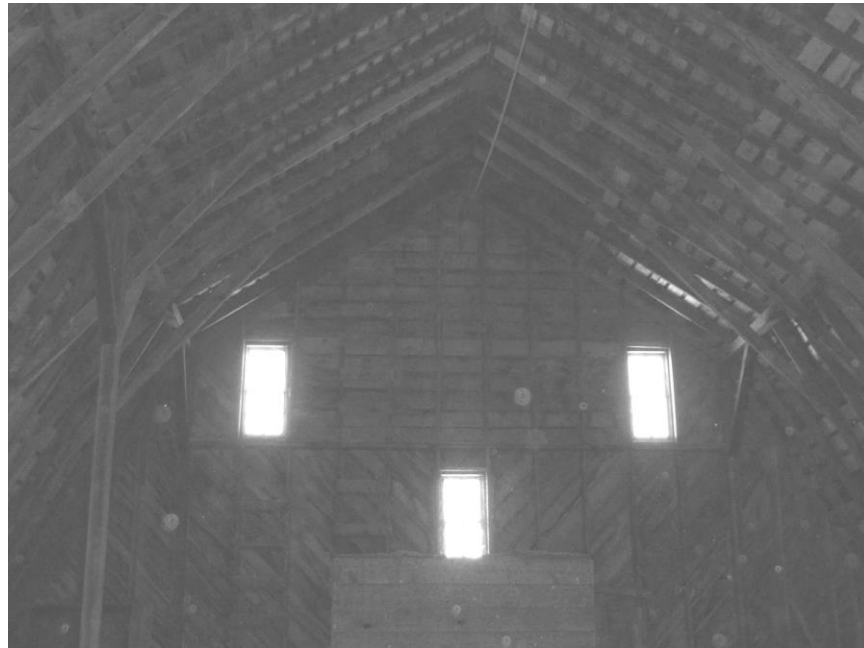
ROLL NUMBER: _____
PHOTO NUMBER: 9

OTHER NOTES: 2x6 stud walls 14' high on the East and West with horizontal sheathing, 2x8 stud walls on the North and South (gable end) walls with sheathing diagonal. 8"x10" four light over 8"x10" four light windows (double hung) for ventilation. Feed track down the center alley and manure track along West wall behind the horse stalls.

CAMERA DIRECTION: Hayloft, looking North, North gable end, note diagonal sheathing.
