SOUTH DAKOTA STATE HISTORIC PRESERVATION OFFICE
HISTORIC SITES SURVEY STRUCTURE FORM

*ADDRESS: 45876 300th Street

SHPO ID: <u>18 CL 00000575</u>			
*PROPERTY NAME: <u>Herman Frier barn</u>			
OTHER NAME: _____			
CURRENT FUNCTION: <u>Small machinery storage</u>	FOUNDATION: <u>Rock w/ sand and lime mortar</u>	<u>Asphalt shingles over cedar shingles</u>	
CURRENT SUBFUNCTION: <u>Storage</u>	ROOF MATERIAL: _____		
HISTORIC FUNCTION: <u>Horse and livestock barn</u>	ROOF SHAPE: <u>Gothic Round</u>		
HISTORIC SUBFUNCTION: <u>Grain and hay storage</u>	STRUCTURAL SYSTEM: <u>Balloon framing</u>	<u>Round Gothic roof.</u>	
	STYLE: <u>Bank barn</u>	<u>Horse and</u>	
OCCUPIED: <u>YES</u>	TYPE: <u>livestock barn</u>	<u>2x6. 1x8 shiplap</u>	
ACCESSIBLE: <u>YES with permission</u>	WALLS: <u>and 1/2"x6" cedar lap siding</u>		
STORIES: <u>3</u>	SIGNIFICANT PERSON: <u>Herman Frier</u>		
*DATE OF CONSTRUCTION: <u>1921</u>	CULTURAL AFFILIATION: <u>German</u>

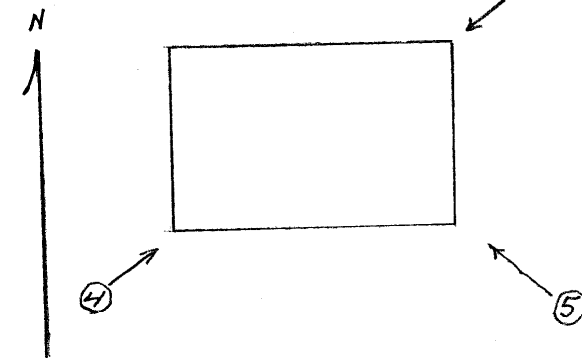
SOUTH ELEVATION

*PHYSICAL NOTES: South side of roof is in poor condition. It is leaking and rotting hayloft floor. Siding is in poor condition. Owner is interested in getting this barn on the Historical Register and restoring it. Siding is in poor condition.

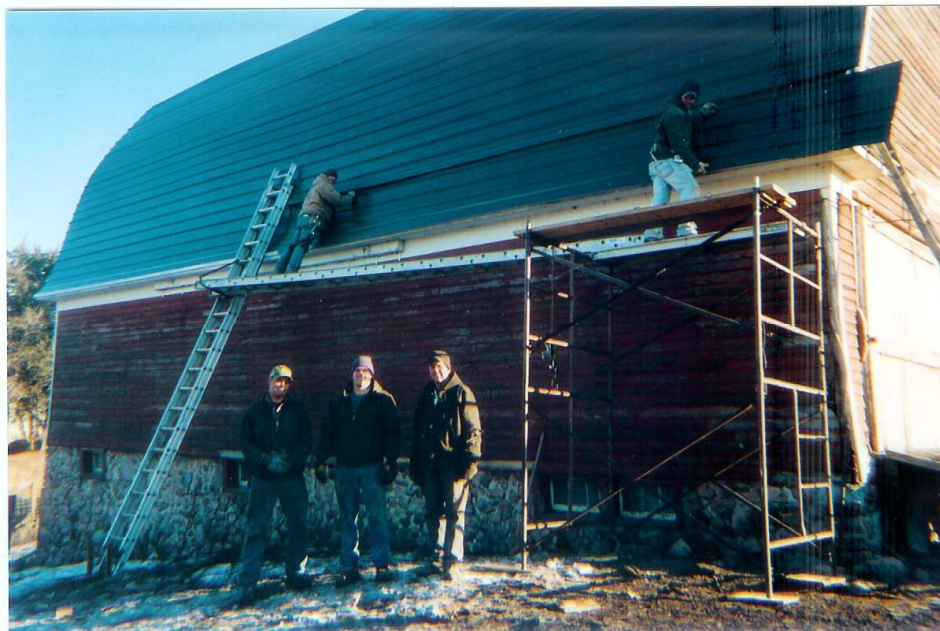
ROLL NUMBER: _____
PHOTO NUMBER: 7

CAMERA DIRECTION: Looking NW, SE corner,
Installing new steel roof

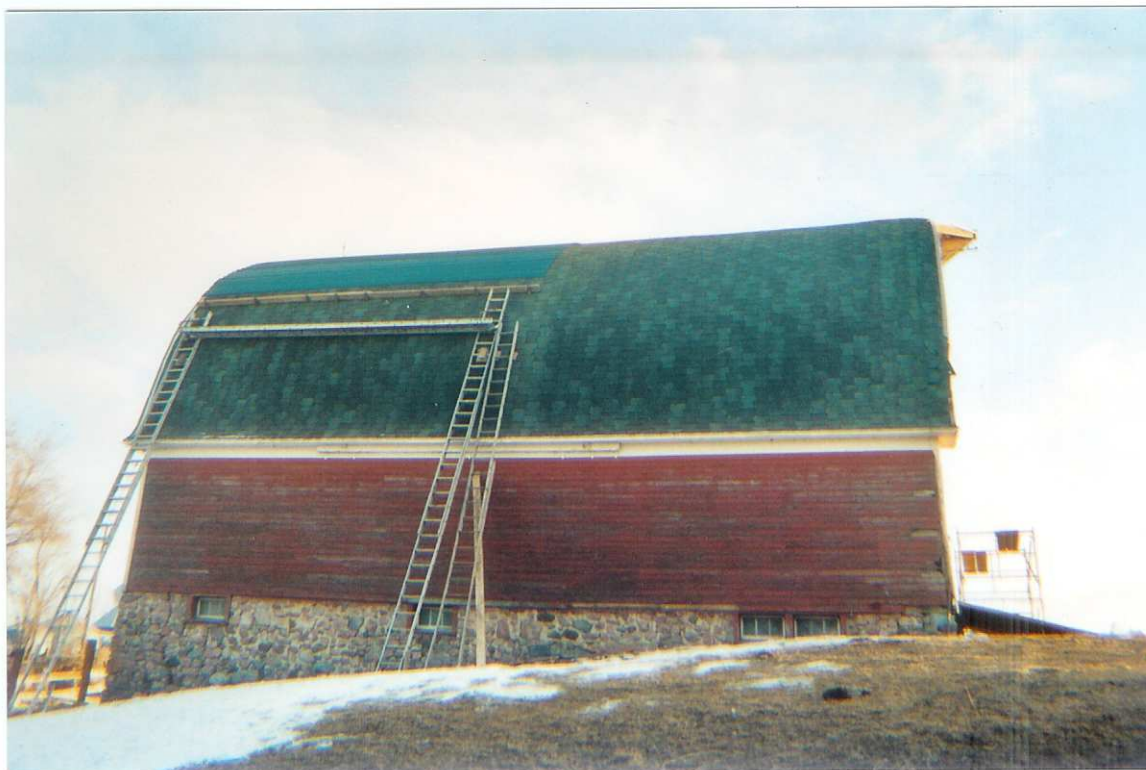
ROLL NUMBER: _____
PHOTO NUMBER: 9

CAMERA DIRECTION: Looking South, North side, starting steel on North side. They applied steel roofing in Febr. to stop the leaking and preserve the barn
