**SOUTH DAKOTA STATE HISTORIC PRESERVATION OFFICE
HISTORIC SITES SURVEY STRUCTURE FORM**

*SURVEY DATE: February 1, 2012 *ADDRESS: Vacant farmstead, no address,
1/2 mile east of Highway 19 on 307th
Street
*SURVEYOR: Jim Stone *COUNTY: Clay
*CITY: Wakonda

SHPO ID: 26 CL 0000573

*PROPERTY NAME: Inman Hesla barn

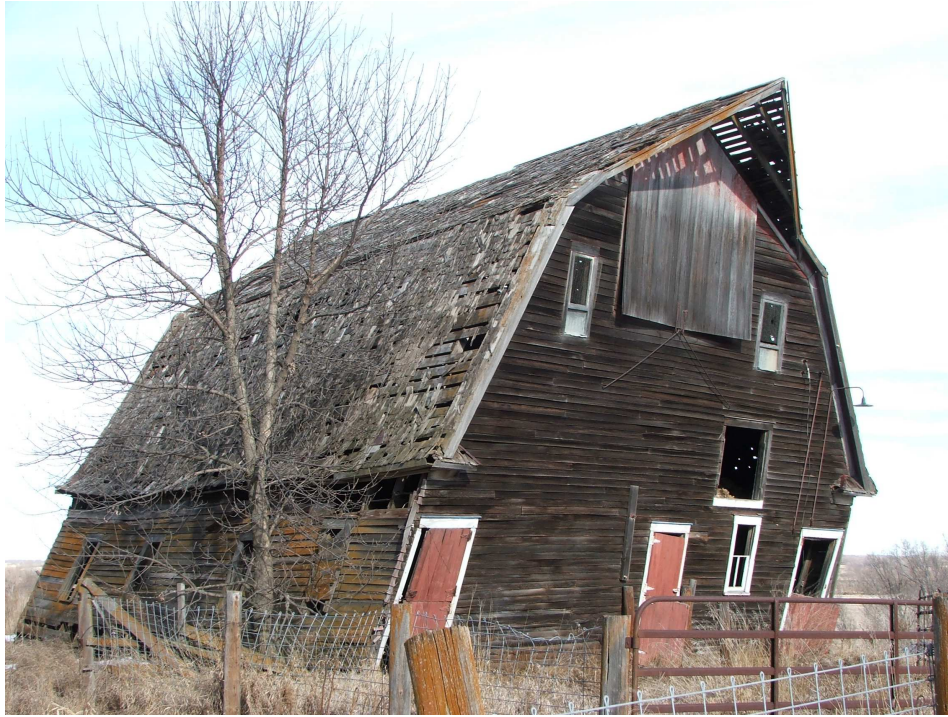
ROLL NUMBER: _____
PHOTO NUMBER: 1
CAMERA DIRECTION: Looking NE, SW corner

*PHYSICAL NOTES: Barn is leaning to the South and East. Without straightening and bracing the barn will fall down in the next 12 to 24 months.

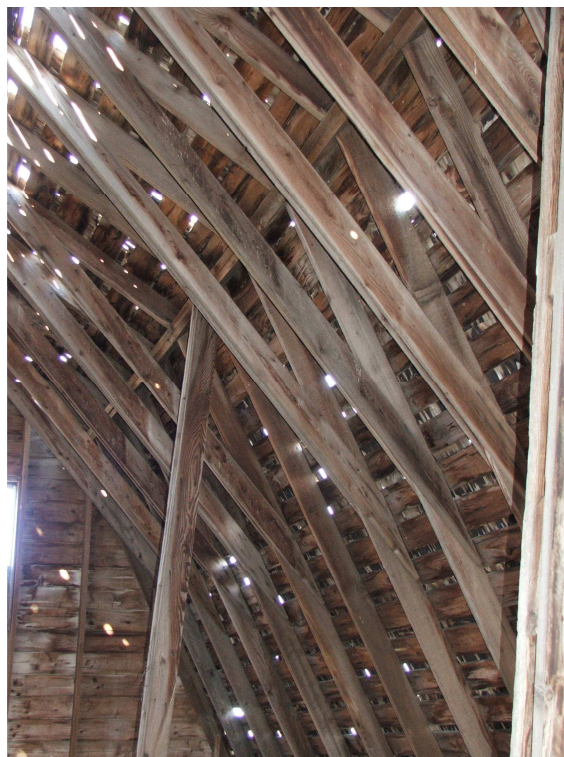
ROLL NUMBER: _____
PHOTO NUMBER: 4
CAMERA DIRECTION: Hayloft, looking North

INTERIOR NOTES: Four rows 6x6 posts and 6x6 beams with 2x8 floor joists. Rows are 7' in from the East and West walls, then 8' O.C. leaving a 4' feed alley. Two rows 6x6 posts and 6x6 beams in hayloft to support roof rafters at hip. Horse stalls are still in place.

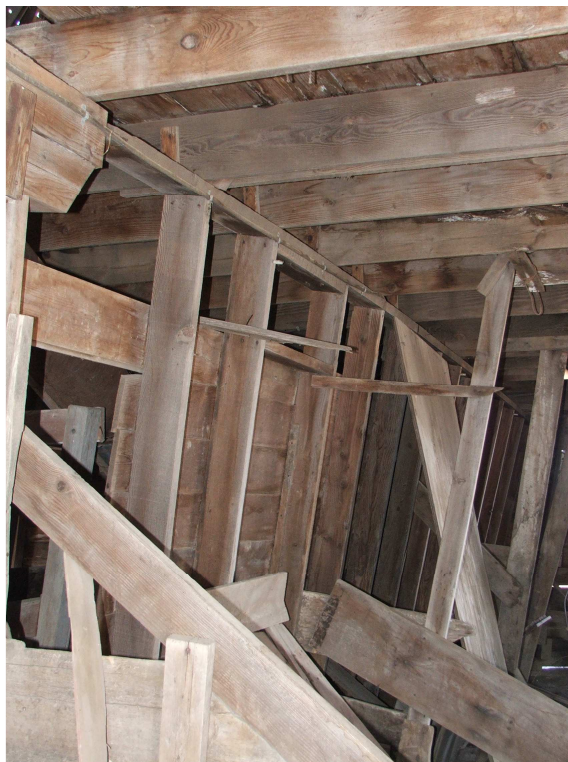
ROLL NUMBER: _____
PHOTO NUMBER: 7
CAMERA DIRECTION: First floor, looking North
Note horse stalls
