SOUTH DAKOTA STATE HISTORIC PRESERVATION OFFICE
HISTORIC SITES SURVEY STRUCTURE FORM

*ADDRESS: 45616 300th Street
*COUNTY: Clay
*CITY: Wakonda

STORIES: 2 SIGNIFICANT PERSON: Ira & Grace Davis
 *DATE OF CONSTRUCTION: About 1900 CULTURAL AFFILIATION: ?

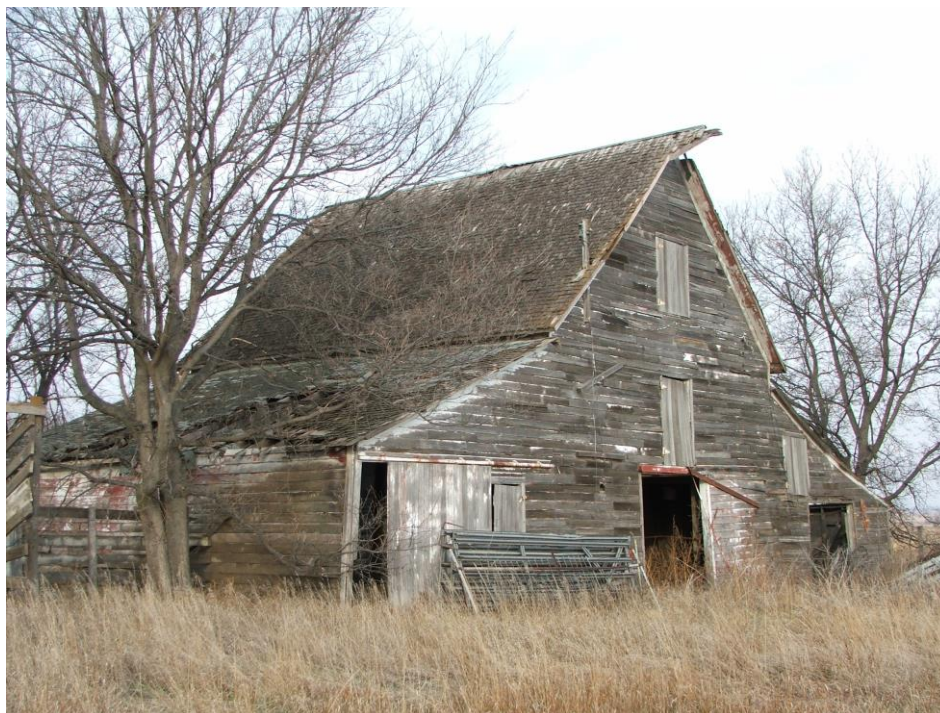
ROLL NUMBER: _____
PHOTO NUMBER: 1
CAMERA DIRECTION: Looking NE, SW corner

*PHYSICAL NOTES: Barn is in poor condition. Roof and hayloft floor have fallen in on the East-to. Roof is leaking and needs to be re-roofed. Siding and doors need a lot of repair.

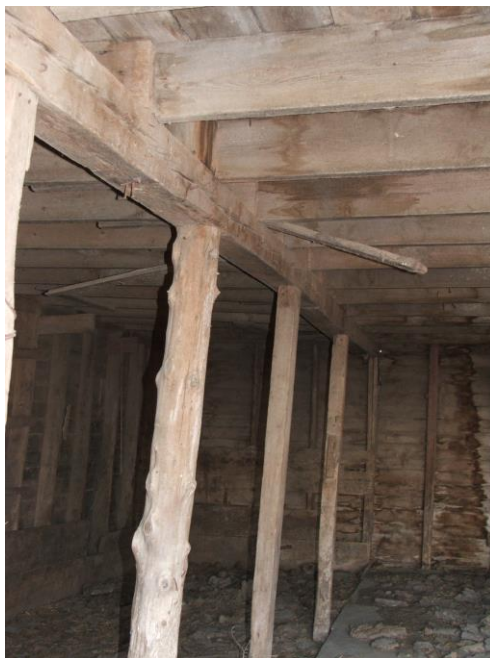
ROLL NUMBER: _____
PHOTO NUMBER: 5

INTERIOR NOTES: Has two rows of 4x6 posts with 6x6 for beam. Floor joists are 2x8's in the main barn and the East lean-to. Has one row of 4x6 posts and (2) 2x8's for a beam in the East lean-to.

CAMERA DIRECTION: First floor, center area,
looking North, posts,
beam and floor joists

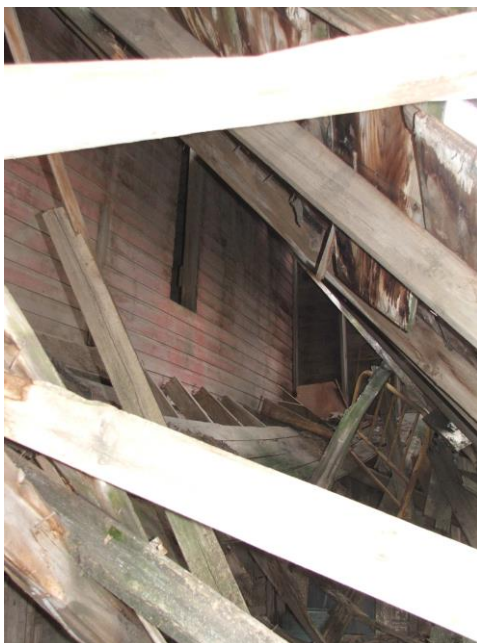
ROLL NUMBER: _____
PHOTO NUMBER: 6

OTHER NOTES: 2x6 stud walls with 1x6 #106 drop siding on the East and West walls of the main barn and the North and East exterior walls. The South and West walls have sheathing and 1/2"x8" cedar lap siding.

CAMERA DIRECTION: First floor, East lean-to,
North, note 1x6 siding on
main barn

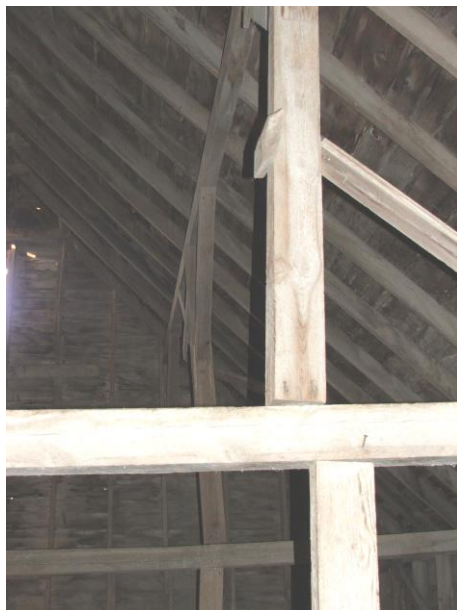
ROLL NUMBER: _____
PHOTO NUMBER: 7

CAMERA DIRECTION: Hayloft, looking North,
4x6 posts under 4x6
cross beam with 4x6
posts on top supporting
6x6 beam

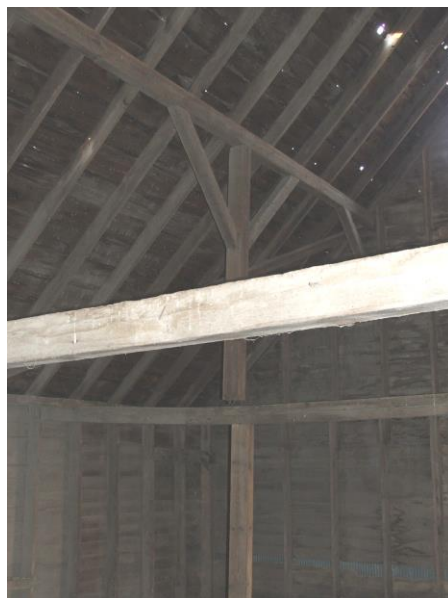
ROLL NUMBER: _____
PHOTO NUMBER: 8

CAMERA DIRECTION: Hayloft, looking NW, 4x6
posts, 4x6 cross beam,
4x6 posts and 6x6 beam
at top supporting rafters.
