**SOUTH DAKOTA STATE HISTORIC PRESERVATION OFFICE
HISTORIC SITES SURVEY STRUCTURE FORM**

*SURVEY DATE: July 26, 2013 *ADDRESS: 31353 462nd Ave.
*SURVEYOR: Jim Stone *COUNTY: Clay
*CITY: Vermillion

HISTORIC FUNCTION: Livestock barn ROOF SHAPE: Gambrel roof

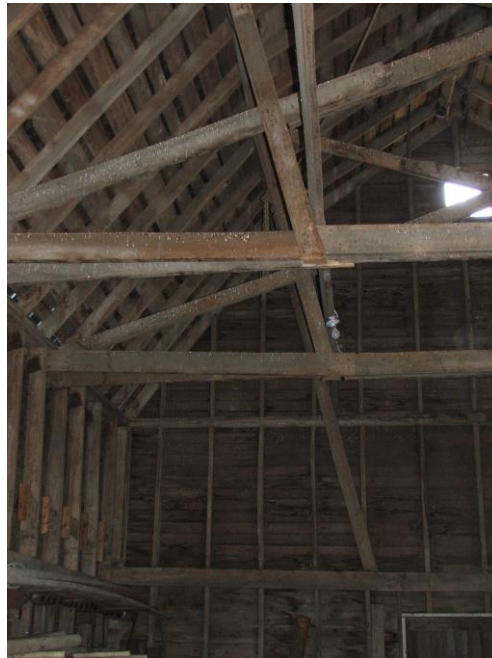
ROLL NUMBER: _____
PHOTO NUMBER: 5

INTERIOR NOTES: No evidence of posts or beams to support hayloft floor. The hayloft floor joists were 2x8's. Double 2x6 posts supported hip and are now used to brace the roof. They are cut off at the bottom of the raised floor joists.

First floor, looking up & NW, 2x8 floor joists raised to about 13', double 2x6 posts cut off with bottom of raised floor joists.

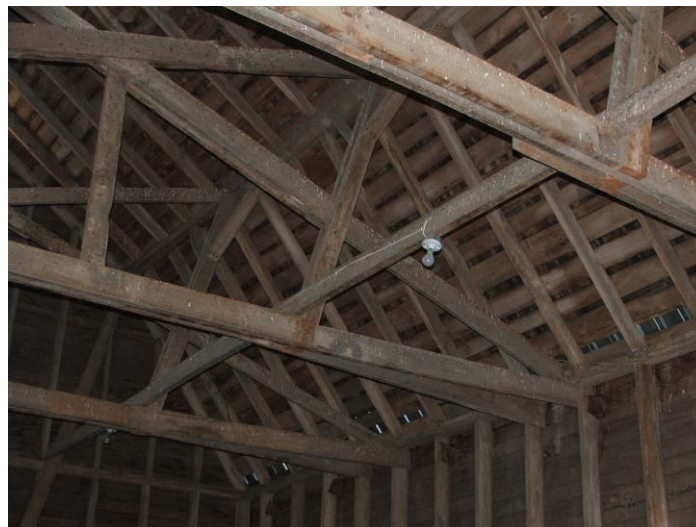
ROLL NUMBER: _____
PHOTO NUMBER: 6

ALTERED/MOVED NOTES: Original site. Any evidence of horse stalls or milk cow stanchions has been removed. Hayloft floor removed. Some of the 2x8 the floor joists raised to about 13' and are 8' O. C. 2x8 joists spliced and brace top of wall up to the opposite hip, 2x6 bracing from the hip down to the raised floor joists. 10'-3" x 10'-6" double swing doors added in the south wall of West lean-to. 17' x 12'-9" sliding door added on the South wall of original barn. A 13'x 34' lean-to added on the East side later and another 15'x34' lean-to added on to East side of first lean-to later. Roof covered with steel roofing.

First floor, looking up & NE, note spliced 2x8's bracing from top of wall up to the opposite hip, 8' O. C.

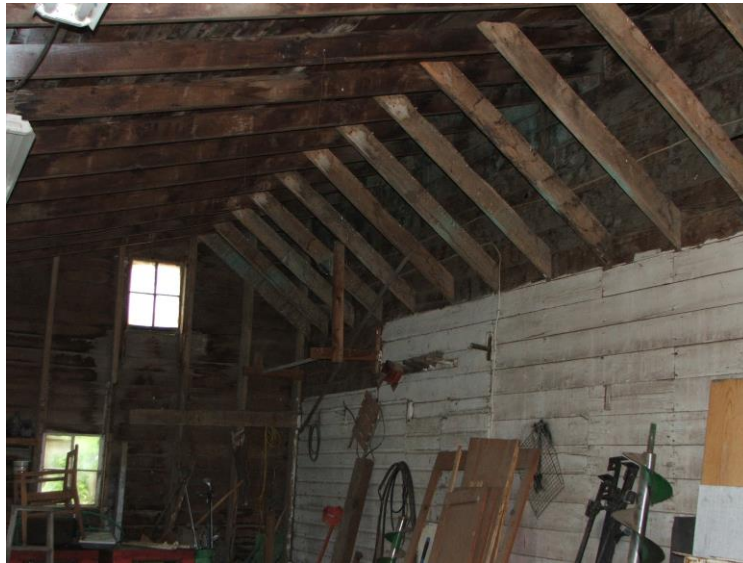
ROLL NUMBER: _____
PHOTO NUMBER: 7

First floor, in West lean-to, looking NE, note original 1x10 shiplap and 2x6 bracing for 2x6 rafters.

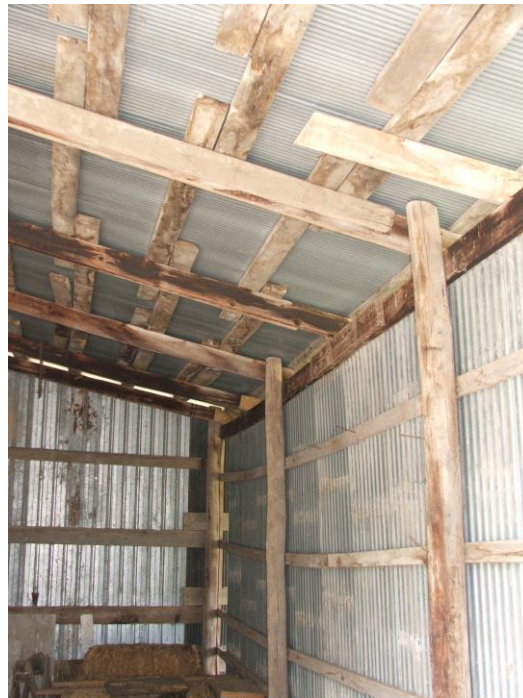
ROLL NUMBER: _____
PHOTO NUMBER: 8

First floor, looking NE, into the first East lean-to, pole barn construction.
