**SOUTH DAKOTA STATE HISTORIC PRESERVATION OFFICE
HISTORIC SITES SURVEY STRUCTURE FORM**

*SURVEY DATE: November 8, 2013 *ADDRESS: 31146 456th Ave.
*SURVEYOR: Jim Stone *COUNTY: Clay
*CITY: Meckling

CURRENT FUNCTION: Vacant FOUNDATION: Poured concrete
 CURRENT SUBFUNCTION: Storage ROOF MATERIAL: Steel roofing over cedar shingles
 HISTORIC FUNCTION: Livestock barn ROOF SHAPE: Gable roof
 HISTORIC SUBFUNCTION: Hay storage STRUCTURAL SYSTEM: Balloon framing
 OCCUPIED: No STYLE: Western feeder barn
Yes with TYPE: Livestock barn
permission WALLS: 2x6 studs, 1x6 car siding

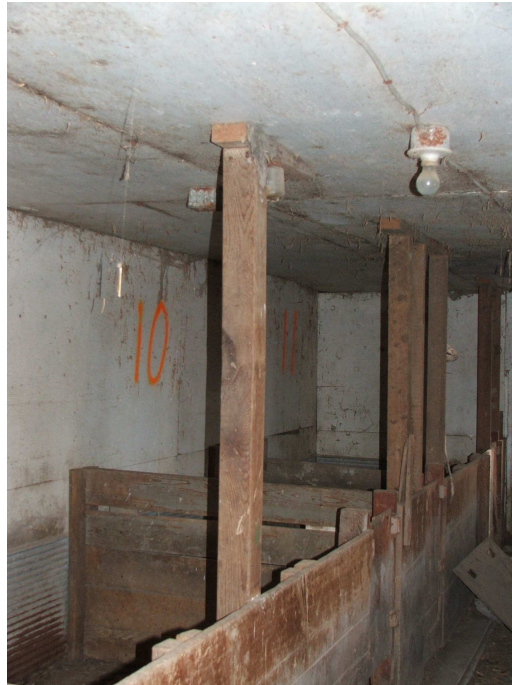
ROLL NUMBER: _____
PHOTO NUMBER: 5

**First floor, West lean-to,
looking SE, wooden
farrowing pens on East
side**

ALTERED/MOVED NOTES: Original site. Roof has been covered with steel roofing over cedar shingles. West lean-to has been insulated and lined for swine farrowing. Eight wood farrowing pens and three steel farrowing crates are still in place. South sliding doors have been removed.

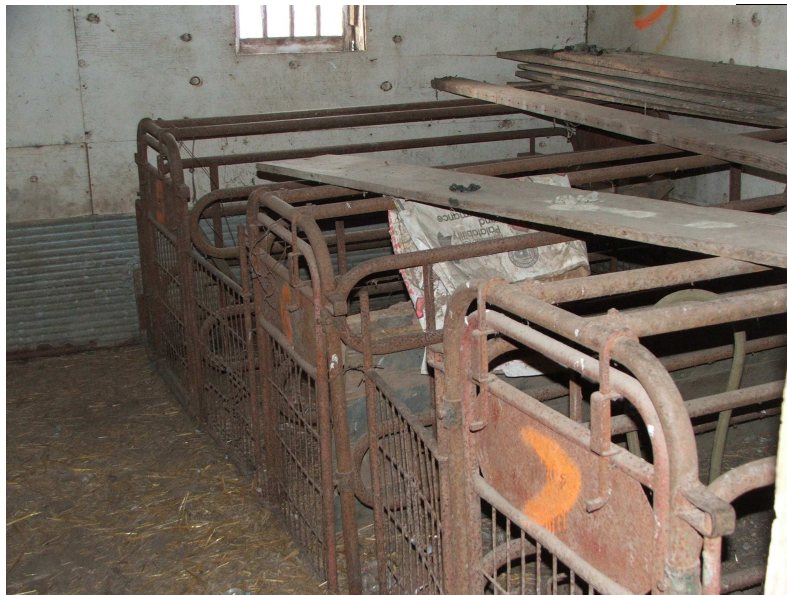
ROLL NUMBER: _____
PHOTO NUMBER: 6

**First floor, West lean-to,
looking NW, Three steel
farrowing crates along
North wall.**

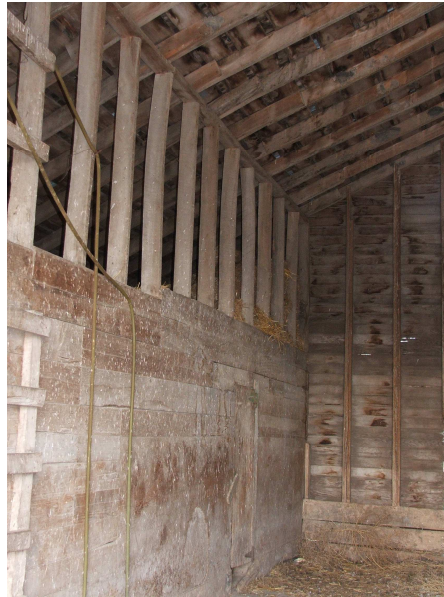
ROLL NUMBER: _____
PHOTO NUMBER: 7

CAMERA DIRECTION: Center hayloft area, looking NW, 2x6 stud wall 14' high with 1x8 shiplap up 8' and open studs above up to 2x6 rafters.

INTERIOR NOTES: 2x6 stud walls 14' high on East and West side of the center 18' hay storage area. These walls have 1x8 shiplap up 8' high and studs are open above to the roof. 2x8 floor joists above on the East and West lean-to's.

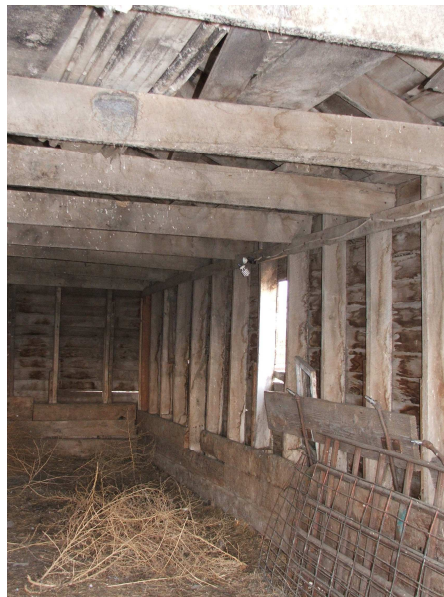
ROLL NUMBER: _____
PHOTO NUMBER: 8

CAMERA DIRECTION: East lean-to, looking NE, 2x6 stud wall and 2x8 ceiling joists
