**SOUTH DAKOTA STATE HISTORIC PRESERVATION OFFICE  
HISTORIC SITES SURVEY STRUCTURE FORM**

\*SURVEY DATE: July 26, 2013 \*ADDRESS: 30884 460th Ave.  
\*SURVEYOR: Jim Stone \*COUNTY: Clay  
\*CITY: Vermillion

CURRENT FUNCTION: Vacant FOUNDATION: Poured concrete  
 CURRENT SUBFUNCTION: Storage ROOF MATERIAL: Steel roofing over cedar shingles  
 HISTORIC FUNCTION: Livestock barn ROOF SHAPE: Gable roof  
 HISTORIC SUBFUNCTION: Hay storage STRUCTURAL SYSTEM: Balloon framing  
 OCCUPIED: No STYLE: Gable roof barn  
 Yes with TYPE: Livestock barn  
 ACCESSIBLE: Yes with permission WALLS: 2x6 studs, 1x10 shiplap, steel roofing

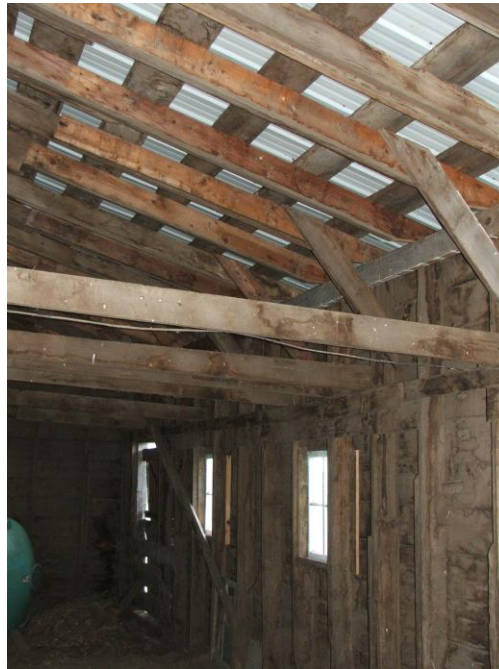
**ROLL NUMBER:** \_\_\_\_\_  
**PHOTO NUMBER:** 5

**First floor, East lean-to,  
looking NE, 2x6 studs,  
2x6 rafters and 2x6  
ceiling joists.**

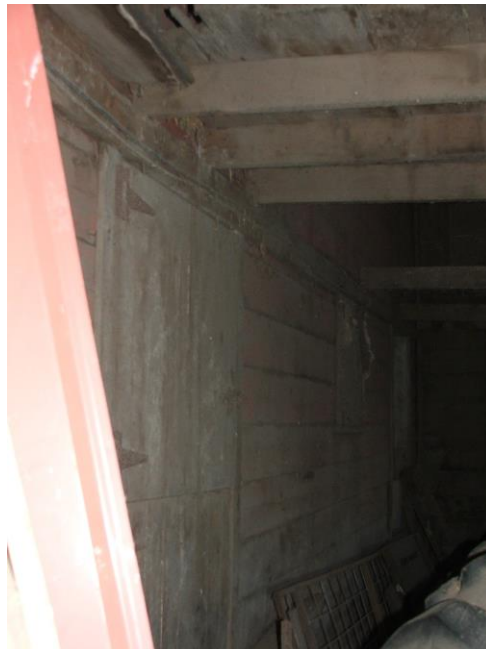
**ROLL NUMBER:** \_\_\_\_\_  
**PHOTO NUMBER:** 6

**OTHER NOTES:** 2x6 stud walls, 1x10 shiplap and 1-1/4"x26" galvanized corrugated steel on all four walls, except at the top on both gable ends. Rafters are 2x6's. Windows are 9" x12" and 4"x24"four light The lean-to on the East side appears to have been built later. The 1x10 ship appears to have been the original siding, because the East wall of the original barn still has red paint.

**First floor, East lean-to,  
looking NW, original East  
wall, 1x10 shiplap with  
red paint**

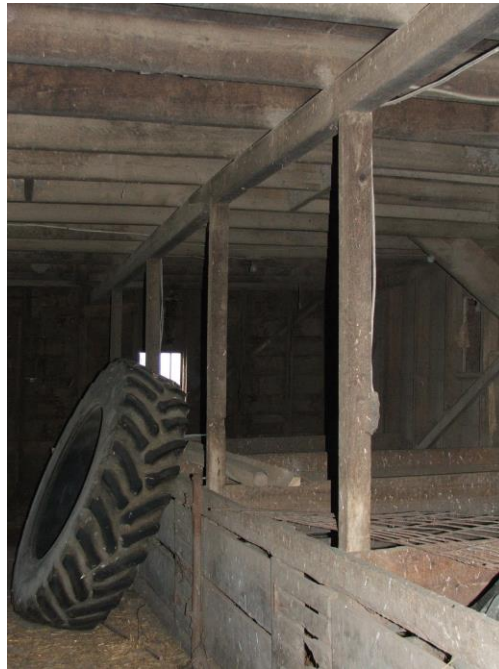
**ROLL NUMBER:** \_\_\_\_\_  
**PHOTO NUMBER:** 7

**ALTERED/MOVED NOTES:** Moved from SE 1/4, SW 1/4 to SW1/4, SW 1/4. Any evidence of horse stalls or milk cow stanchions has been removed. The roof and all but the top of the gable end walls have been covered with covered with 1-1/4" x 26" galvanized corrugated steel roofing. Roofing is applied horizontal on walls. Lean-to on the East side may have been added later, because the 1x10 shiplap is painted red on the East wall of the original barn. The original barn was remodeled into a swine farrowing barn, at the time it was moved.

**INTERIOR NOTES:** Two rows of 4x4 posts and 4x6 beams to support hayloft floor. The hayloft floor joists are 2x8's. 2x6 bracing from the center of rafters down to hayloft floor, 4' O. C.

**First floor, original barn,  
looking NE, 4x4 posts,  
4x6 beam, farrowing  
pens on East wall.**

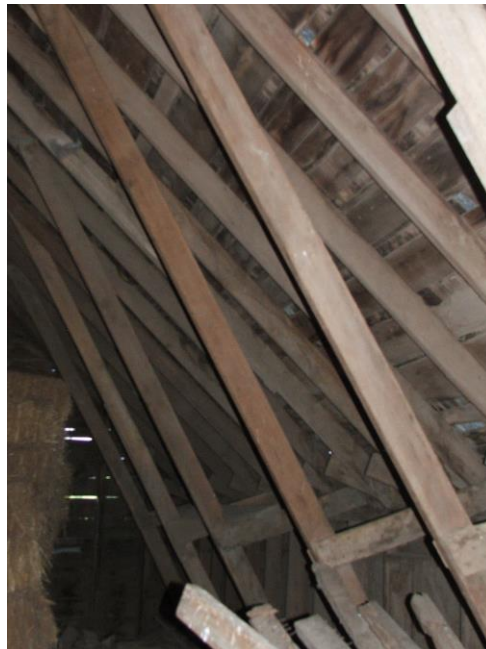
**ROLL NUMBER:** \_\_\_\_\_  
**PHOTO NUMBER:** 8

**Hayloft. looking NE, 2x6  
brace from center of  
rafter down to hayloft  
floor, 4' O. C.**

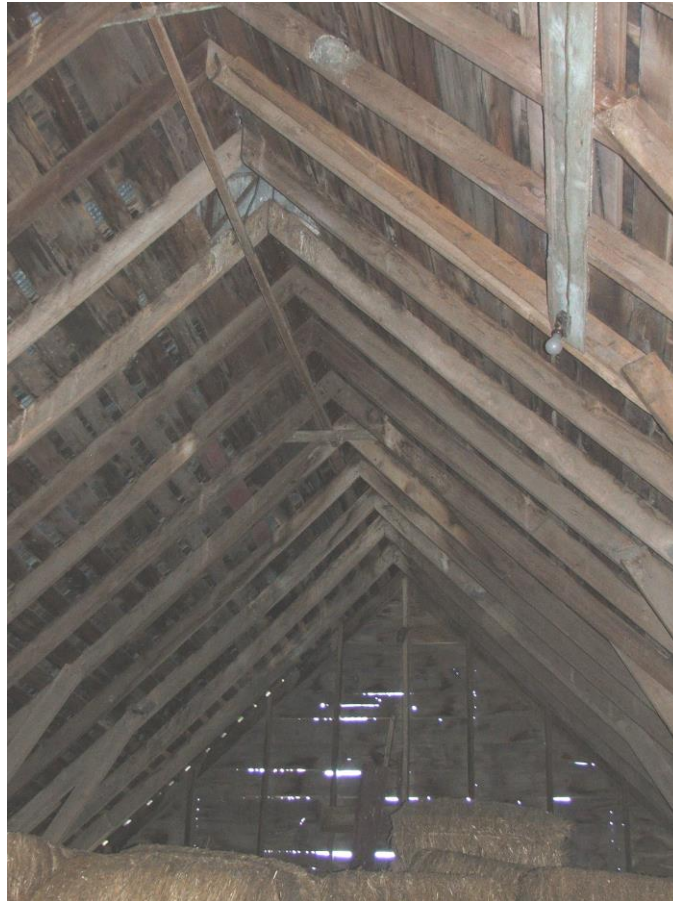
**ROLL NUMBER:** 9  
**PHOTO NUMBER:** 9  
**CAMERA DIRECTION:** Hayloft. looking North,  
2x6 rafters, hay track  
and North gable end.
