**SOUTH DAKOTA STATE HISTORIC PRESERVATION OFFICE
HISTORIC SITES SURVEY STRUCTURE FORM**

*SURVEY DATE: August 12, 2013 *ADDRESS: 30672 457th Ave.
*SURVEYOR: Jim Stone *COUNTY: Clay
*CITY: Wakonda

CURRENT FUNCTION: Storage FOUNDATION: Poured concrete
 CURRENT SUBFUNCTION: Storage ROOF MATERIAL: Steel roofing over cedar shingles
 HISTORIC FUNCTION: Dairy barn ROOF SHAPE: Gable roof
 HISTORIC SUBFUNCTION: Hay & grain storage STRUCTURAL SYSTEM: Balloon framing
 OCCUPIED: Yes STYLE: Gable roof barn
 TYPE: Dairy barn
2x6 studs, 1x12 shiplap sheathing and 1/2"x6" cedar lap siding

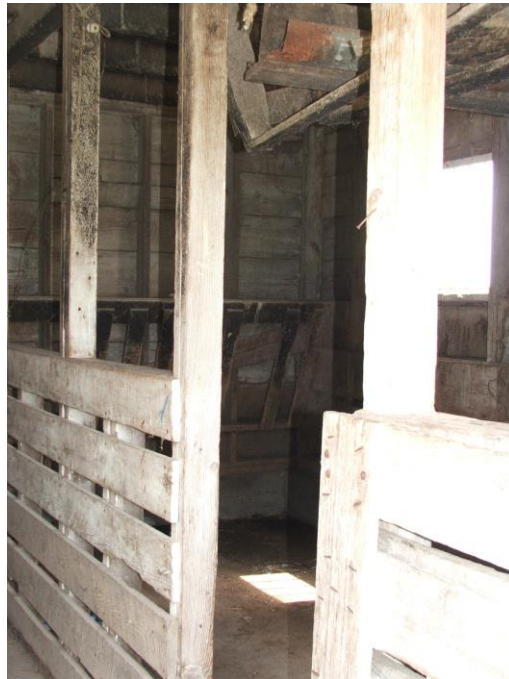
ROLL NUMBER: _____
PHOTO NUMBER: 5

CAMERA DIRECTION: First floor, looking SE,
calf pen in the SW
corner.

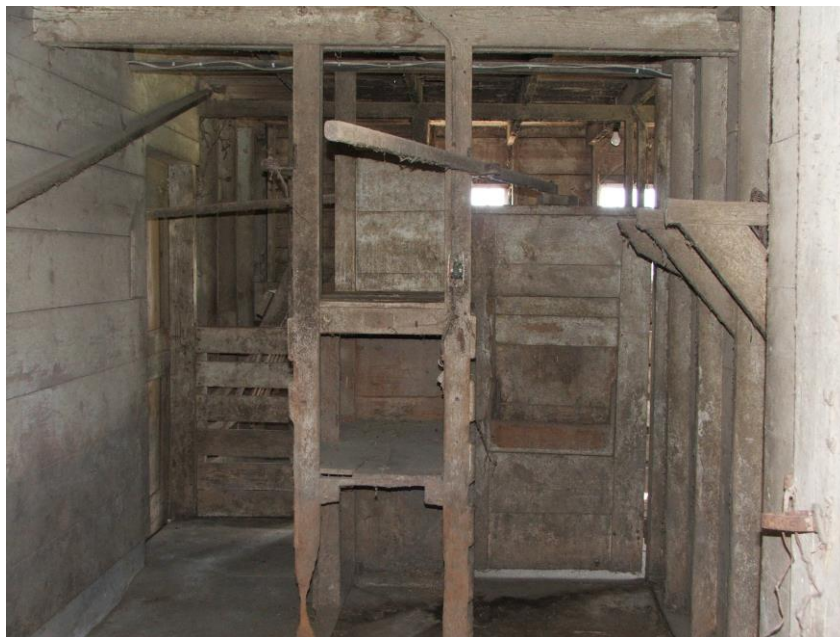
ROLL NUMBER: _____
PHOTO NUMBER: 6

INTERIOR NOTES: Two rows of 4x6 posts with 4x6's for beams support center of 2x6 rafters in the West 16' x 32' which serves as a hayloft. 2x6 floor joists in this area are supported with 2x4 walls on first floor. Two milk cow stanchions still in the milking parlor. Granary, calf pen and milk room are still in the West side. Interior wall on the East side of the West 16' is 2x6 studs with 1x12 shiplap 8' high. The interior wall on the West side of the East 44' is 2x6 studs with 1x12 shiplap to the peak.

CAMERA DIRECTION: First floor, looking
South, into two stall
milking parlor.

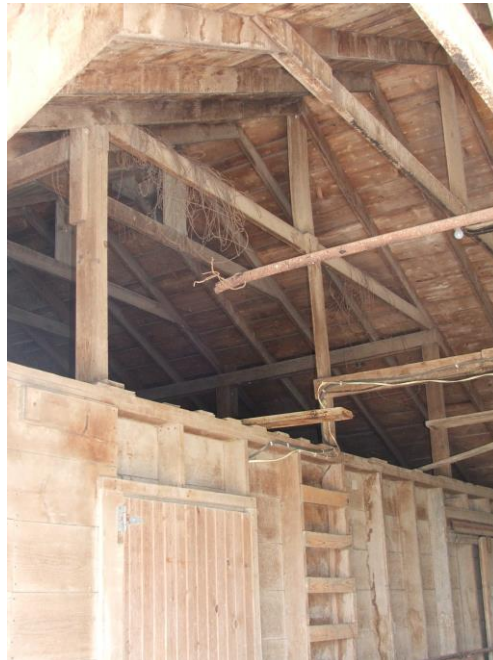
ROLL NUMBER: _____
PHOTO NUMBER: 7

**First floor, looking NW
up into hayloft over the
West 16' x 32'**

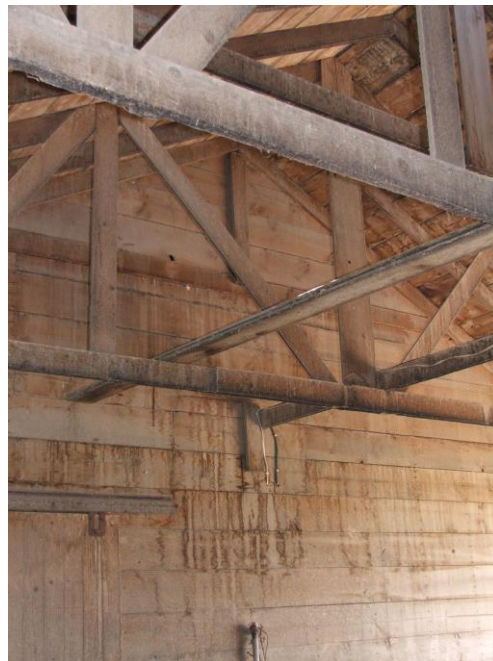
ROLL NUMBER: _____
PHOTO NUMBER: 8

**First floor, looking SE,
West wall of the East 44',
2x6 wall with 1x12
shiplap up to the peak.**

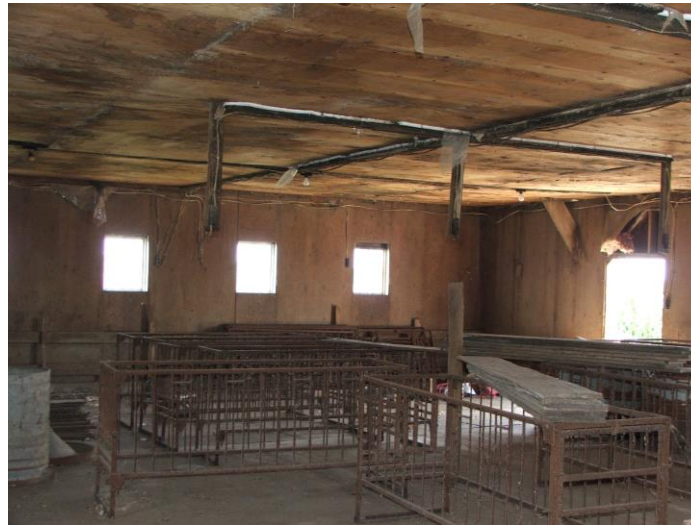
ROLL NUMBER: _____
PHOTO NUMBER: 9

ALTERED/MOVED NOTES: Original site. Roof covered with steel roofing over cedar shingles. Dirt floors in East 64' x 32' feet have been poured with concrete to convert into a swine farrowing and finishing building. The walls and ceiling in the East 32' x 44' were insulated and lined with plywood at the same time.

CAMERA DIRECTION: First floor, looking SE,
East 32' x 44' converted
into swine farrowing and
finishing building.
