**SOUTH DAKOTA STATE HISTORIC PRESERVATION OFFICE**  
**HISTORIC SITES SURVEY STRUCTURE FORM**

\*ADDRESS: 46868 304<sup>th</sup> Street

HISTORIC FUNCTION: Livestock barn

TYPE: Livestock barn

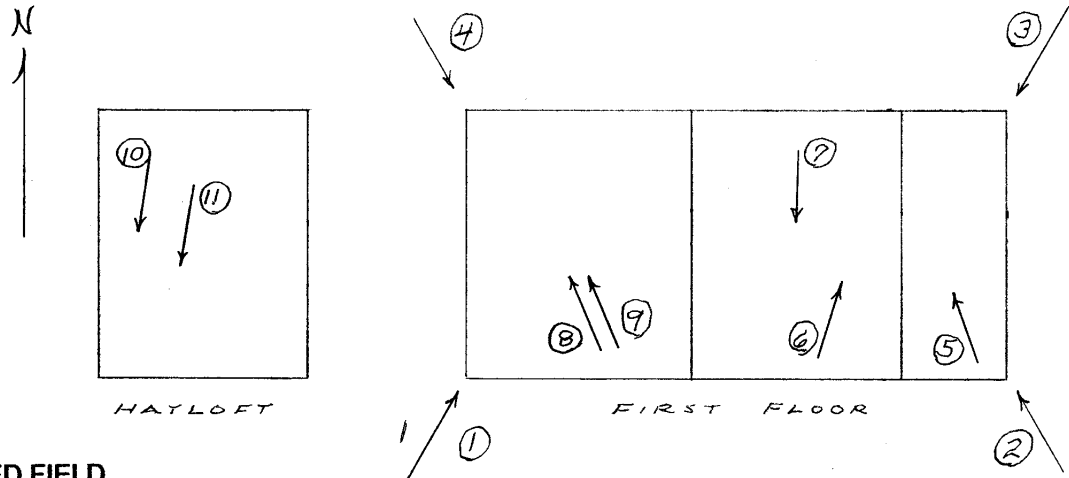
**PHOTOGR**

\*PHYSICAL NOTES: Barn is in fair condition. The roof is leaking. Needs roof re-roofed and repairs  
on the doors.

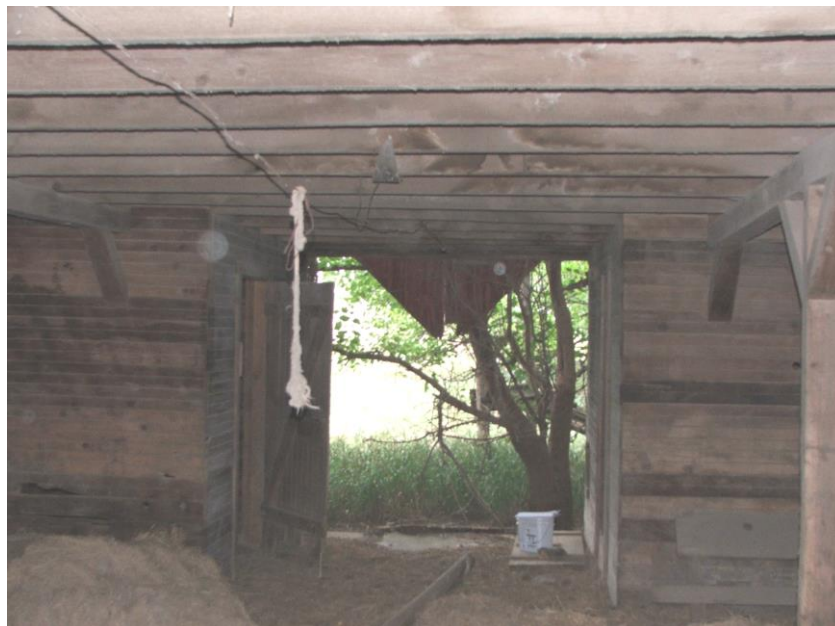
ROLL NUMBER: \_\_\_\_\_  
PHOTO NUMBER: 7

INTERIOR NOTES: Has two rows 6x6 posts and a 6x6 for a beam. 2x8 floor joists. 10'x10' granary 16'  
high is still in place in the SW corner of the main barn and a 10'x10' granary with a 10'x10' granary above  
in the hay loft in the SE corner of the main barn. All of the horse stalls are still in place.

CAMERA DIRECTION: First floor, center of  
barn, looking South, two  
granaries on the South  
end.

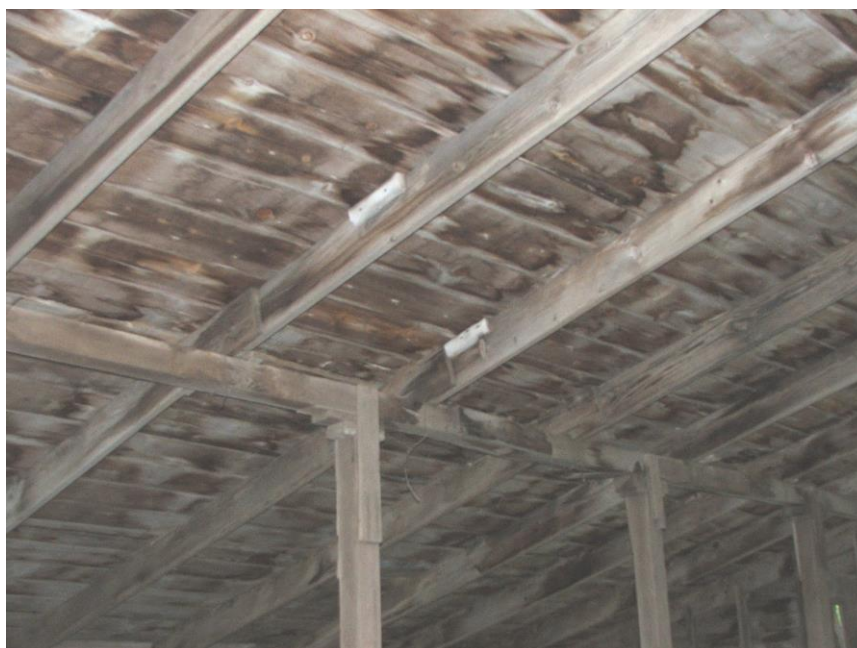
ROLL NUMBER: \_\_\_\_\_  
PHOTO NUMBER: 8

OTHER NOTES: Windows were 9"x12" four light. Walls are 2x6 with 1x6 car siding on all four walls and  
1/2"x6" cedar lap siding was installed over that a long time ago. However the 30' x 36' addition on the  
West side has 2x6 studs and 2x4 studs alternating on all three walls. Rafters are 2x6 except the West  
lean-to where they are 2x12's 4' O.C. There is a row of 6x6 posts and a 6x6 beam supporting the center  
of the 2x12 rafters. House was built in 1901.

CAMERA DIRECTION: First floor, West lean-to,  
looking NW, 2x12 rafters  
and 6x6's for support

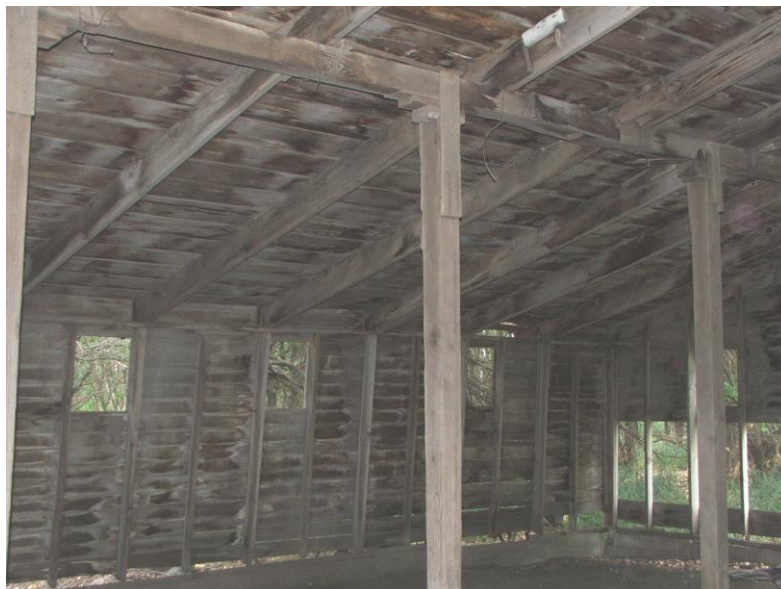
ROLL NUMBER: \_\_\_\_\_  
PHOTO NUMBER: 9

First floor, West lean-to,  
looking NW, posts and  
beam support of roof,  
note 2x12 rafters 4' O.C.

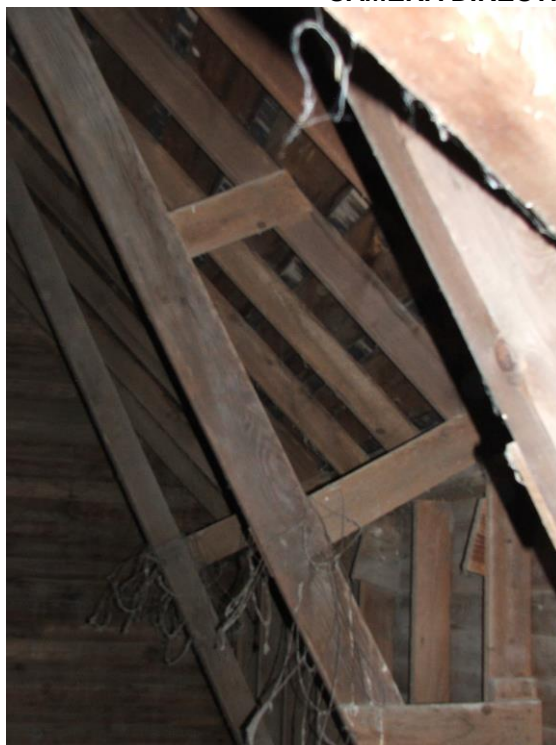
ROLL NUMBER: \_\_\_\_\_  
PHOTO NUMBER: 10

Hayloft, looking South,  
lower rafter bracing

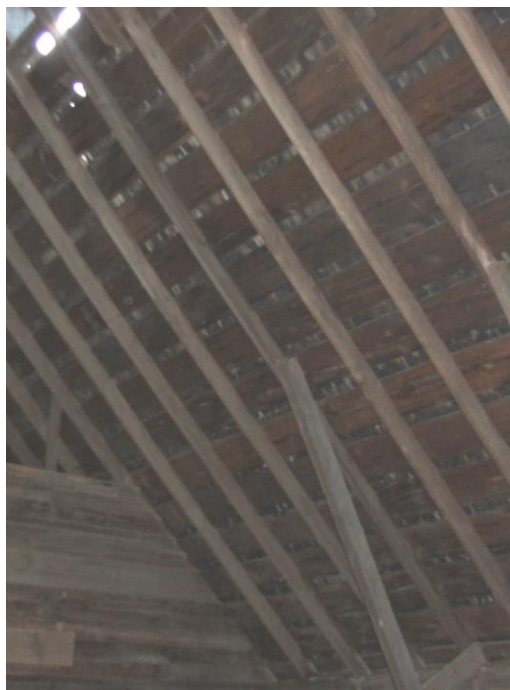
ROLL NUMBER: \_\_\_\_\_  
PHOTO NUMBER: 11

CAMERA DIRECTION: Hayloft, looking South,  
upper rafter bracing &  
16' high granary in the  
SW corner
