**SOUTH DAKOTA STATE HISTORIC PRESERVATION OFFICE
HISTORIC SITES SURVEY STRUCTURE FORM**

*SURVEY DATE: March 20, 2013 *ADDRESS: 46173 298th Street
*SURVEYOR: Jim Stone *COUNTY: Clay
*CITY: Centerville

CURRENT FUNCTION: Vacant FOUNDATION: Poured concrete
 CURRENT SUBFUNCTION: Storage ROOF MATERIAL: Steel over cedar
 HISTORIC FUNCTION: Livestock barn ROOF SHAPE: shingles
 HISTORIC SUBFUNCTION: Hay storage STRUCTURAL SYSTEM: Gambrel
 OCCUPIED: Yes STYLE: Balloon framing
Yes with TYPE: Gambrel roof barn
 ACCESSIBLE: permission WALLS: Livestock barn
2x6 studs, 1x6
#106 drop siding

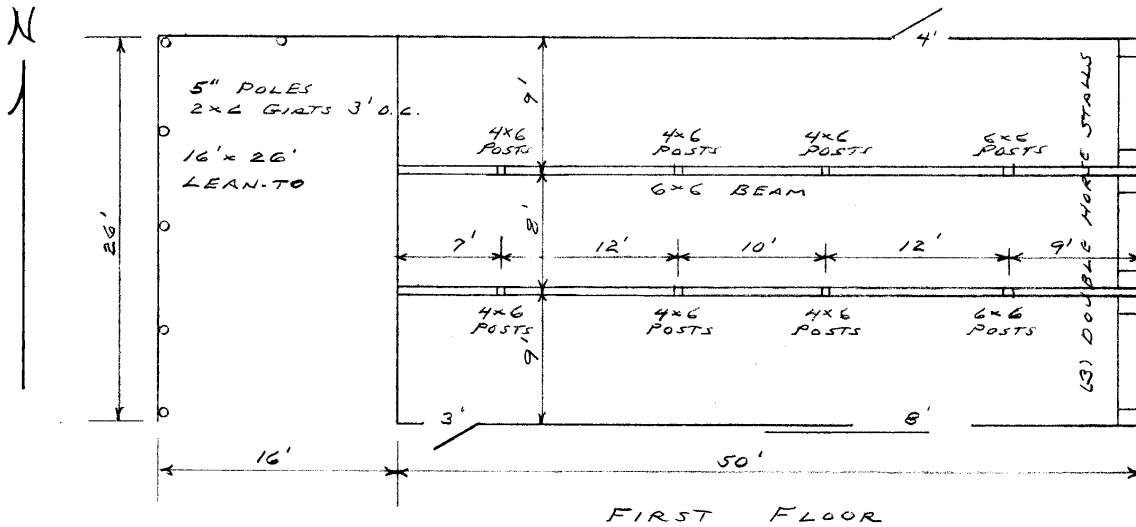
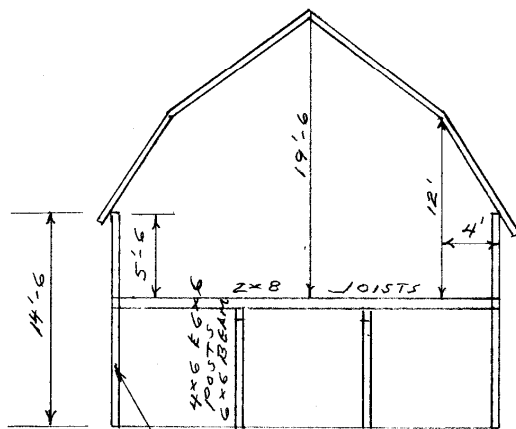
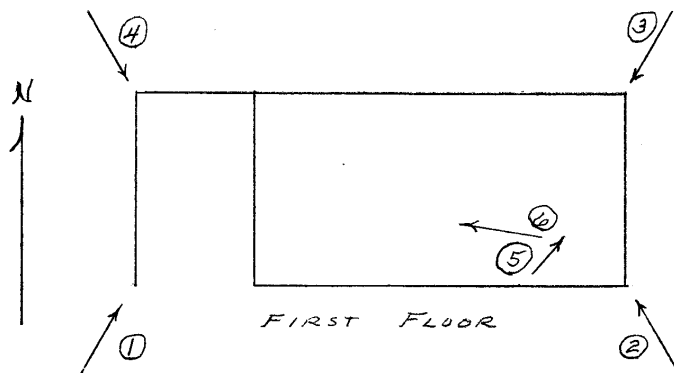
SKETCH MAP

2x6 STUDS
1x6 #102 DROP
SIDING

HAYLOFT SEALED
OFF - NO PICTURES
OR CONSTRUCTION
BRACING

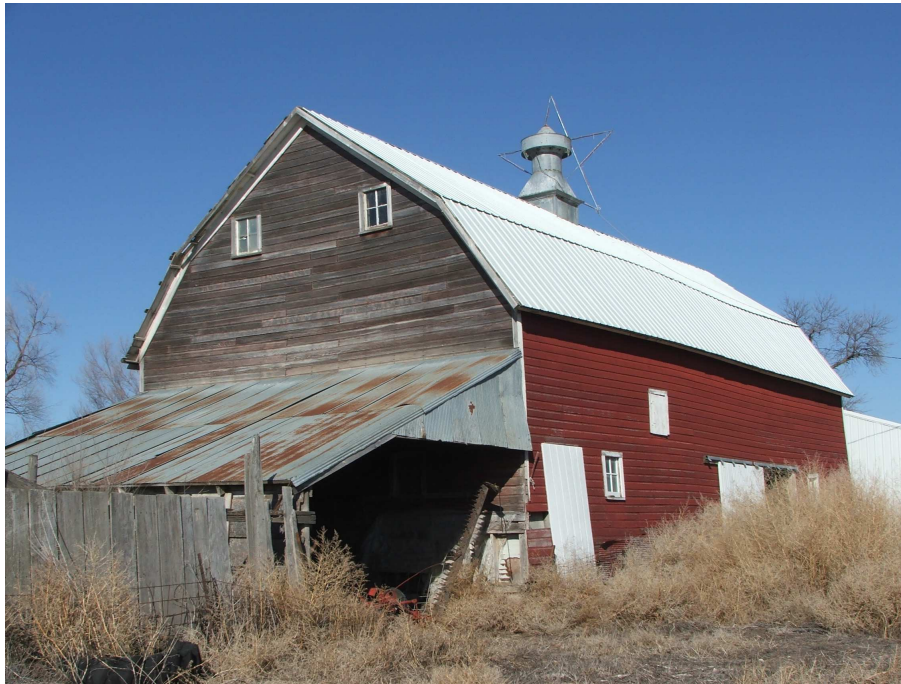
ROLL NUMBER: _____
PHOTO NUMBER: 1
CAMERA DIRECTION: Looking NE, SW corner

*PHYSICAL NOTES: Barn is in fair condition. 6x6 sills are rotting out. Barn is leaning a little to the North.

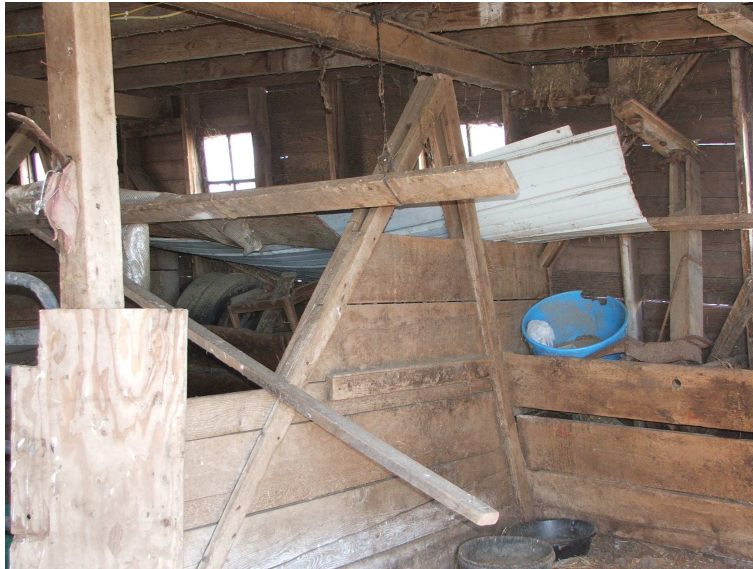
ROLL NUMBER: _____
PHOTO NUMBER: 5

INTERIOR NOTES: The original barn has two rows of 6x6 and 4x6 posts and 6x6 for a beam. The floor joists for the hayloft floor are 2x8's. Three double horse stalls are still in place on the East wall. 6x6 posts supporting the 6x6 beam are between the horse stalls, the rest of the posts are 4x6's.

CAMERA DIRECTION: First floor, looking NE, horse stalls on the East wall, note one of two 6x6 posts, rest are 4x6's

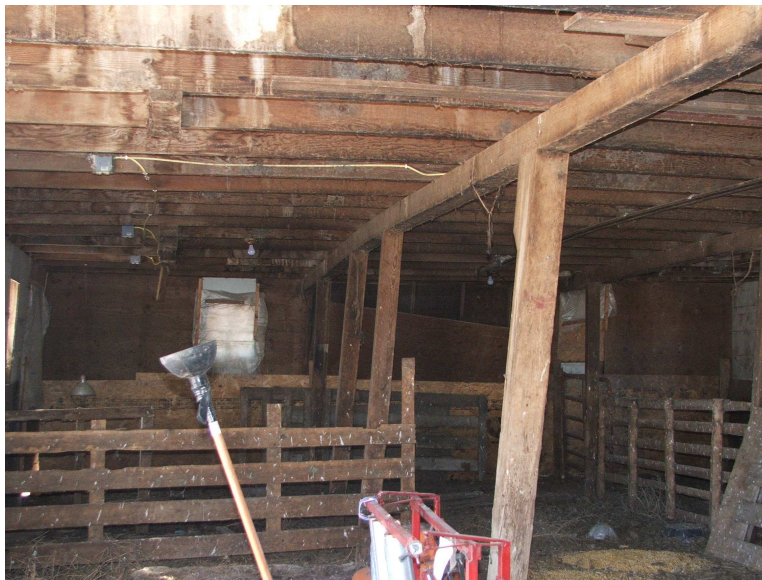
ROLL NUMBER: _____
PHOTO NUMBER: 6

CAMERA DIRECTION: First floor, looking West, pens that were used for livestock in the past, note leaning of posts.
