**SOUTH DAKOTA STATE HISTORIC PRESERVATION OFFICE  
HISTORIC SITES SURVEY STRUCTURE FORM**

\*SURVEY DATE: February 25, 2013 \*ADDRESS: 31176 452<sup>nd</sup> Ave.  
\*SURVEYOR: Jim Stone \*COUNTY: Clay  
\*CITY: Gayville

CURRENT FUNCTION: Shop

HISTORIC FUNCTION: Livestock barn

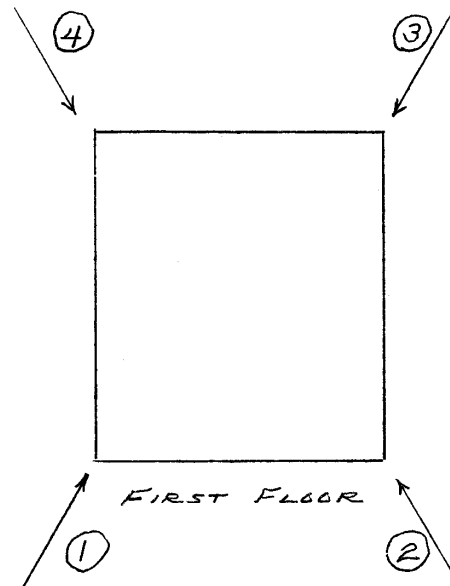
**PHOTOGR**

ALTERED/MOVED NOTES: Original site. Any evidence of horse stalls and milk cow stanchions has been removed. Some of the doors have been replaced with residential doors. A 9' x 7' overhead added in the South end of East wall. Some of the windows are replaced with residential windows.

\*PHYSICAL NOTES: Barn is in fair condition. Needs some siding repair.
