**SOUTH DAKOTA STATE HISTORIC PRESERVATION OFFICE
HISTORIC SITES SURVEY STRUCTURE FORM**

*SURVEY DATE: July 8, 2013 *ADDRESS: 30005 456th Ave.
*SURVEYOR: Jim Stone *COUNTY: Clay
*CITY: Wakonda

CURRENT FUNCTION: <u>Hog barn</u>	FOUNDATION: <u>Native stone with sand and lime mortar</u>
CURRENT SUBFUNCTION: <u>Farrowing barn</u>	ROOF MATERIAL: <u>Steel roofing over cedar shingles</u>
HISTORIC FUNCTION: <u>Livestock barn</u>	ROOF SHAPE: <u>Gable roof</u>
HISTORIC SUBFUNCTION: <u>Hay and grain storage</u>	STRUCTURAL SYSTEM: <u>Balloon framing</u>
OCCUPIED: <u>Yes</u>	STYLE: <u>Western feeder barn</u>
ACCESSIBLE: <u>Yes with permission</u>	TYPE: <u>Livestock barn</u>
	WALLS: <u>2x4 studs, 1x8 drop siding steel roofing.</u>
STORIES: <u>2</u>	SIGNIFICANT PERSON: <u>M. D. Thompson</u>
*DATE OF CONSTRUCTION: <u>Pre 1900</u>	CULTURAL AFFILIATION: <u>?</u>

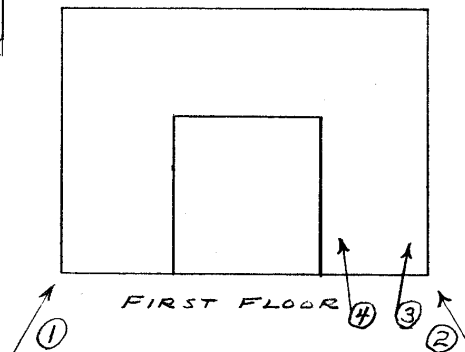
EAST ELEVATION PHOTOGRAPH

- 2x4 STUDS
- 1x8 #106 DROP SIDING
- 2x6 STUDS
- 1x10 SHIPLAP

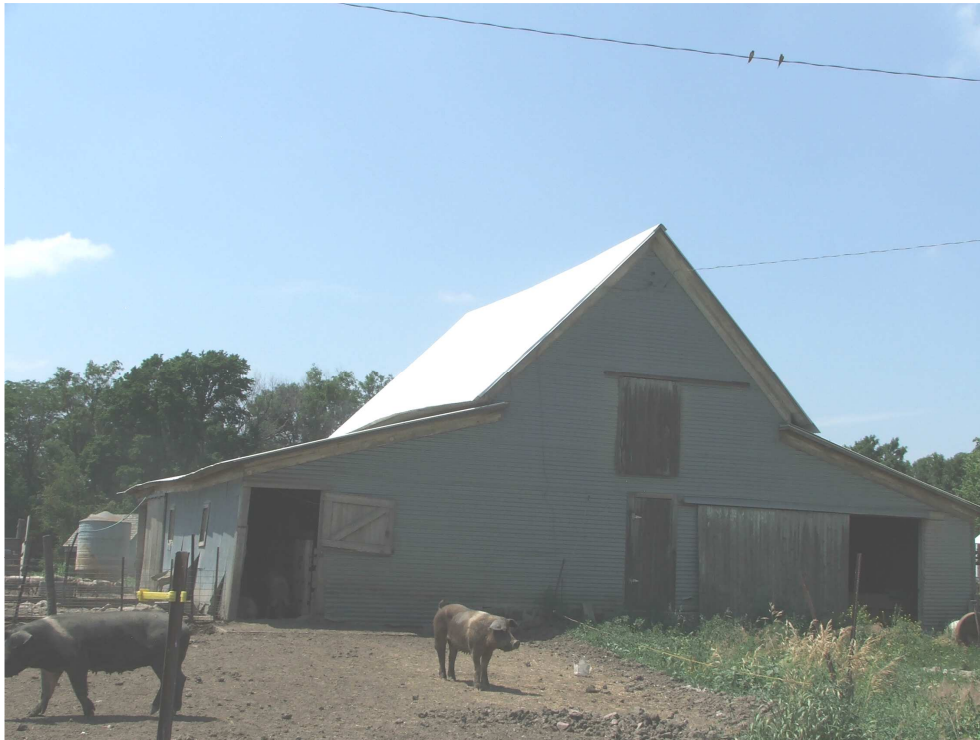
ROLL NUMBER: _____
PHOTO NUMBER: 1
CAMERA DIRECTION: Looking NW, SE corner

*PHYSICAL NOTES: Barn is in fair condition.

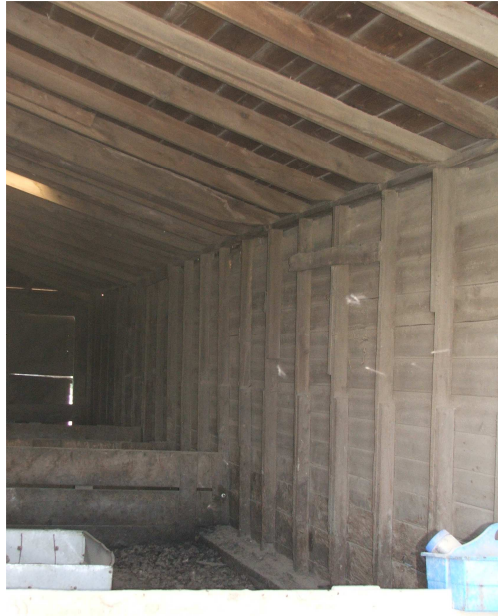
OTHER NOTES: 2x4 stud walls with 1 x 8 #106 drop siding and horizontal steel roofing on lean-to walls. 2x6 stud walls with 1x10 shiplap on center barn. Rafters are 2x6's. Windows are 8" x 10" four light.

ROLL NUMBER: _____
PHOTO NUMBER: 3
CAMERA DIRECTION: First Floor, looking NW,
2x4 wall of North lean-to.

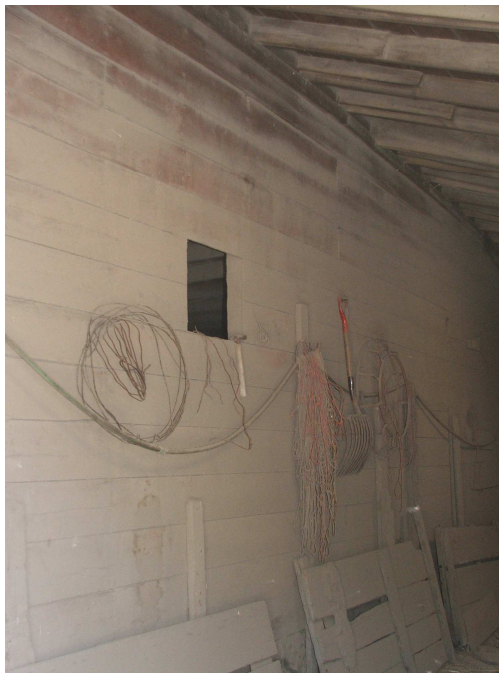
ROLL NUMBER: _____
PHOTO NUMBER: 4
CAMERA DIRECTION: First floor, looking SW
into North lean-to, North
wall of center barn, 2x6
studs and 1x10 shiplap.
