SOUTH DAKOTA STATE HISTORIC PRESERVATION OFFICE
HISTORIC SITES SURVEY STRUCTURE FORM

*ADDRESS: 45753 Timber Road
*COUNTY: Clay
*CITY: Vermillion

SHPO ID: _____	
*PROPERTY NAME: _____	
OTHER NAME: _____	
CURRENT FUNCTION: <u>Farm machinery storage</u>	FOUNDATION: <u>Poured concrete</u>
CURRENT SUBFUNCTION: <u>Storage</u>	ROOF MATERIAL: <u>Steel</u>
HISTORIC FUNCTION: <u>Livestock barn</u>	ROOF SHAPE: <u>Gambrel</u>
HISTORIC SUBFUNCTION: <u>Hay and grain storage</u>	STRUCTURAL SYSTEM: <u>Balloon framing</u>
	STYLE: <u>Gambrel roof barn</u>
OCCUPIED: <u>Yes</u>	TYPE: <u>Livestock barn</u>
	<u>2x6, sheathing &</u>
ACCESSIBLE: <u>Yes with permission</u>	WALLS: <u>steel roofing</u>
STORIES: <u>2</u>	SIGNIFICANT PERSON: <u>Martin Knutson</u>
*DATE OF CONSTRUCTION: <u>?</u>	CULTURAL AFFILIATION: <u>Norwegian</u>

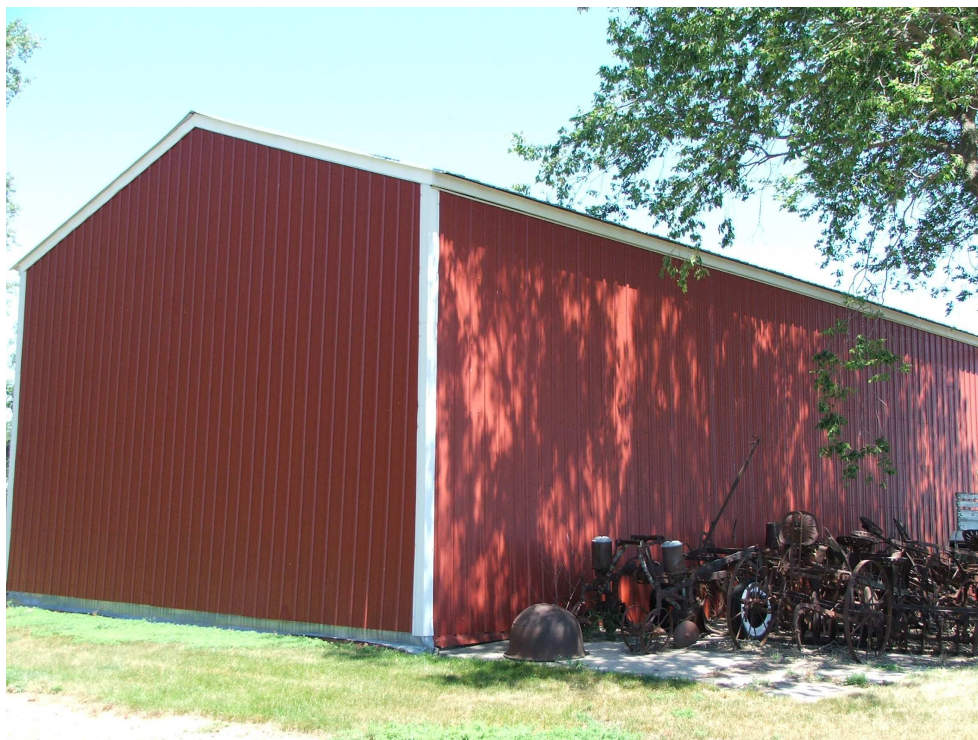
ROLL NUMBER: _____
PHOTO NUMBER: 1
CAMERA DIRECTION: Looking NE, SW corner

*PHYSICAL NOTES: Barn is in excellent condition. A very good idea to continue the use of an old barn for today's agriculture needs.

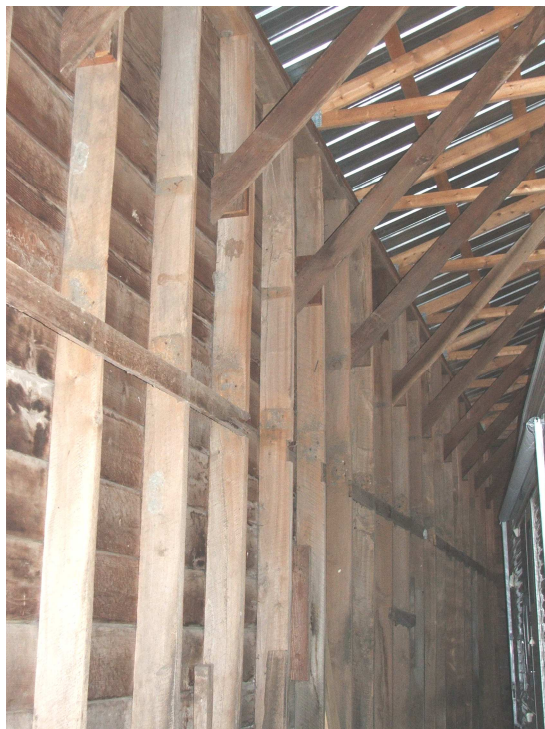
ROLL NUMBER: _____
PHOTO NUMBER: 5

ALTERED/MOVED NOTES: Original site. Gambrel roof was removed. Manufactured trusses were used for new roof. Walls and roof are covered with steel roofing. All stalls, stanchions, calf pen, granary and hayloft floor have been removed. Barn has been remodeled into a machinery storage building. The 2x6 walls 14'-6" high and 2x6 rafter to wall bracing are all that is still in use.

CAMERA DIRECTION: Looking West, South wall, original stud wall and rafter bracing

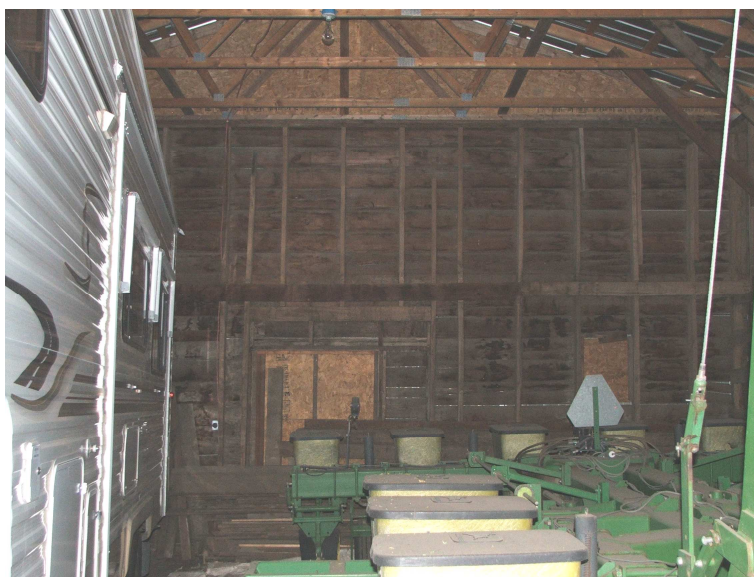
ROLL NUMBER: _____
PHOTO NUMBER: 6

CAMERA DIRECTION: Looking West, new trusses and original West wall

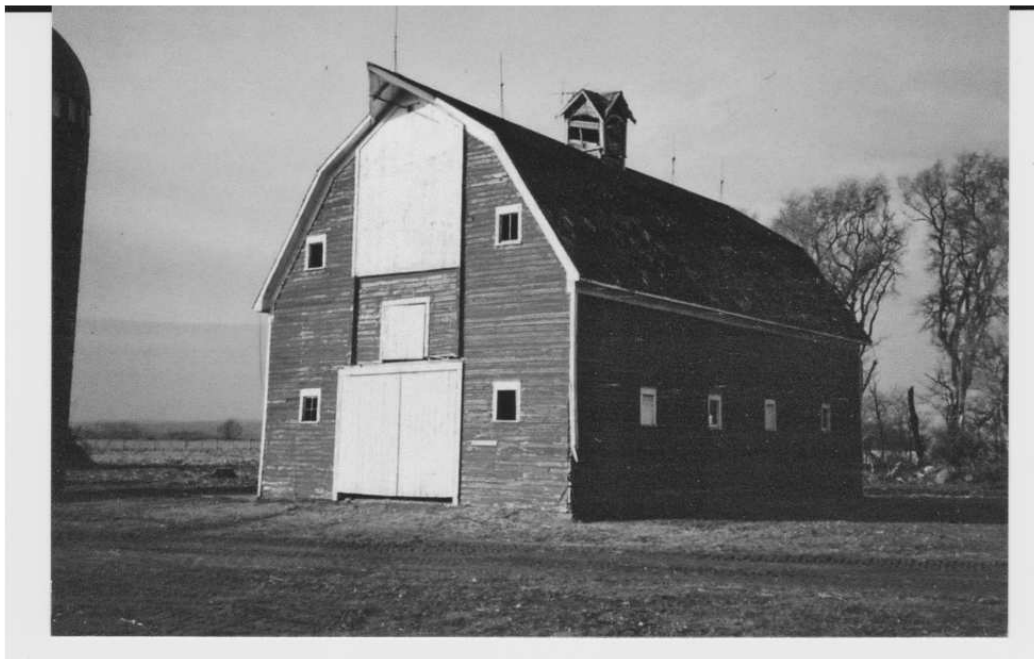
ROLL NUMBER:
PHOTO NUMBER: 7
CAMERA DIRECTION: Original barn before
remodeling

INTERIOR NOTES: Had 6x6 posts and 6x6 beams to support hayloft floor. Joists were 2x8. All of the 2x6's for studs, rafters and bracing, 2x8 floor joists, 6x6 posts and 6x6 beams were rough sawn cottonwood.
