**SOUTH DAKOTA STATE HISTORIC PRESERVATION OFFICE
HISTORIC SITES SURVEY STRUCTURE FORM**

*SURVEY DATE: July 13, 2012 *ADDRESS: 45582 307th Street
*SURVEYOR: Jim Stone *COUNTY: Clay
*CITY: Volin

CURRENT FUNCTION: Sheep and goats FOUNDATION: Poured concrete
Asphalt shingles,
cedar shingles
removed
 CURRENT SUBFUNCTION: Hay storage ROOF MATERIAL: _____
 HISTORIC FUNCTION: Cattle barn ROOF SHAPE: Gambrel
 HISTORIC SUBFUNCTION: Hay and grain storage STRUCTURAL SYSTEM: Balloon framing
 OCCUPIED: Yes STYLE: Gambrel roof barn
 Yes with TYPE: Livestock barn
 ACCESSIBLE: permission WALLS: 2x6, sheathing &
1/2"x6" cedar siding

STORIES: 2 SIGNIFICANT PERSON: Lewis & Julia Bervin
 *DATE OF CONSTRUCTION: 1918 CULTURAL AFFILIATION: Norwegian

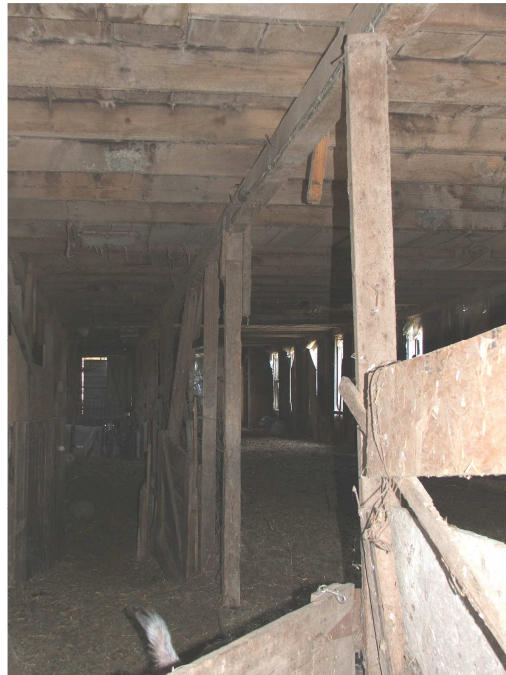
ROLL NUMBER: 5
PHOTO NUMBER: 5

INTERIOR NOTES: Had two rows 4x4 posts and 4x4 beams to support hayloft floor. Joists were 2x8. Had two metal ducts from the hayloft floor up to each of the three cupola's. Duct work has been removed, but the wire brackets that held the ducts in place between the rafters are still there.

CAMERA DIRECTION: First floor, looking North,
4x4 posts, 4x4 beams &
2x6 floor joists

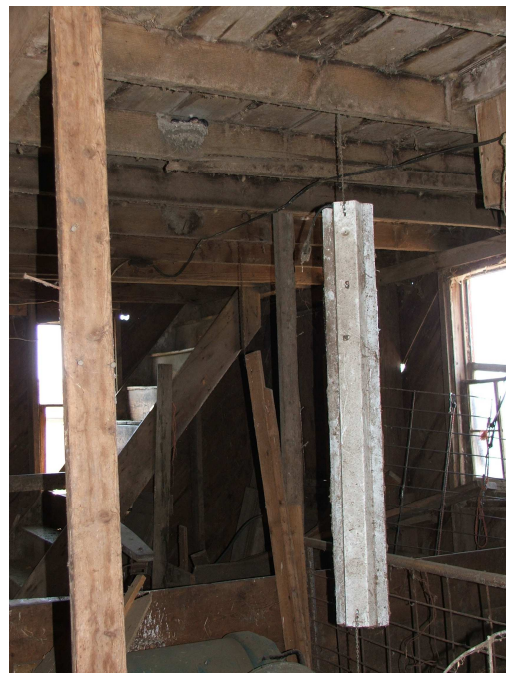
ROLL NUMBER: 6
PHOTO NUMBER: 6

CAMERA DIRECTION: First floor, looking SW,
stairs to hayloft SW
corner

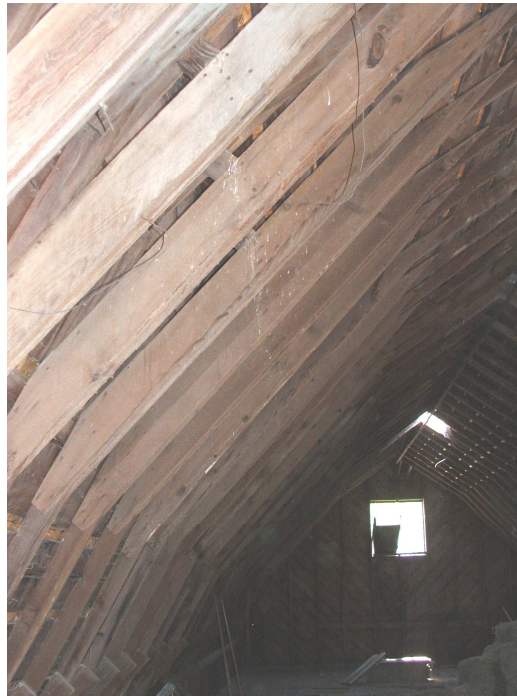
ROLL NUMBER: _____
PHOTO NUMBER: 7

OTHER NOTES: Windows were 8"x10" four light over 8"x10" four light, double hung for ventilation. 2x6 stud walls with diagonal sheathing and 1/2"x6" cedar siding on all four walls. 2x4 rafters with two 1x6 braces on each hip. A short 2x4 was at the hip, held in place with two short 1x6's, down to the two 1x6 braces. No rafter to wall bracing.

CAMERA DIRECTION: Hayloft, looking North,
lower rafter and hip
bracing

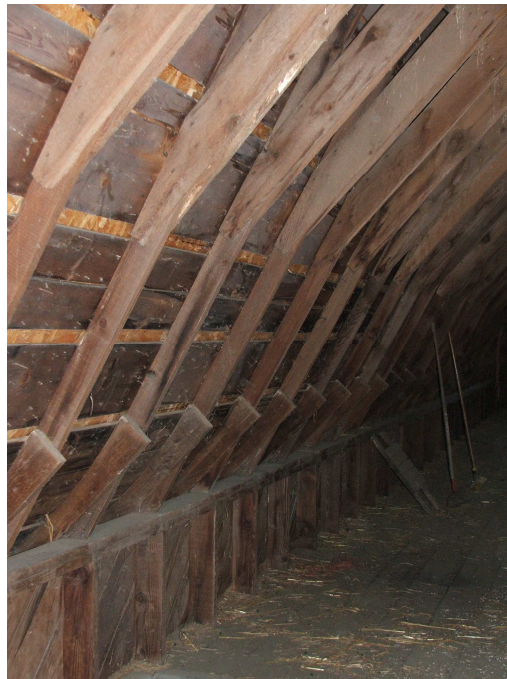
ROLL NUMBER: _____
PHOTO NUMBER: 8

CAMERA DIRECTION: Hayloft, looking North,
rafter bracing at the hip

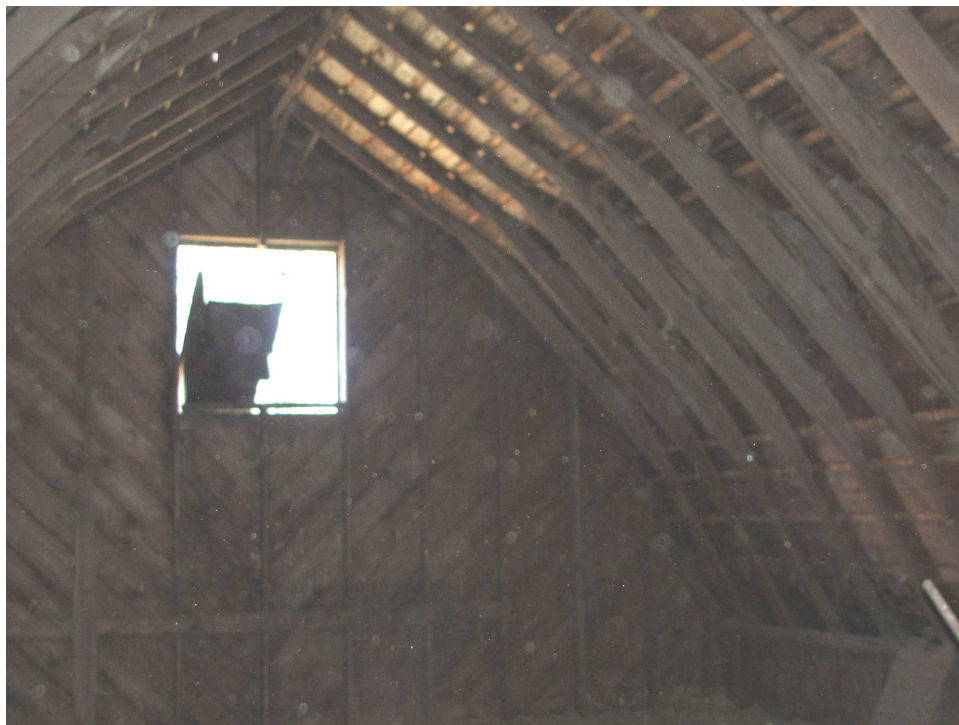
ROLL NUMBER: _____
PHOTO NUMBER: 9

CAMERA DIRECTION: Hayloft, looking North
rafter bracing, diagonal
sheathing on gable end
