**SOUTH DAKOTA STATE HISTORIC PRESERVATION OFFICE
HISTORIC SITES SURVEY STRUCTURE FORM**

*SURVEY DATE: December 2, 2012 *ADDRESS: 30534 461th Ave.
*SURVEYOR: Jim Stone *COUNTY: Clay
*CITY: Wakonda

CURRENT FUNCTION:	<u>Cattle barn and calving barn</u>	FOUNDATION:	<u>Poured concrete foundation</u>
CURRENT SUBFUNCTION:	<u>Storage</u>	ROOF MATERIAL:	<u>Steel roofing over cedar shingles</u>
HISTORIC FUNCTION:	<u>Livestock barn</u>	ROOF SHAPE:	<u>Gable</u>
HISTORIC SUBFUNCTION:	<u>Hay and grain storage</u>	STRUCTURAL SYSTEM:	<u>Heavy posts and beams, mortised and tendon w/ pegs, bank barn with gable roof</u>
OCCUPIED:	<u>Yes</u>	STYLE:	<u>barn</u>
ACCESSIBLE:	<u>Yes with permission</u>	TYPE:	<u>Livestock barn</u>
		WALLS:	<u>2x6 studs with sheathing, 1/2"x6" cedar lap siding</u>
STORIES:	<u>2</u>	SIGNIFICANT PERSON:	<u>Ole Syverson Leivold</u>
*DATE OF CONSTRUCTION:	<u>Pre- 1900</u>	CULTURAL AFFILIATION:	<u>Norwegian</u>

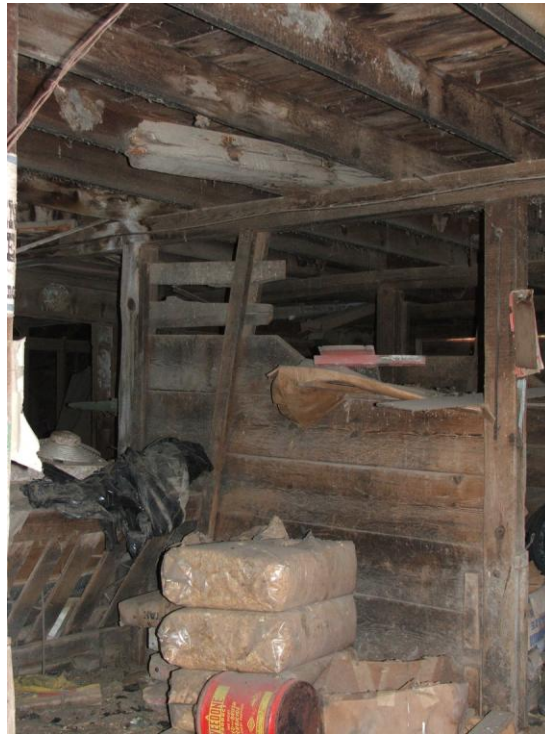
ROLL NUMBER: _____
PHOTO NUMBER: 5

CAMERA DIRECTION: First floor, looking SE,
one of six double horse
stalls on West side.

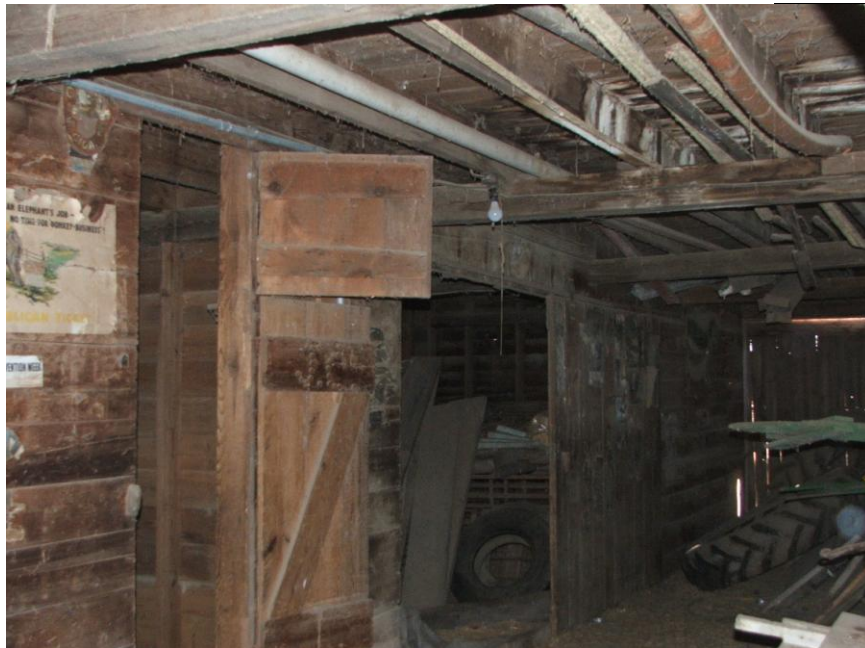
ROLL NUMBER: _____
PHOTO NUMBER: 6

CAMERA DIRECTION: First floor, looking SE,
center grain bin and hay
storage in SE corner

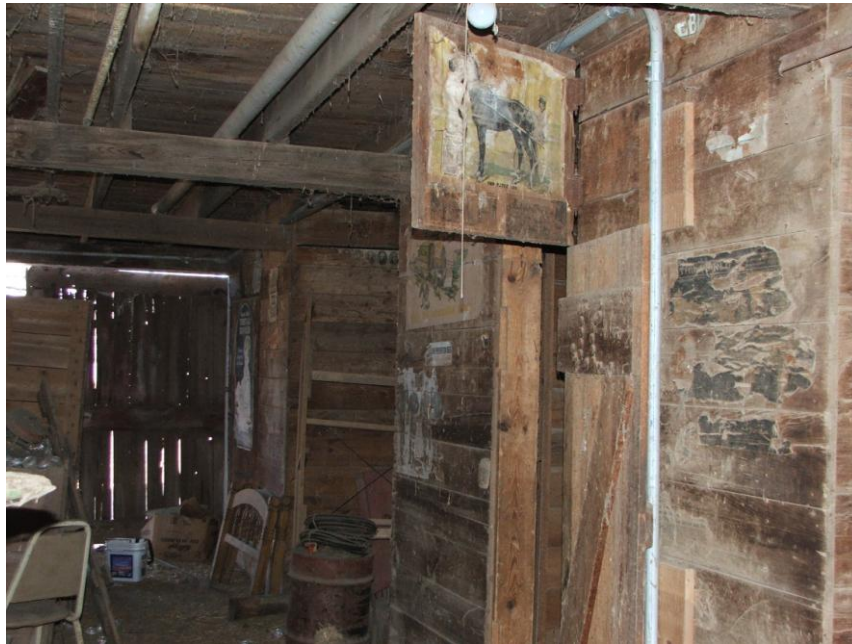
ROLL NUMBER: _____
PHOTO NUMBER: 7

**First floor, looking NE,
Center granary, tack
room and granary on
East side.**

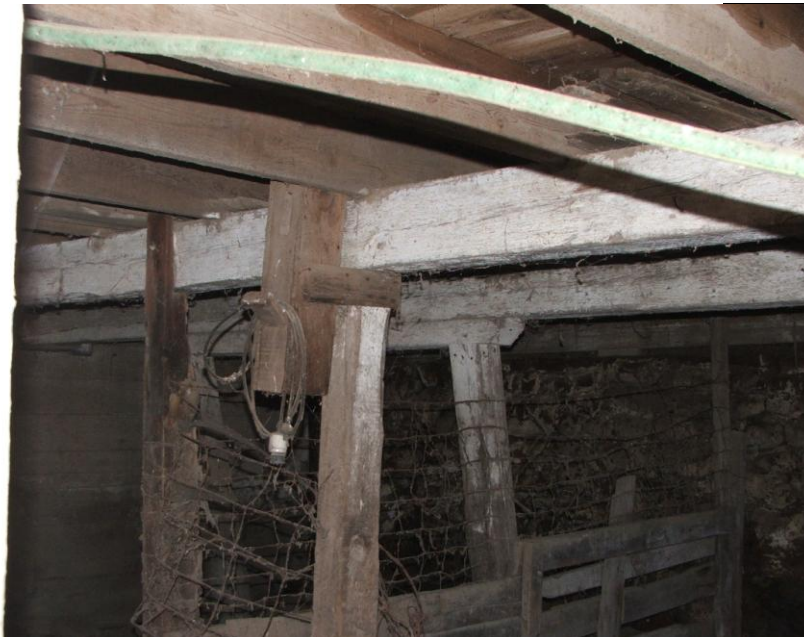
ROLL NUMBER: _____
PHOTO NUMBER: 8

**Basement, looking SW,
6x6 posts, 6x8 beams
and 2x8 floor joists and
plank floor for the East**

CAMERA DIRECTION: 20' of the main barn

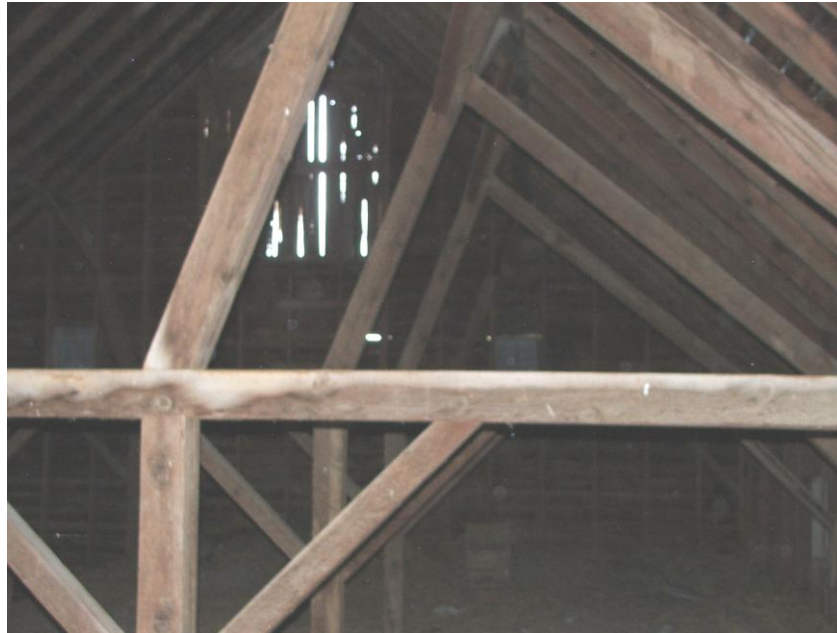
ROLL NUMBER: _____
PHOTO NUMBER: 9

**Hayloft, looking South,
6x6 posts, 6x6 beams
and 4x4 bracing, note
round pegs.**

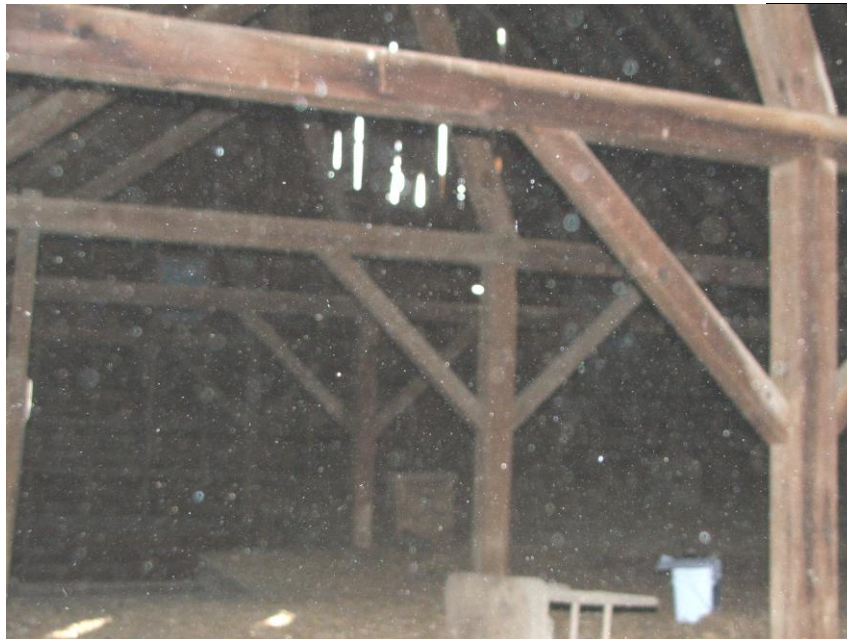
ROLL NUMBER: _____
PHOTO NUMBER: 10

**Hayloft, looking SW, 6x6
posts, 6x6 beams, 4x4
bracing all mortised and
tendon with round pegs.**

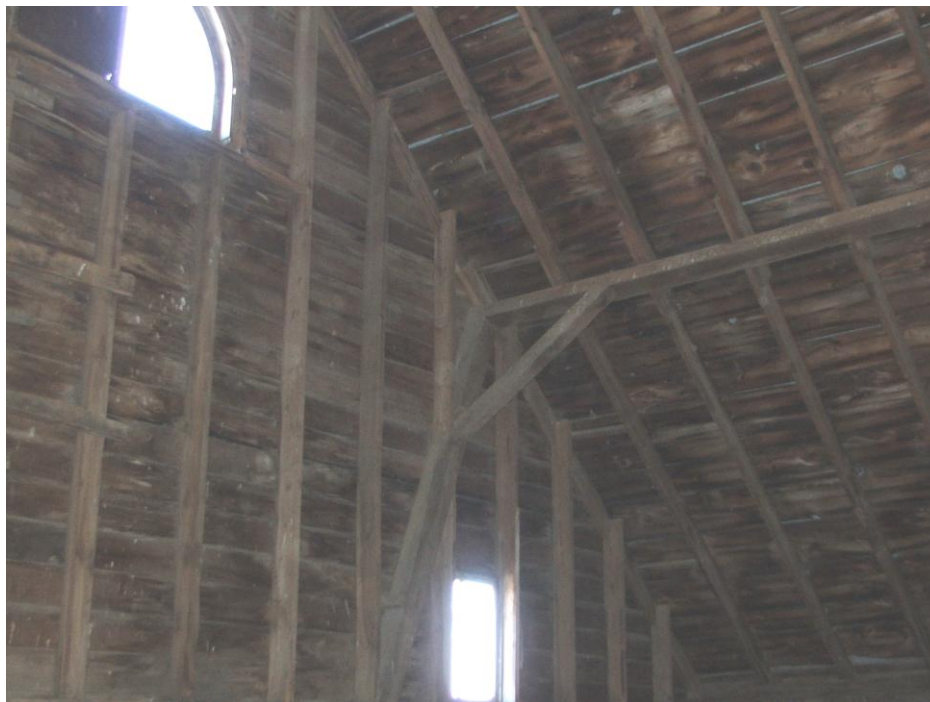
ROLL NUMBER: _____
PHOTO NUMBER: 11

CAMERA DIRECTION: Hayloft, looking NE, 6x6 angled post in the gable wall supporting 6x6 beam supporting center of rafters. This posts also sits on a 6x6 beam built into the gable wall.
