**SOUTH DAKOTA STATE HISTORIC PRESERVATION OFFICE  
HISTORIC SITES SURVEY STRUCTURE FORM**

\*SURVEY DATE: July 29, 2012 \*ADDRESS: 30574 461<sup>st</sup> Ave.  
\*SURVEYOR: Jim Stone \*COUNTY: Clay  
\*CITY: Wakonda

CURRENT FUNCTION: <u>Vacant</u>	FOUNDATION: <u>Poured concrete</u>
CURRENT SUBFUNCTION: <u>Storage</u>	ROOF MATERIAL: <u>Cedar shingles</u>
HISTORIC FUNCTION: <u>Livestock barn</u>	ROOF SHAPE: <u>Gambrel</u>
HISTORIC SUBFUNCTION: <u>Hay and grain storage</u>	STRUCTURAL SYSTEM: <u>Balloon framing</u>
	STYLE: <u>Gambrel roof barn</u>
OCCUPIED: <u>Yes</u>	TYPE: <u>Livestock barn</u>
	<u>2x6, sheathing,</u>
ACCESSIBLE: <u>Yes with permission</u>	WALLS: <u>1/2"x6" cedar lap siding</u>

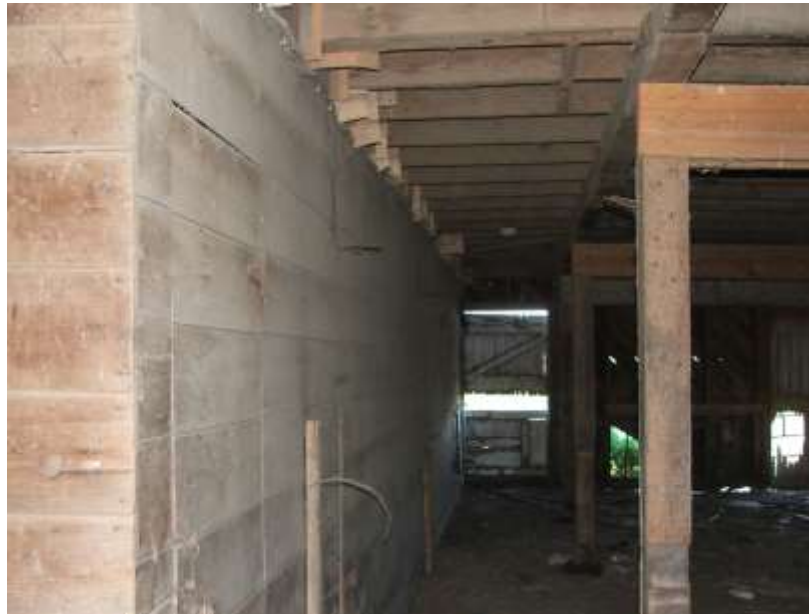
**ROLL NUMBER:** \_\_\_\_\_  
**PHOTO NUMBER:** 5

INTERIOR NOTES: Has two rows 6x6 posts and 6x6 beams and a 2x4 wall with 1x10 shiplap to support the hayloft floor. Floor joists are 2x8's. Has a nice staircase up to the hayloft. The 8'x10' granary is still in place.

**CAMERA DIRECTION:** First floor, looking East,  
feed alley, 2x4 solid wall  
North, posts and beam  
South

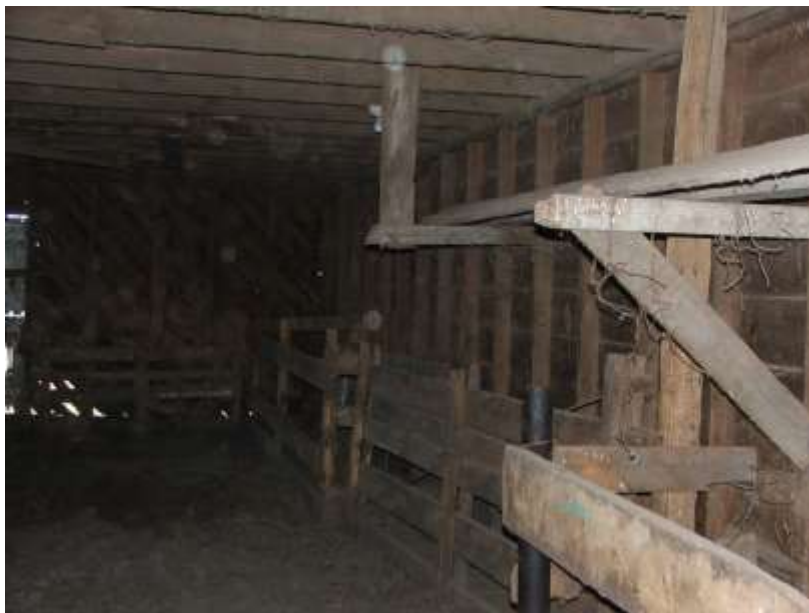
**ROLL NUMBER:** \_\_\_\_\_  
**PHOTO NUMBER:** 6

**CAMERA DIRECTION:** First floor, North side,  
looking East

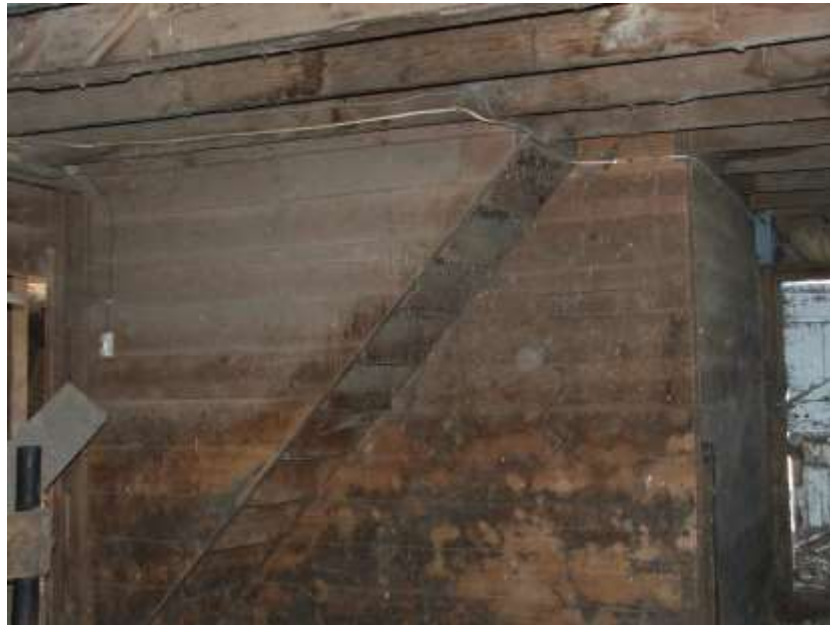
**ROLL NUMBER:** \_\_\_\_\_  
**PHOTO NUMBER:** 7

**First floor, North side,  
looking West, stairs,  
granary & alley**

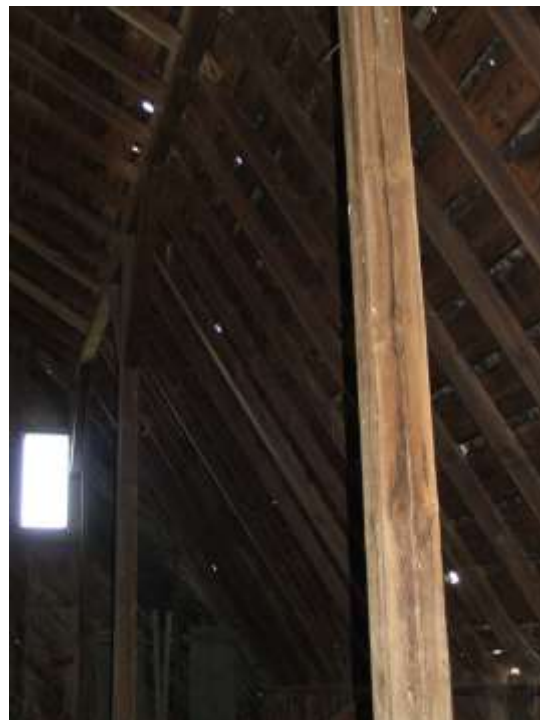
**ROLL NUMBER:** \_\_\_\_\_  
**PHOTO NUMBER:** 8

OTHER NOTES: Windows were 8"x10" four light on the first floor and 8"x10" four light over 8"x10" four light, double hung, in hayloft. Walls are 2x6 with diagonal sheathing on all four walls and 1/2"x6" cedar lap siding. Two 6x6 posts with a 6x6 beam support the hip on each side. There is a 6x6 rafter behind each post. Two 2x10's brace the bottom of 6x6 rafter down to bottom of 6x6 post and down to floor joists.

**Hayloft, looking East,  
6x6 posts, 6x6 beam and  
6x6 rafter behind 6x6**

**CAMERA DIRECTION:** post

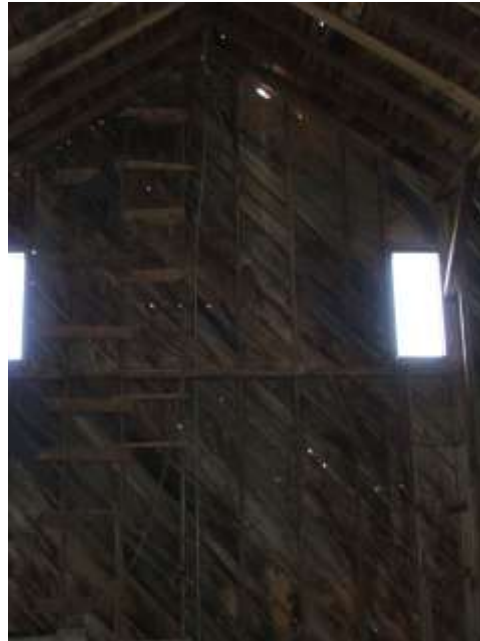
**ROLL NUMBER:** \_\_\_\_\_  
**PHOTO NUMBER:** 9

**CAMERA DIRECTION:** Hayloft, looking East,  
gable end and diagonal  
sheathing

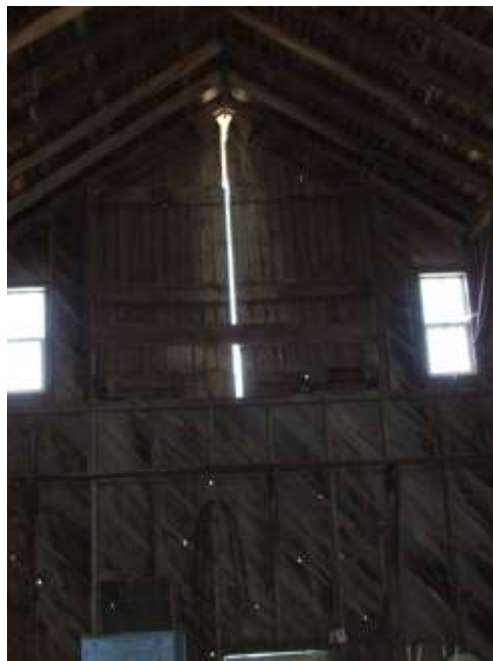
**ROLL NUMBER:** \_\_\_\_\_  
**PHOTO NUMBER:** 10

**CAMERA DIRECTION:** Hayloft. Looking West,  
hayloft door and  
diagonal sheathing
