**SOUTH DAKOTA STATE HISTORIC PRESERVATION OFFICE
HISTORIC SITES SURVEY STRUCTURE FORM**

*SURVEY DATE: July 20, 2012 *ADDRESS: 30624 470th Ave.
*SURVEYOR: Jim Stone *COUNTY: Union
*CITY: Beresford

CURRENT FUNCTION: Livestock barn

HISTORIC FUNCTION: Draft horse barn

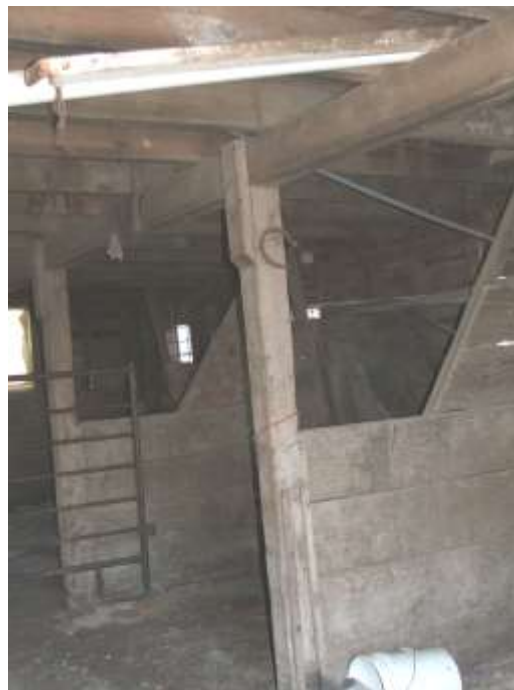
INTERIOR NOTES: Has two rows 6x6 posts and (3) 2x8's beam to support hayloft floor. Floor joists are 2x8's. Horse stalls and harness room are still in place.

ROLL NUMBER: _____
PHOTO NUMBER: 4
CAMERA DIRECTION: First floor, looking NE, post, beam and horse stalls

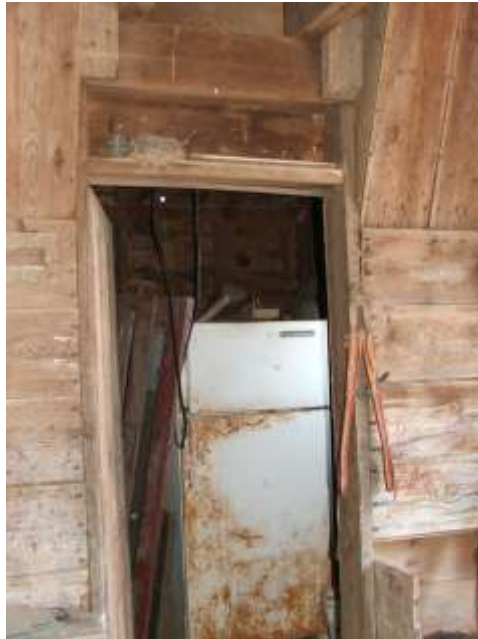
ROLL NUMBER: _____
PHOTO NUMBER: 5
CAMERA DIRECTION: First floor, looking East, harness room

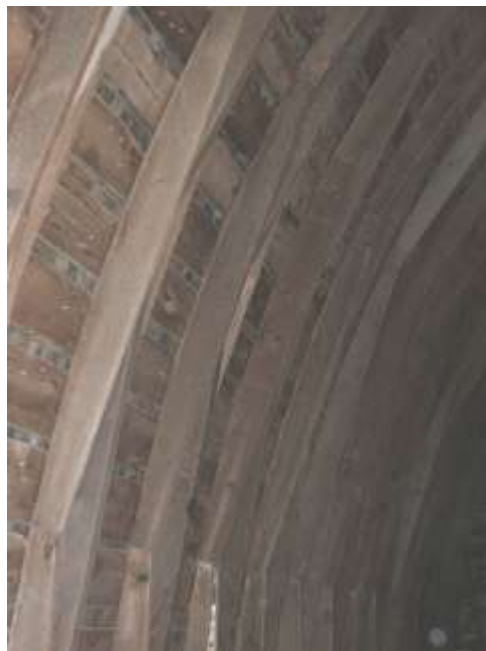
OTHER NOTES: Windows were 8"x10" four light. Walls are 2x6 with 1x10 shiplap sheathing and 1/2"x6" cedar lap siding. Rafters are site built from short 2x6's with 1x6's on each side, joints staggered. 10'x10' granary in SE corner of hayloft, divided into a 4'x10' and a 6'x 10' bins.

ROLL NUMBER: _____
PHOTO NUMBER: 6
CAMERA DIRECTION: Hayloft, looking North, site built gothic round rafters, laminated 1x6-2x6-1x6

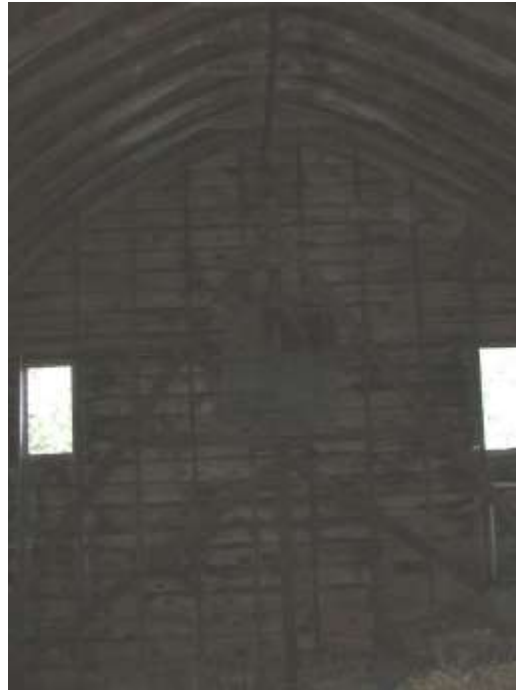
ROLL NUMBER: _____
PHOTO NUMBER: 7

CAMERA DIRECTION: Hayloft, looking North, rafters, North gable end and diagonal bracing

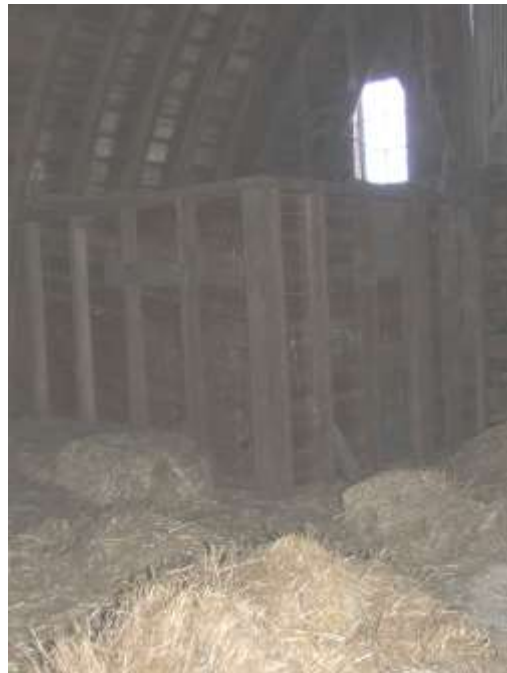
ROLL NUMBER: _____
PHOTO NUMBER: 8

CAMERA DIRECTION: Hayloft, looking SE, granary in hayloft
