SOUTH DAKOTA STATE HISTORIC PRESERVATION OFFICE
HISTORIC SITES SURVEY STRUCTURE FORM

*ADDRESS: 45924 300th Street
*COUNTY: Clay
*CITY: Centerville

CURRENT FUNCTION:	<u>Cow calf barn</u>	FOUNDATION:	<u>Poured concrete</u>
CURRENT SUBFUNCTION:	<u>Cow calf barn</u>	ROOF MATERIAL:	<u>Steel over cedar shingles</u>
HISTORIC FUNCTION:	<u>Livestock barn</u>	ROOF SHAPE:	<u>Gable</u>
HISTORIC SUBFUNCTION:	<u>Hay storage</u>	STRUCTURAL SYSTEM:	<u>Balloon framing</u>
OCCUPIED:	<u>Yes</u>	STYLE:	<u>Western feeder barn</u>
ACCESSIBLE:	<u>Yes with permission</u>	TYPE:	<u>Livestock barn</u>
			<u>2x4 and 2x6 studs,</u>
			<u>1x8 sheathing, 12"x</u>
			<u>7" embossed cut</u>
			<u>stone steel siding</u>
WALLS:			
STORIES:	<u>2</u>	SIGNIFICANT PERSON:	<u>Roy Ward</u>
*DATE OF CONSTRUCTION:	<u>Early 1900's</u>	CULTURAL AFFILIATION:	<u>English</u>

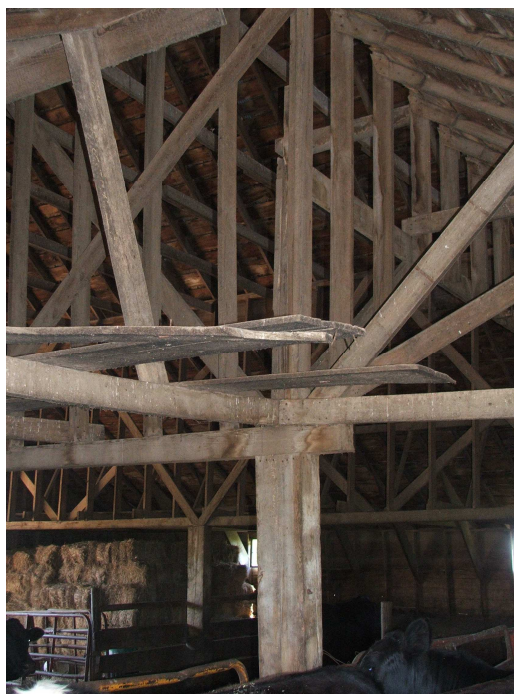
ROLL NUMBER: _____
PHOTO NUMBER: 4

INTERIOR NOTES: Two rows of 10"x10" posts, 20' O. C. and 6x6 beams support the two 40' East and West walls of center barn. 14' lean-to's on the West, North and East sides. All evidence of horse stalls or milk cow stanchions has been removed. 14' wide x 12' high double sliding doors on the North side. Walls are built up with a gable roof to allow for this doorway.

CAMERA DIRECTION: First floor, looking SW,
10'x 10' posts with 6x6
beam supporting the 40'
East wall of the center
barn, note 2x6 open stud
walls above 6x6 beam.

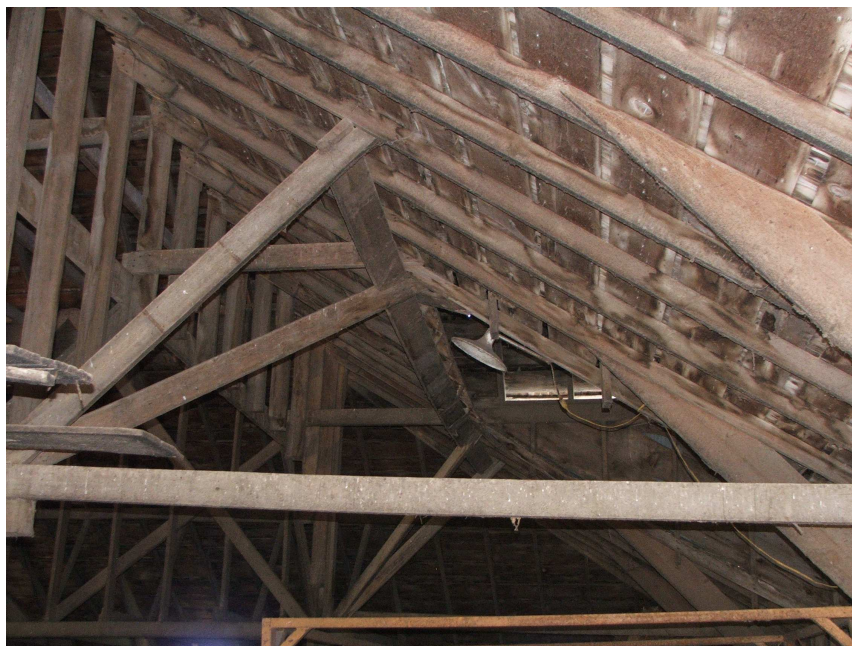
ROLL NUMBER: _____
PHOTO NUMBER: 5

OTHER NOTES: 2x4 stud walls with 1x8 horizontal sheathing on all four walls with 12"x7" embossed cut stone steel siding. Walls in the center 28' x 40' are open 2x6 stud walls above the 6x6 beams, with sheathing on the South wall and above the lean-to roof on the West, North and East sides. Rafters are 2x4. 2x6 braces with a 2x8 beam support the lean-to rafters.

CAMERA DIRECTION: First floor, looking West,
2x6 bracing with 2x8
beam supporting 2x4
rafters on lean-to.
